# Rail Accident Report

## **Tram collision at Soho Benson Road, Midland Metro 19 December 2006**

# Tram collision at Soho Benson Road, Midland Metro, 19 December 2006

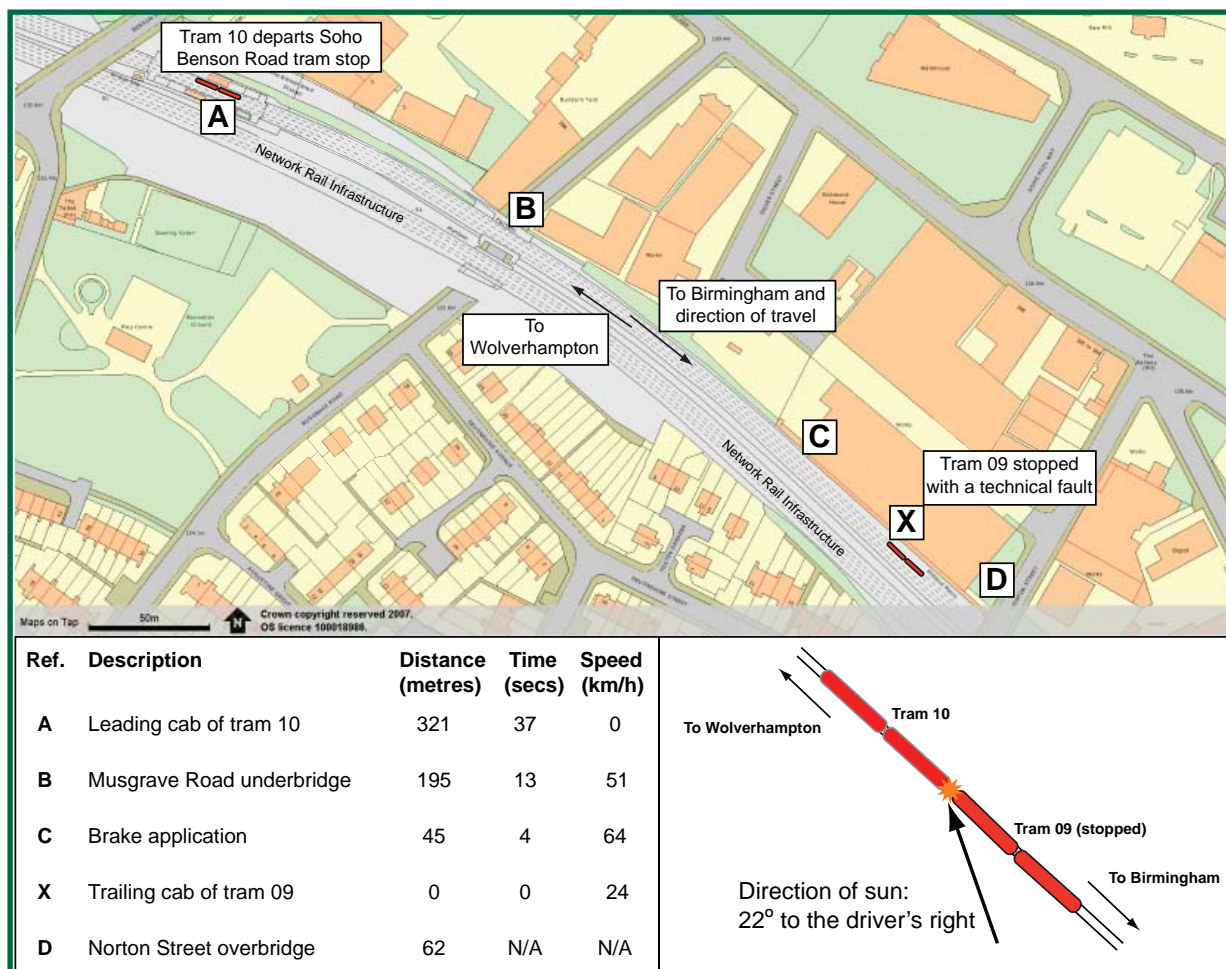
Figure 3: Location of the collision

- 18 The collision occurred between Soho Benson Road (Soho) and Jewellery Quarter tram stops, at a location 62 metres north west of Norton Road overbridge. This location is 18 km from Wolverhampton. See Figure 3.

- 28 After tram 09 departed Soho nine minutes late at 11:49 hrs the original fault reoccurred and caused an automatic application of the service brake that brought the tram to a halt 62 metres north west of Norton Road overbridge. See Figure 3. At this location, tram 09 was obscured from trams departing Soho due to right hand track curvature and vegetation on Network Rail infrastructure at Musgrave Road underbridge. See Figure 5.
- 29 Tram 09's driver called the control centre using the cab mobile phone and waited for the call to be answered. The driver did not use the tram's hazard warning lights to warn other trams of the obstruction.
- 30 Up to this time tram 10's driver had not seen tram 09 ahead at any time in its journey, even when the time interval between trams reduced to one minute.

- 50 A site survey and reconstruction confirmed that in good visibility, a Birmingham bound tram driver has an uninterrupted line of sight from Musgrave Road underbridge to the location of stationary tram 09, Norton Road overbridge and beyond. See Figure 3.

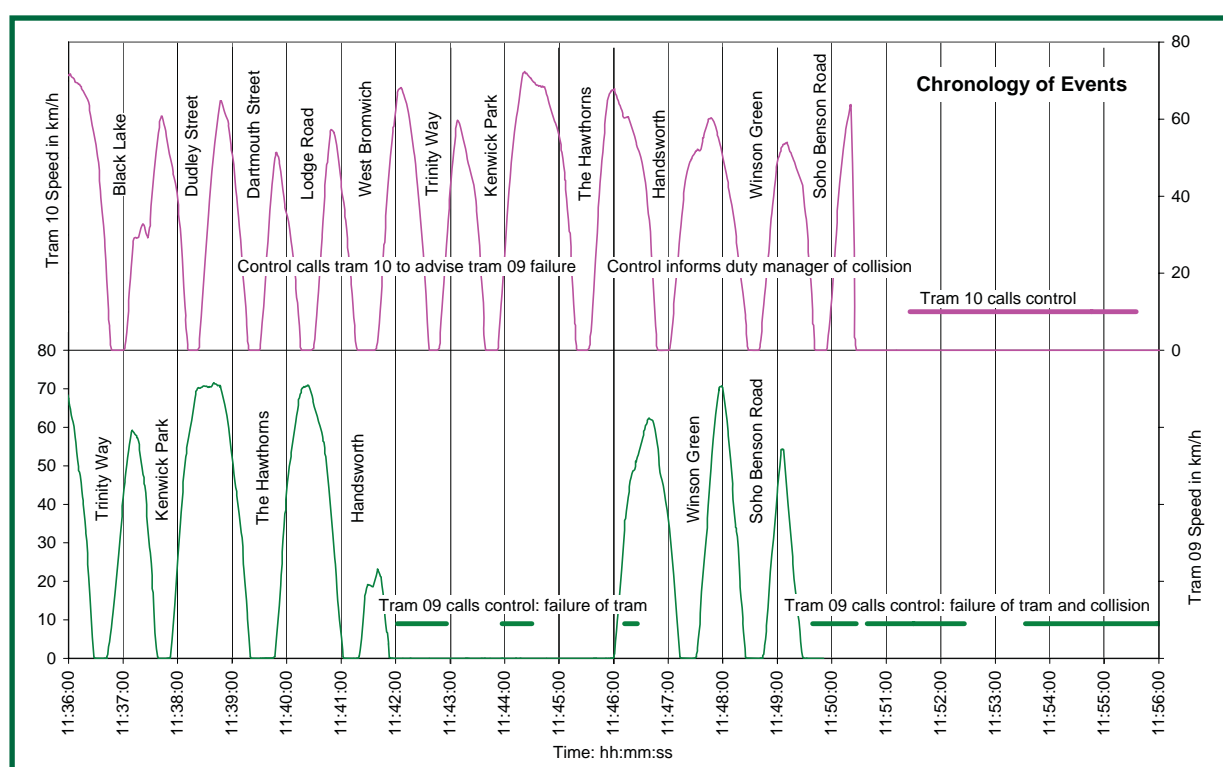
Figure 4: Chronology of events up to and including the collision

- 26 Tram 10 was running two minutes behind schedule. It was thus one minute behind tram 09 after Handsworth tram stop. See Figure 4 for a chronology of events up to and including the collision.
