# Rail Accident Report

## **Derailment of a tram on the Seaton Tramway 18 March 2007**

# **Derailment of a tram on the Seaton Tramway**

## **18 March 2007**

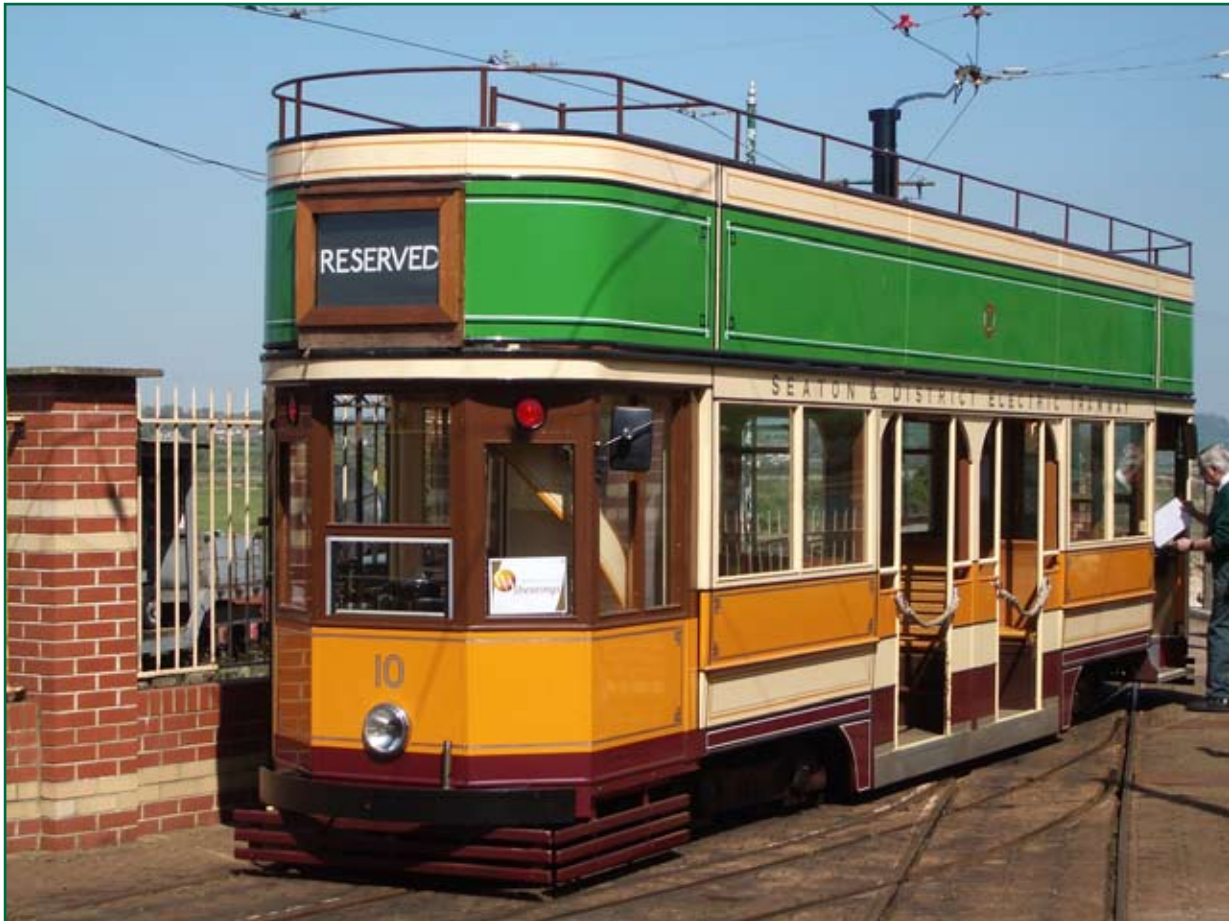
Figure 2: Seaton Tram no. 10

9. The tramway uses a fleet of electrically powered trams, some rebuilt from historic vehicles, and some purpose built for the system. The most modern trams are a fleet of three, purpose built for the line between 2002 and 2005. The tram involved in the derailment, No 10, was one of these trams, and was operating on the 12:31 hrs service from Colyton to Seaton (Figure 2). The only crew on the tram was the driver, and it was carrying ten passengers.
