Rail Accident Investigation Branch

# Rail Accident Report

## **Derailment of a freight train at Maltby North 28 June 2006**

## **28 June 2006**

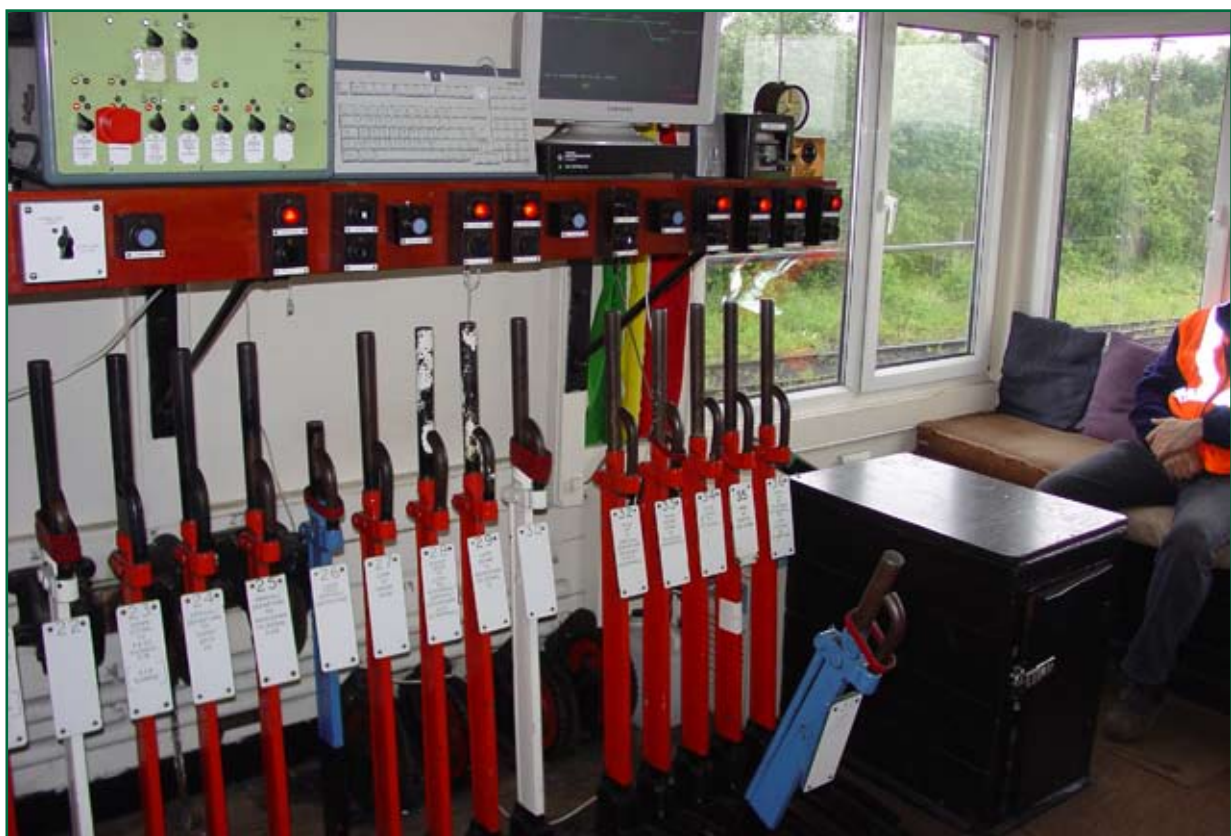
- 81 Where a lever works an electrical unit, such as a point machine, the electric circuit is made or broken via contacts which are driven by the lever. Levers which only operate electrical units do not require as much effort to move them as levers that work mechanical signals and points and these levers have had the handle section cut down to remind the signaller of this fact. Figure 9 shows the electrical lock and the lever contact bands that make up the electrical switch on number 31 lever. Figure 10 shows the operating floor of the box and lever frame with lever 31 in reverse and lever 36 normal.

*Figure 10: Interior of Maltby Colliery signal box*

- 82 Signal M36 signals routes through number 31 points in both directions, normal and reverse. Thus the signal lever 36 can be pulled with 31 points lever in either position. The mechanical interlocking prevents 31 lever from being moved from either position if M36 signal is clear. This interlocking was tested by both Network Rail and the RAIB and found to be fully effective.
