Rail Accident Report

**Derailment at Trooperslane near Carrickfergus,
Northern Ireland
23 April 2006**

Derailment at Trooperslane near Carrickfergus, Northern Ireland 23 April 2006

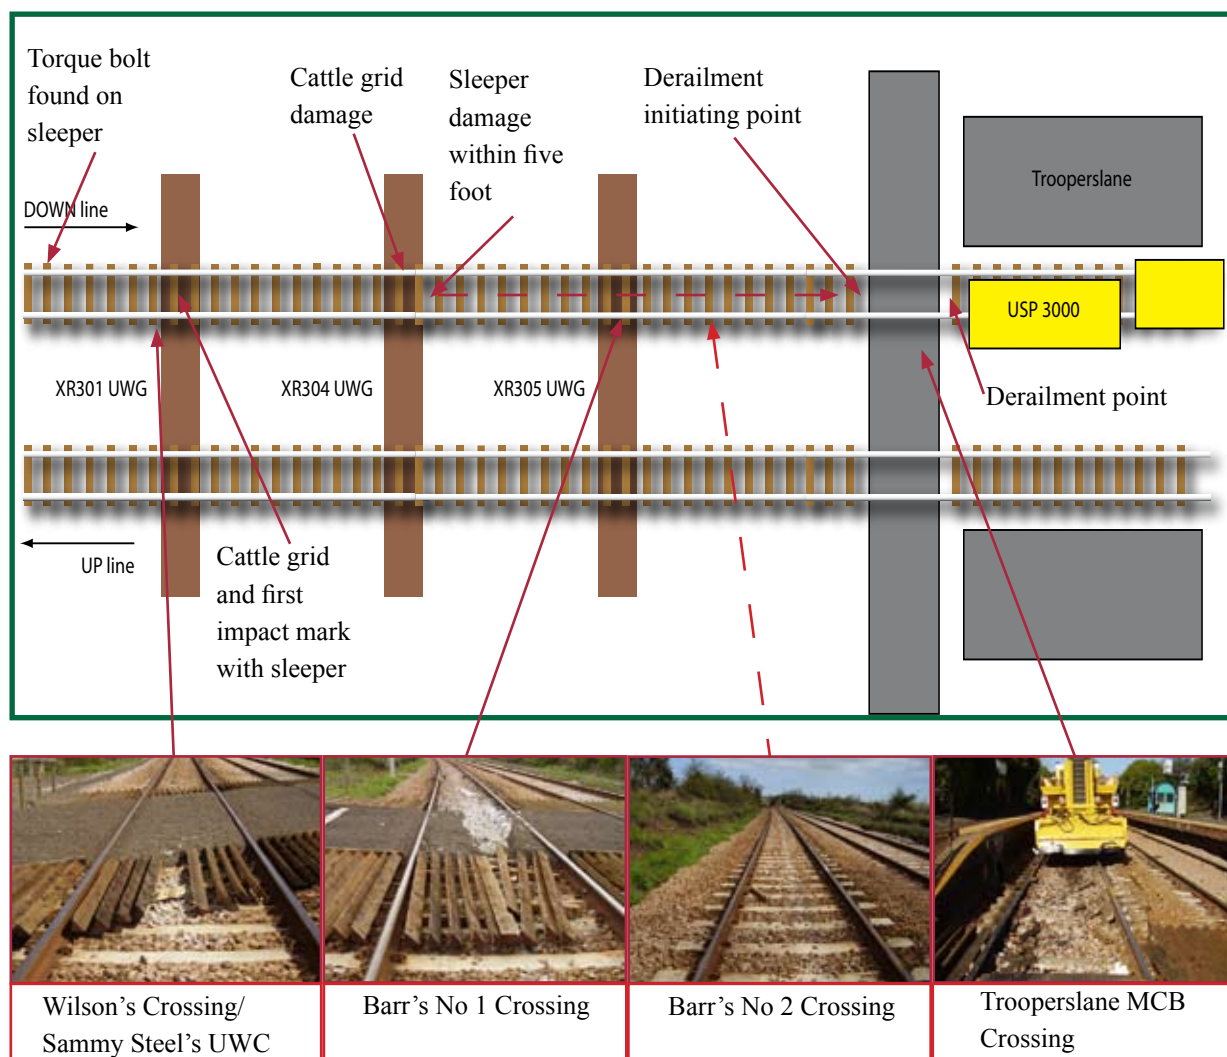
Figure 7 Detailed diagram showing immediate incident route prior to derailment

- 62 As the train passed over crossing X301 (7 miles 163 metres) (Figure 7) the guard became aware of bad riding of the regulator. Ballast and chippings from the crossing sprayed out and upwards from around the front axle towards the ballast regulator cab. He initially thought this had been caused by person(s) unknown throwing stones at the cab.

- 123 The cattle grids either side of the UWC X301, 304 and 305 had fractured and splintered, which corroborated witness testimony about the chippings and ballast hitting the underside of the regulator at UWC crossing X301 and the bad ride encountered from there to Trooperslane (Figures 7 and 11).
- 124 The securing pin was found at 7 miles 45 metres (paragraph 105) in the *cess* side of the running rail of the down line on a concrete sleeper.
- 125 There was no damage to the track between the immediate area of UWC X301 and 6 miles 1700 metres, nor between that point and York Road depot
- 126 A track walk and visual search for the missing castellated nut and split pin was undertaken between York Road depot and 7 miles 46 metres but they were not located.

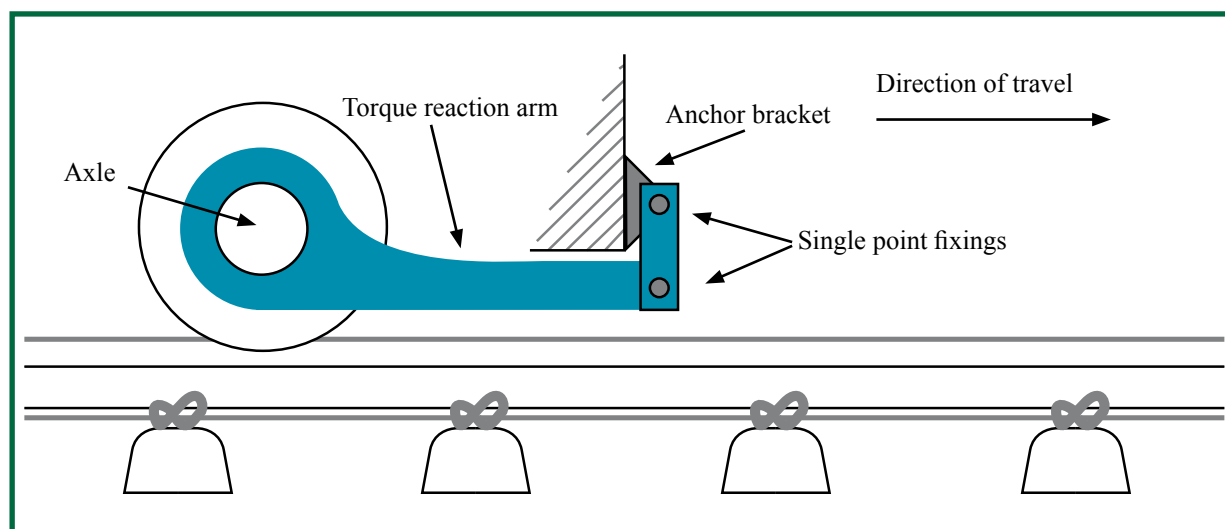
- 97 The gearbox drives the rotation of the regulator's wheels. This creates an opposing torque, and this is resisted by a torque arm that prevents the gearbox from rotating (Figure 8).
- 98 The torque arm is attached to the axle of the ballast regulator which was leading in the direction of travel on 23 April 2006. The torque arm extends forward from the axle to the front of the machine where it is held by the headstock (Figure 9).

Figure 8: Schematic cross-section through regulator viewed from right in direction of travel. The torque reaction arm is shown in position linking powered axle to anchor bracket mounted on headstock
