# Rail Accident Report

## Fire on HGV shuttle in the Channel Tunnel 21 August 2006

This report is published by the Rail Accident Investigation Branch, Department for Transport.

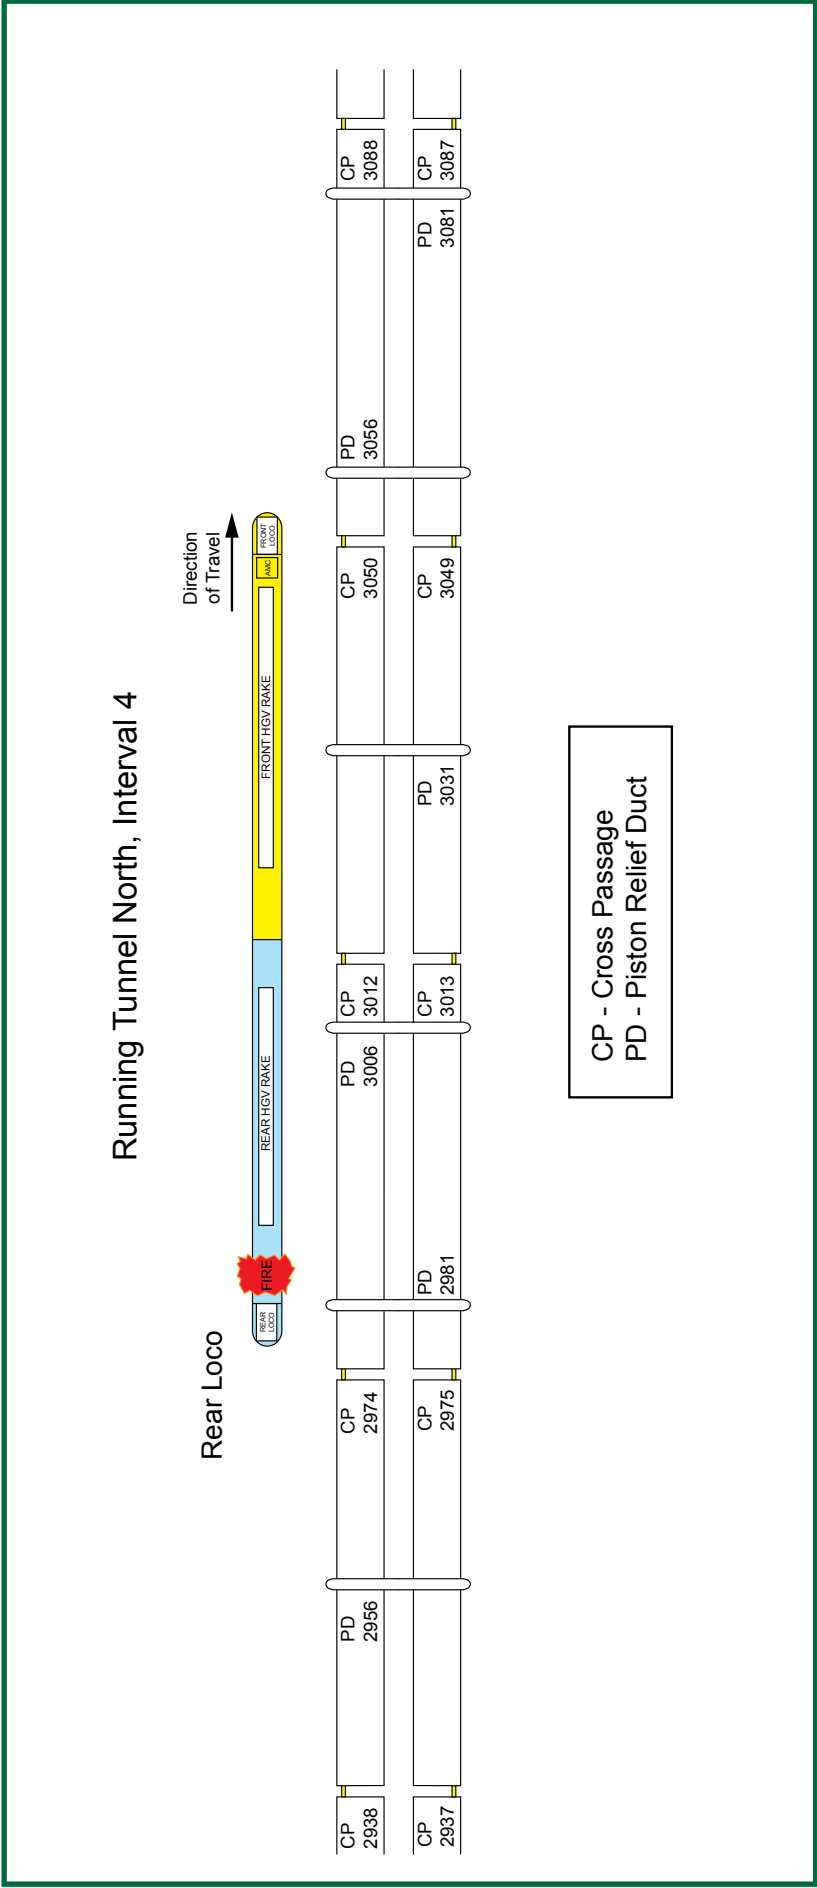
Figure 3: Diagram of the area in which Mission 7370 came to a stand

- 42 As soon as the driver was certain he had passed fully through the 'go zone', he brought the shuttle to a stand at CP3050 at 13:40 hrs (Figure 3). After receiving a call from the RCC authorising an evacuation, he assisted the Chef de Train with the process.

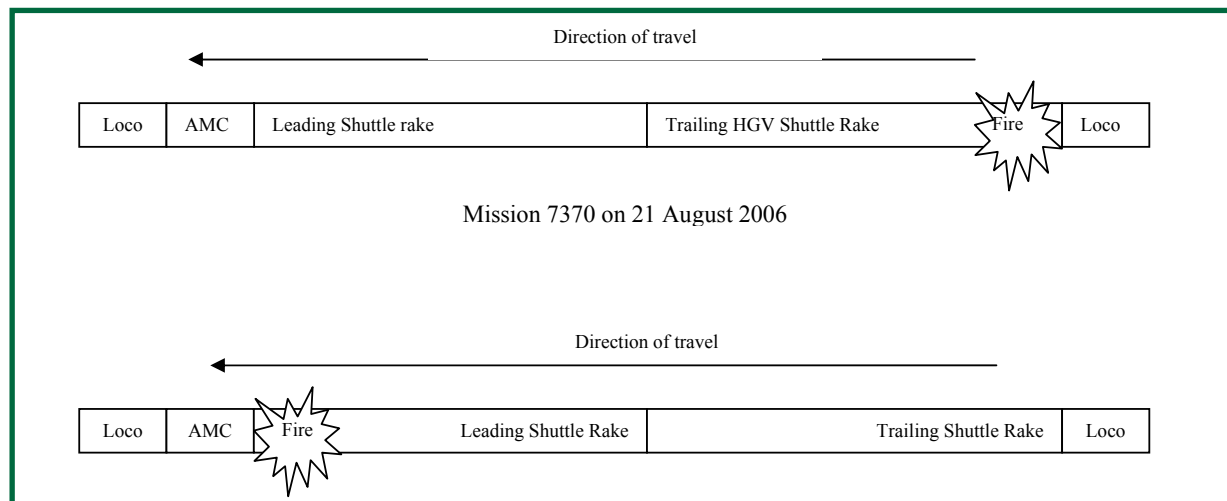
Figure 11: Alternative scenario involving fire at front of the shuttle

Lorry on fire at front of shuttle (adjacent to AMC)

313 With a fire at the front of the shuttle and smoke present, the train crew would have been faced with three possibilities according to the relevant Eurotunnel procedure:

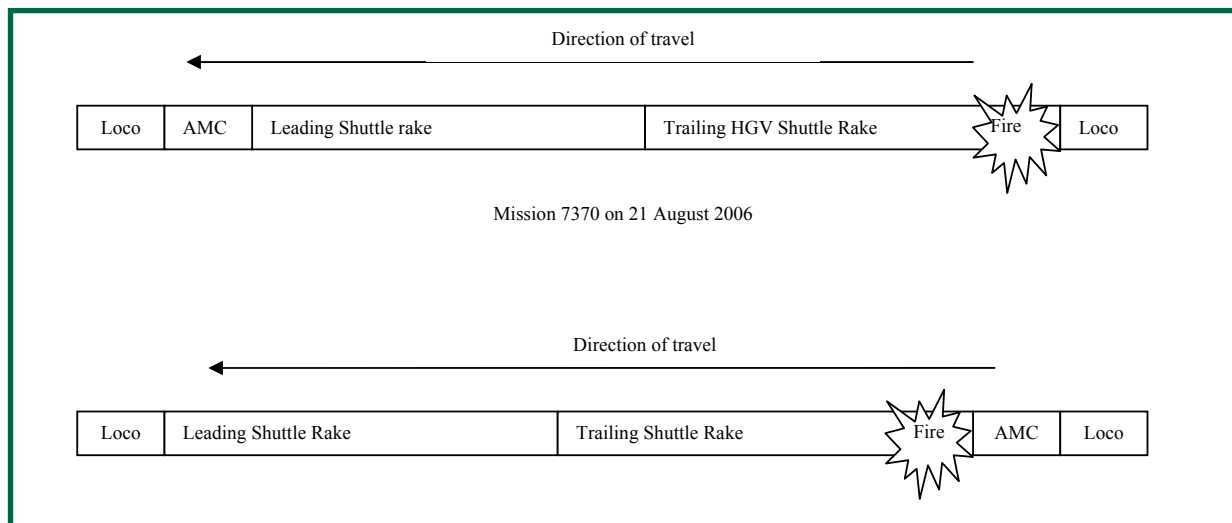
Figure 12: Alternative scenario involving fire and AMC at rear of shuttle

316 If the AMC had been located at the rear of the shuttle any smoke from the HGV on fire would have been initially blown over the AMC. The Chef de Train would have closed the HVAC inlets to ensure that the AMC was sealed from smoke ingress.

- 317 The relevant Eurotunnel procedure calls for the initial response to the incident by the EMS Controller to switch on the SVS fans and configure them to blow smoke away from the AMC. If the AMC had been at the rear of the shuttle, this would have meant blowing smoke in the opposite direction from that which was actually required on 21 August 2006, i.e. the SVS would have been configured to blow smoke from the UK to France, away from the back of the shuttle.

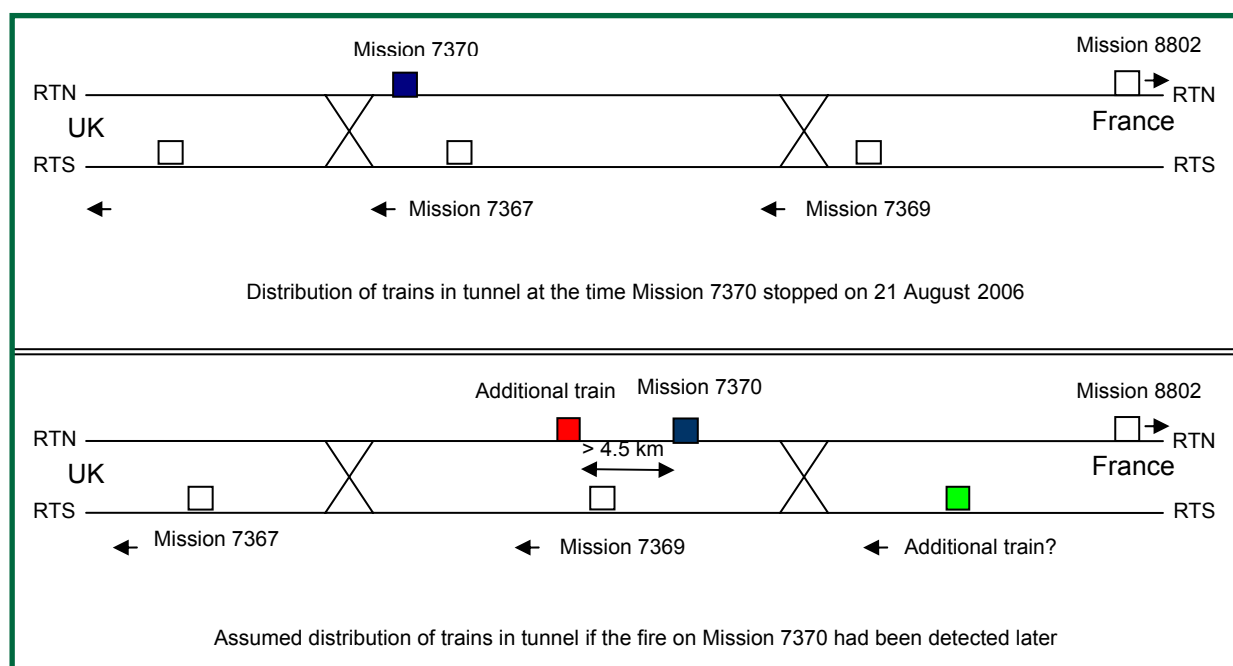
Figure 13: Alternative scenario involving an additional train in the running tunnel

Train stopped in tunnel behind the shuttle with fire on board

323 The complication that potentially arises from having a train located in the running tunnel behind a HGV shuttle with a fire on board is that the need to blow smoke away from the AMC means that the smoke is being blown towards any train(s) following the incident shuttle.
