Rail Accident Report

**Derailment at Birmingham Snow Hill,
Midland Metro
29 January 2007**

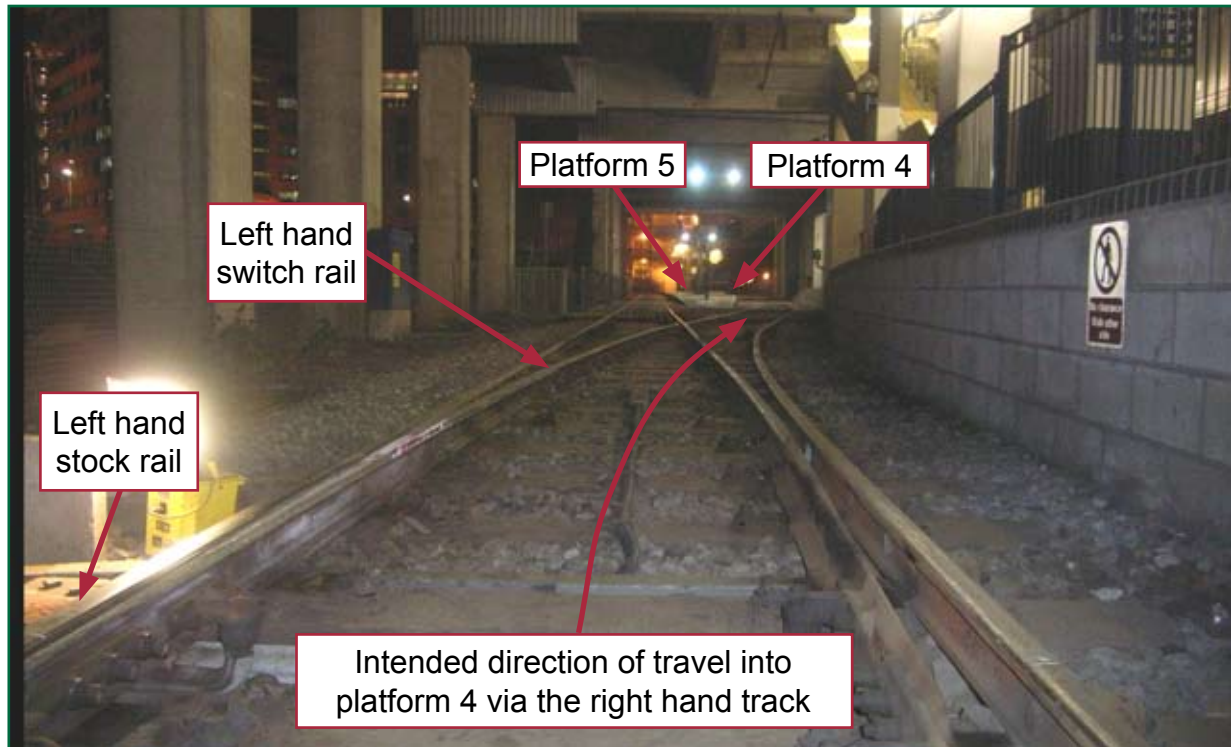
Figure 3: The approach to Snow Hill terminus

- 13 The derailment occurred at the S&C on the approach to Birmingham Snow Hill terminus where the single track becomes double track. Travelling into Birmingham Snow Hill, the left and right hand tracks go to platforms five and four respectively. See Figure 3.

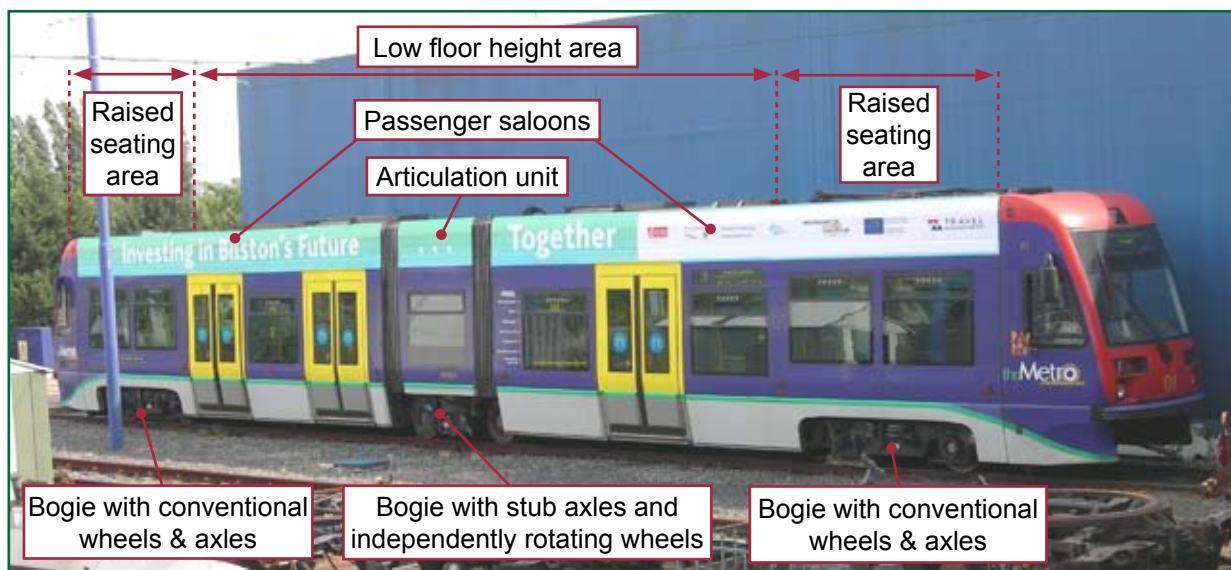
Figure 4: The layout of the tram

- 14 Each tram consists of two saloon units joined by a centre articulation unit. Each saloon unit has a driving cab and a raised seating area immediately above a powered bogie with conventional *wheelsets*. The tram's low floor height is achieved by mounting the articulation unit on a non-powered bogie with stub axles and independently rotating wheels (IRWs). See Figure 4.

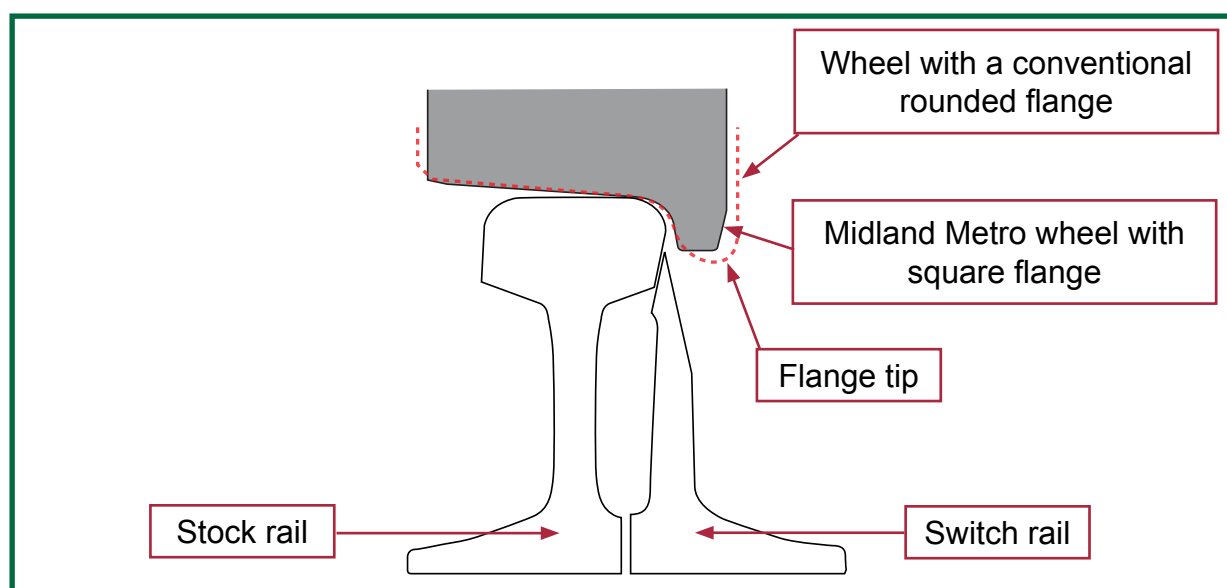
Figure 10: As-designed tram wheel and switch tip geometry

- 37 The as-designed switch rail is chamfered to a 'knife edge' and undercuts the stock rail at its tapered end to ensure that wheel contact occurs away from the switch tip. See Figure 10.
