Rail Accident Report

Derailment of a train at Croxton Level Crossing 12 September 2006

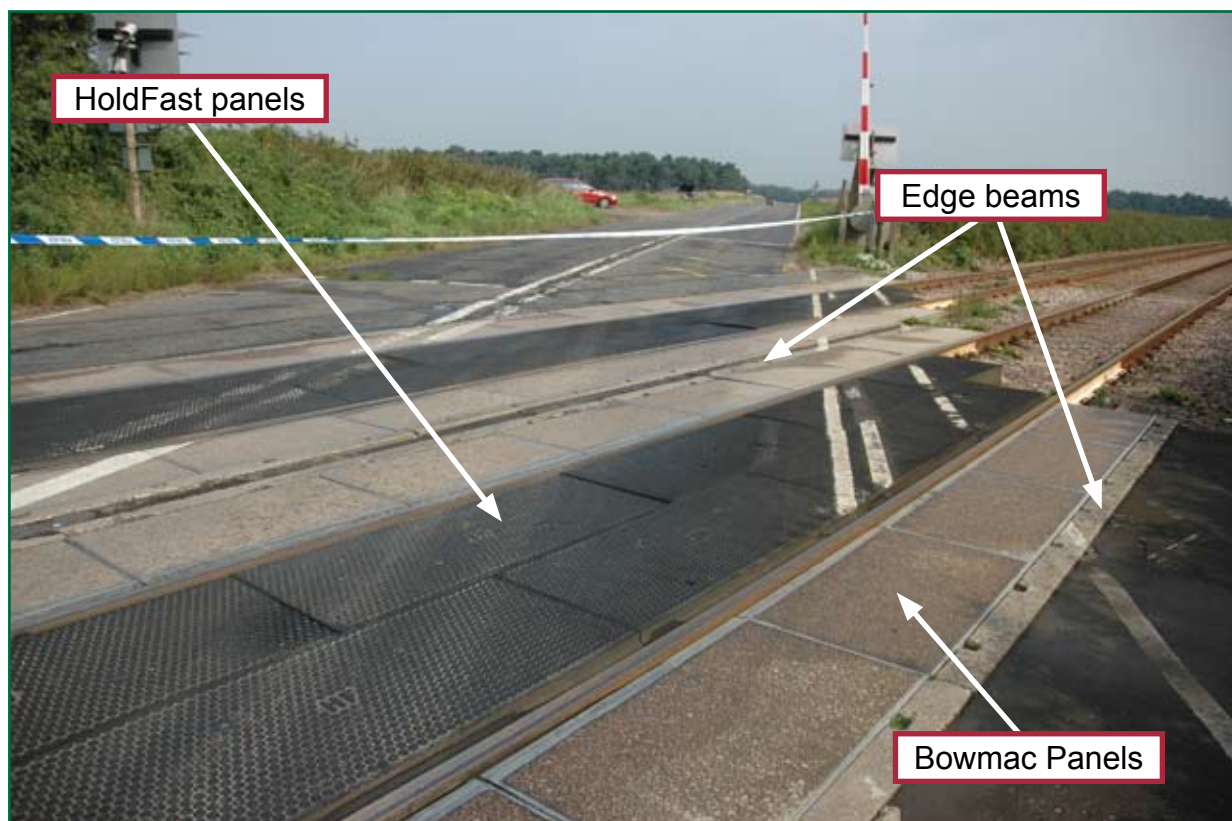
- 46 Railtrack installed HoldFast panels in the four foot of the down line at Croxton during July or August of 2000. They ordered a second delivery of panels for the four foot of the up line, which they fitted over the weekend of 22/23 August 2001. They installed the panels with a stagger of 600 mm on the down line and 1200 mm on the up line, with the most north-easterly and south-westerly panels in each line leading by these respective amounts (Figure 3).

Figure 3: Croxton level crossing looking in a north-easterly direction

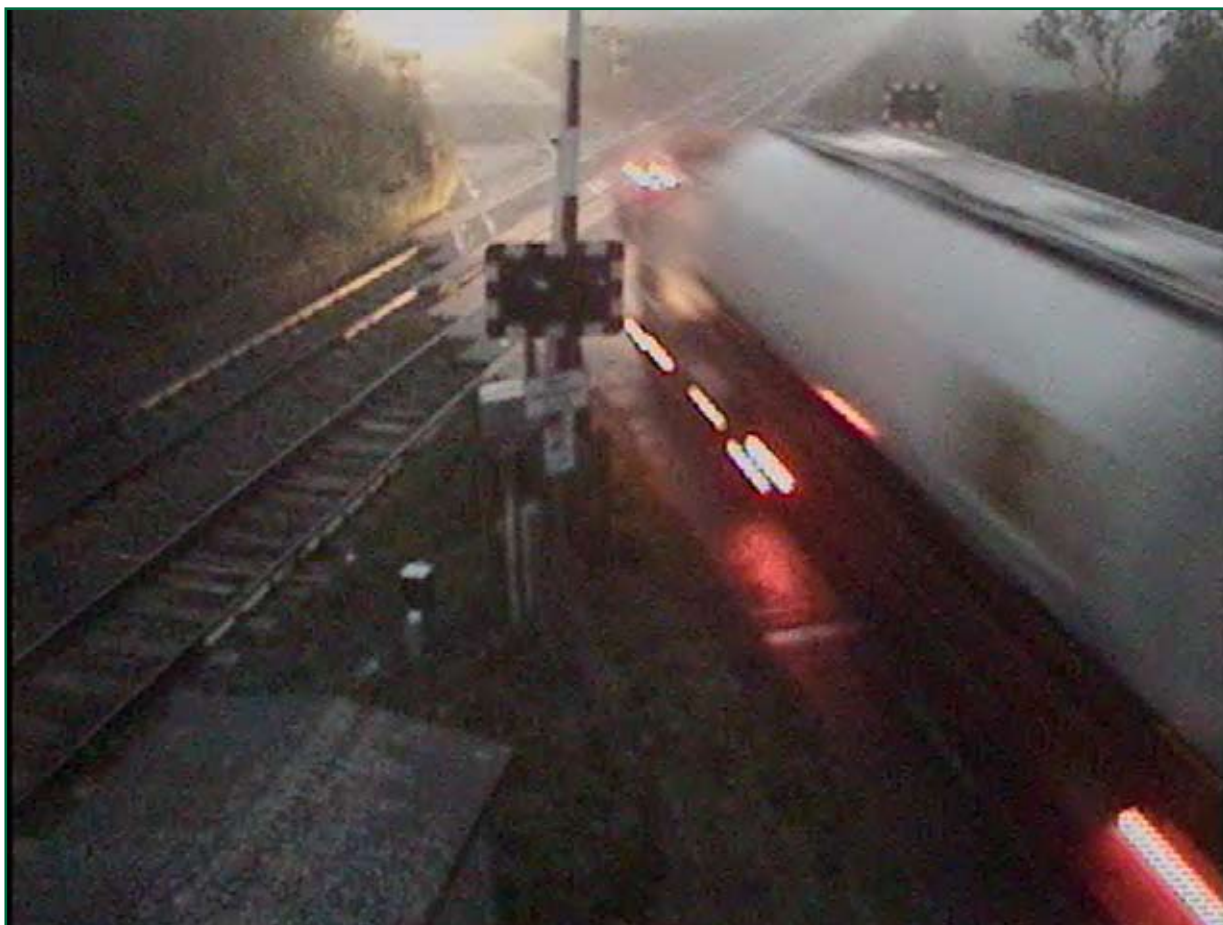
- 77 At 05:54:34 hrs a tanker trailer lorry passed over the crossing (Figure 6). Examination of the CCTV image taken at 05:54:38 hrs shows that an object was present in the four foot of the up line, which had not been visible prior to the lorry's passage.

Figure 6: CCTV image of tanker trailer lorry passing over the crossing

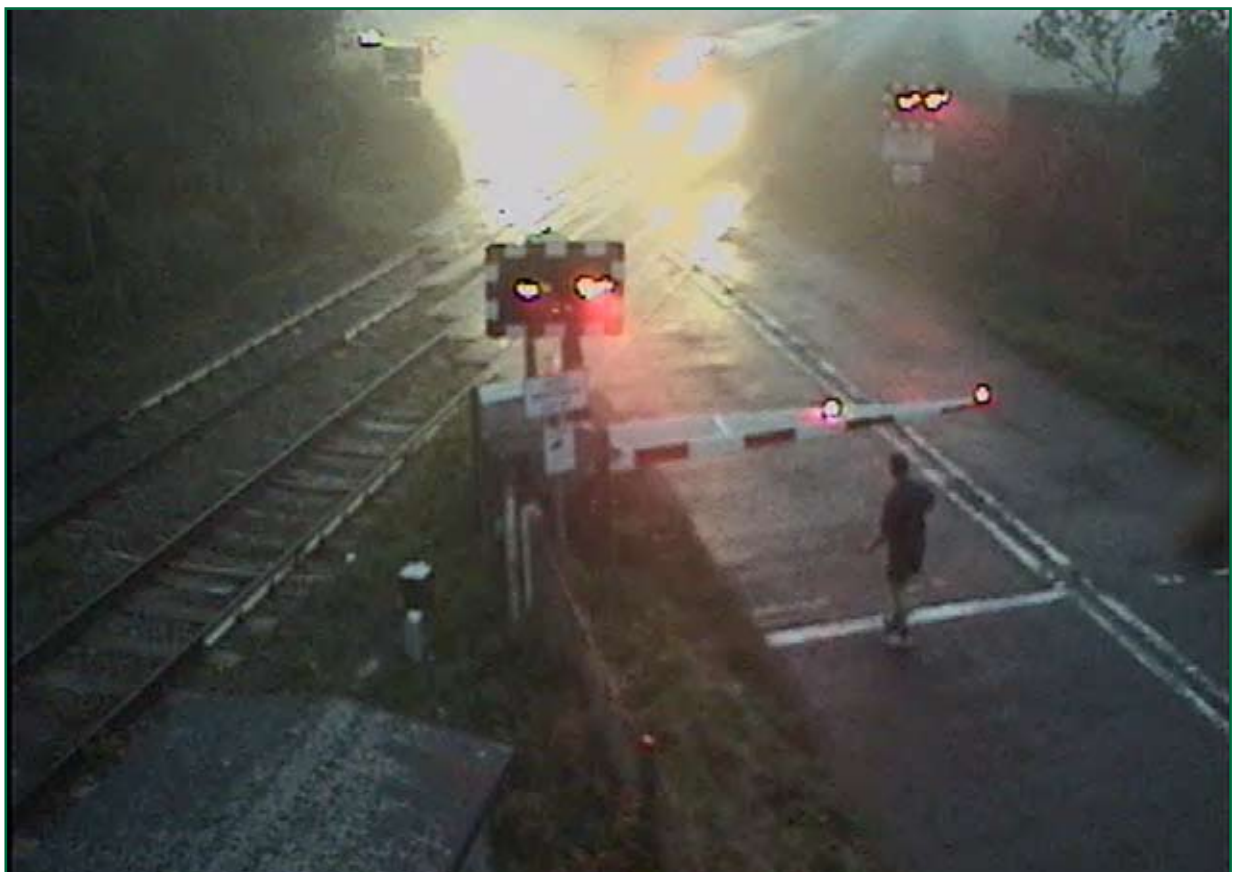
- 89 At 06:03:23 hrs the train entered the crossing (Figure 8) and struck the dislodged panel. The collision derailed the leading bogie, but the rest of the train remained on the track. The train driver applied the emergency brake after realising that the train was running derailed, and the train ran 463 m before coming to a halt (Figure 2).

Figure 8: CCTV image of 1K55 approaching Croxton level crossing

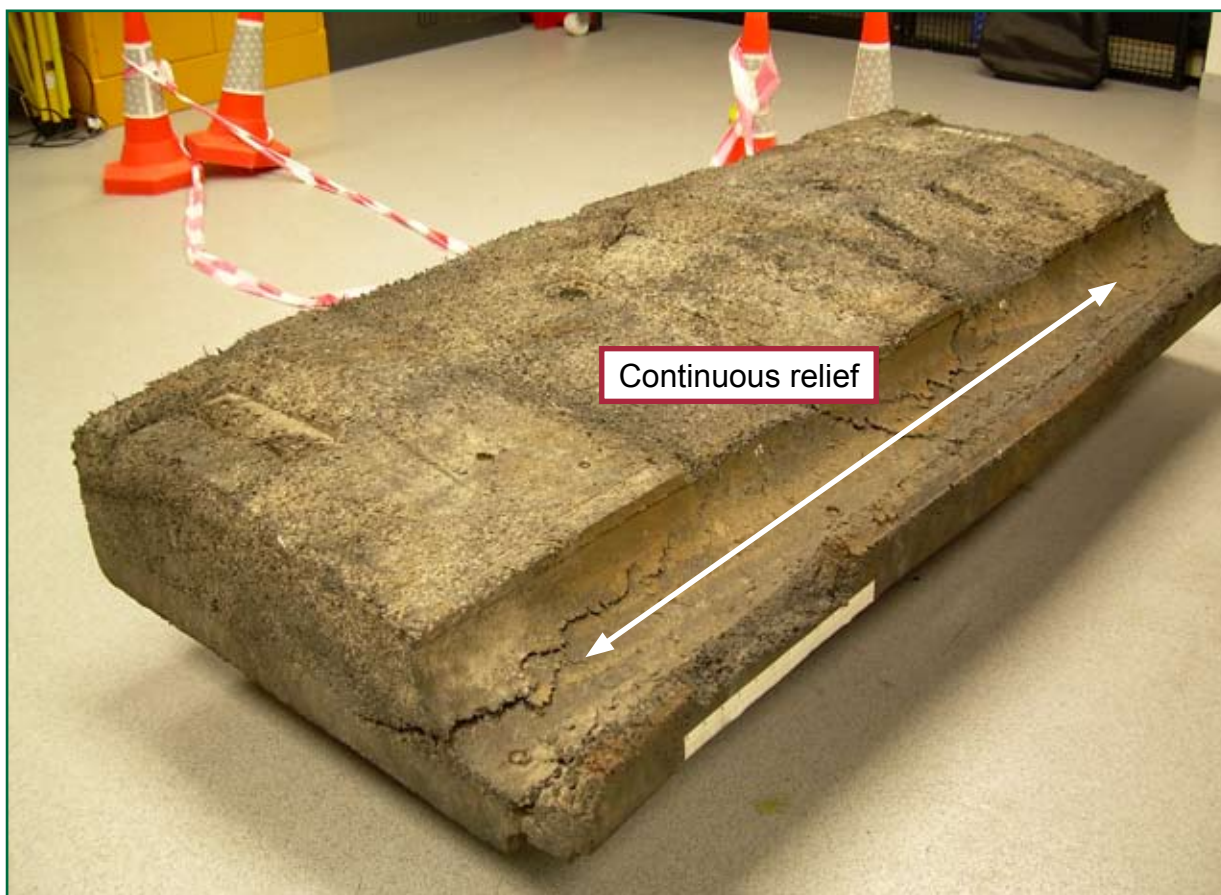
Figure 13: Continuous relief area on underside of panel B4

147 On the underside close to the rail foot, there is an arch-shaped recess known as the relief (Figure 13). This recess is required in order to give clearance for the rail clips.

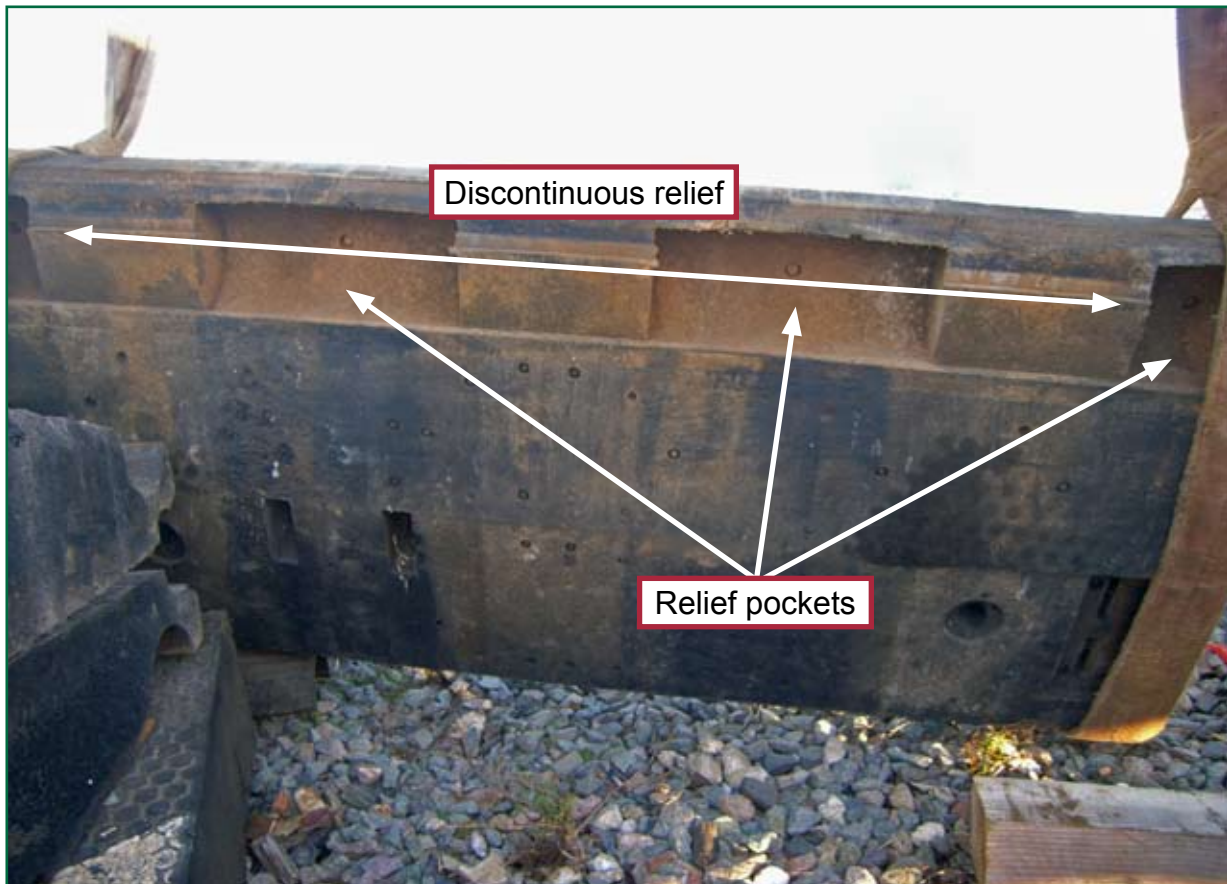
- Continuous relief, where the relief was for the full length of the panel (Figure 13).
- Discontinuous relief, where the relief was restricted to short lengths over the length of the panel. The areas that were not relieved were solid and integral with the rest of the panel (Figure 14).

Figure 14: Discontinuous relief area on HoldFast panel underside

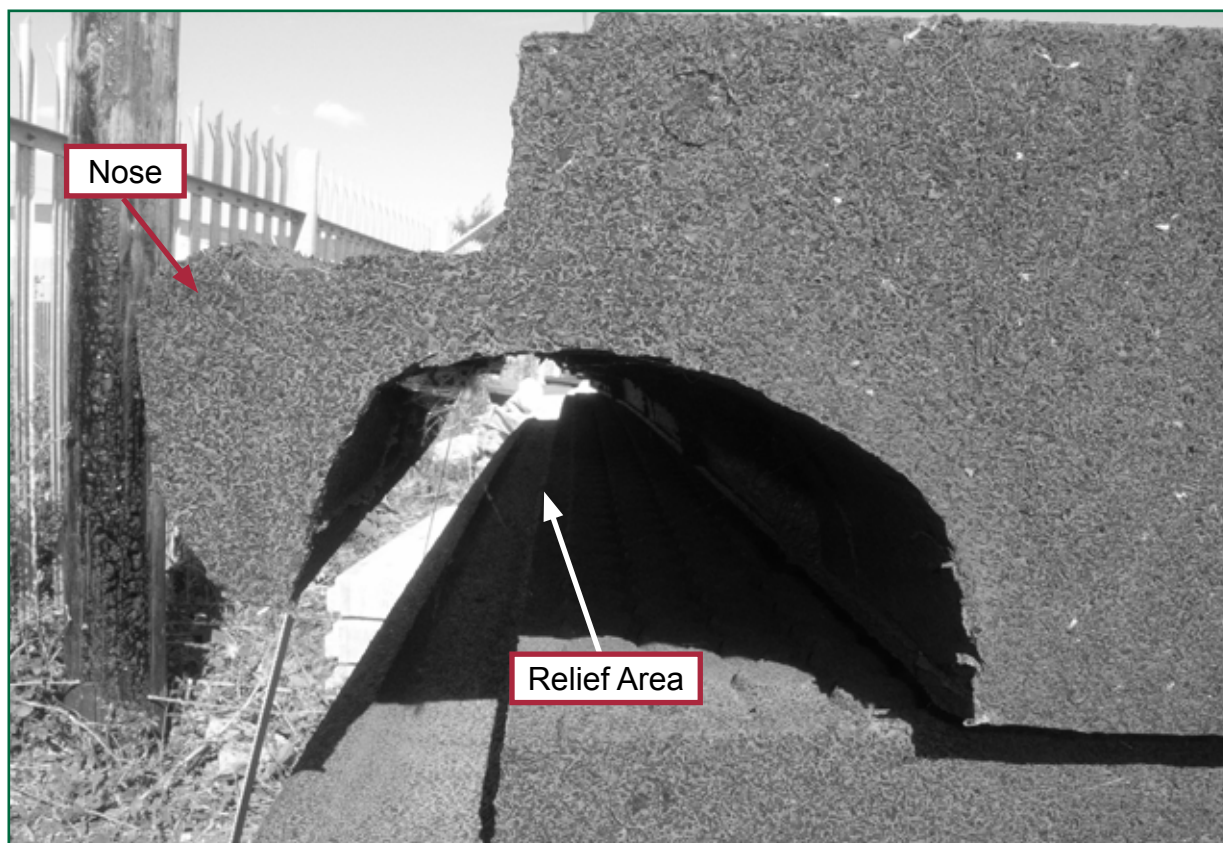
- 155 The material in the relief area was relatively thin in comparison to the rest of the panel (Figure 15). As well as the relief on the underside, the upper surface had a channel close to the rail to provide clearance for train *wheel flanges* to pass through. This gave a relatively flexible area, known as the nose, as compared to the rest of the panel.

Figure 15: End view of panel nose area

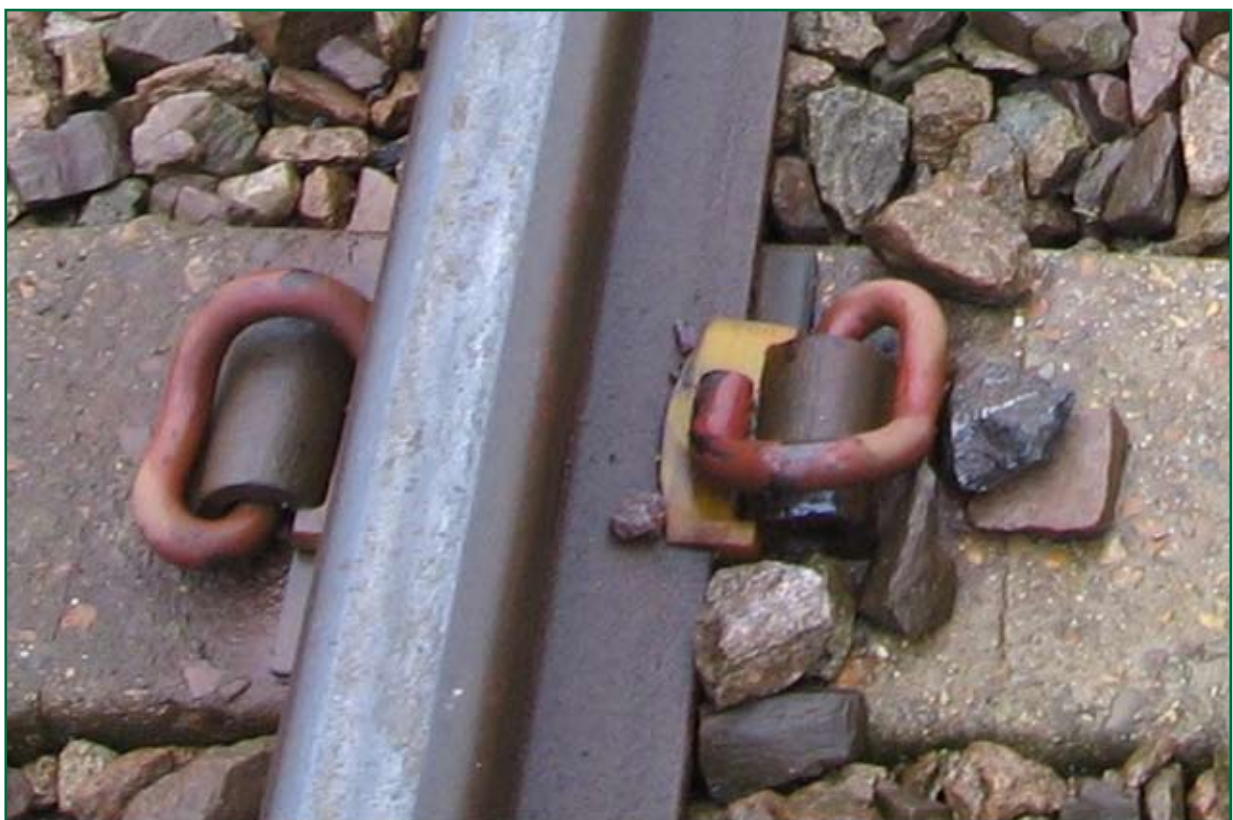
161 All of the panels at Croxton had the same identifier ie 00324, and there was no means of inspectors determining the relief type, or the ages of the panels, once they were installed in position.

Figure 22: Pandrol rail clip and insulators

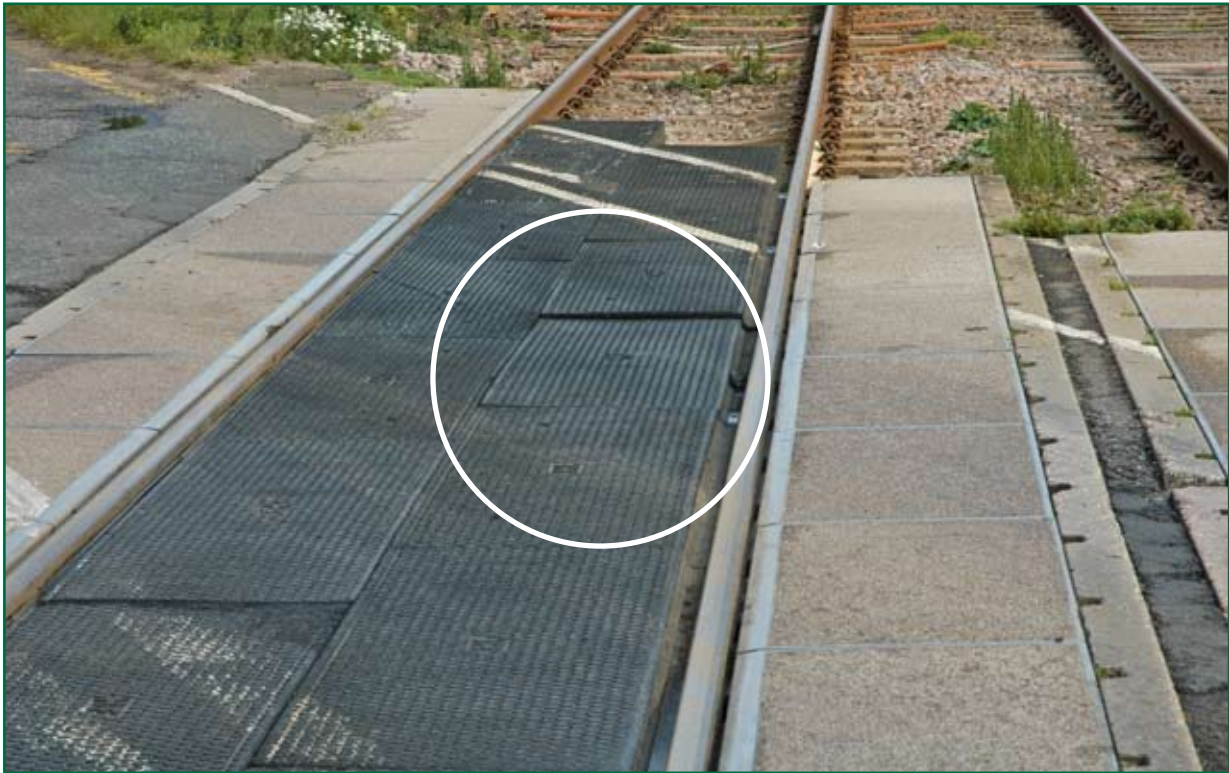
- 210 The third order from HoldFast to Rosehill Polymers for the replacement of panels damaged in the fire (paragraph 47), requests that the panels are the same as supplied previously. Rosehill Polymers supplied these from stock; they were of type 00324GPN, that is of the discontinuous relief type.

- 211 It is not known why the continuous relief panels were supplied to Croxton on the first two orders; neither the supplier nor the manufacturer have offered an explanation for this. However, HoldFast did not recognise any performance differences between the two types of relief and Railtrack did not appreciate that there was a difference.

Figure 31: Diagonally opposite panel to panel B4 (in the down line of the other road carriageway)

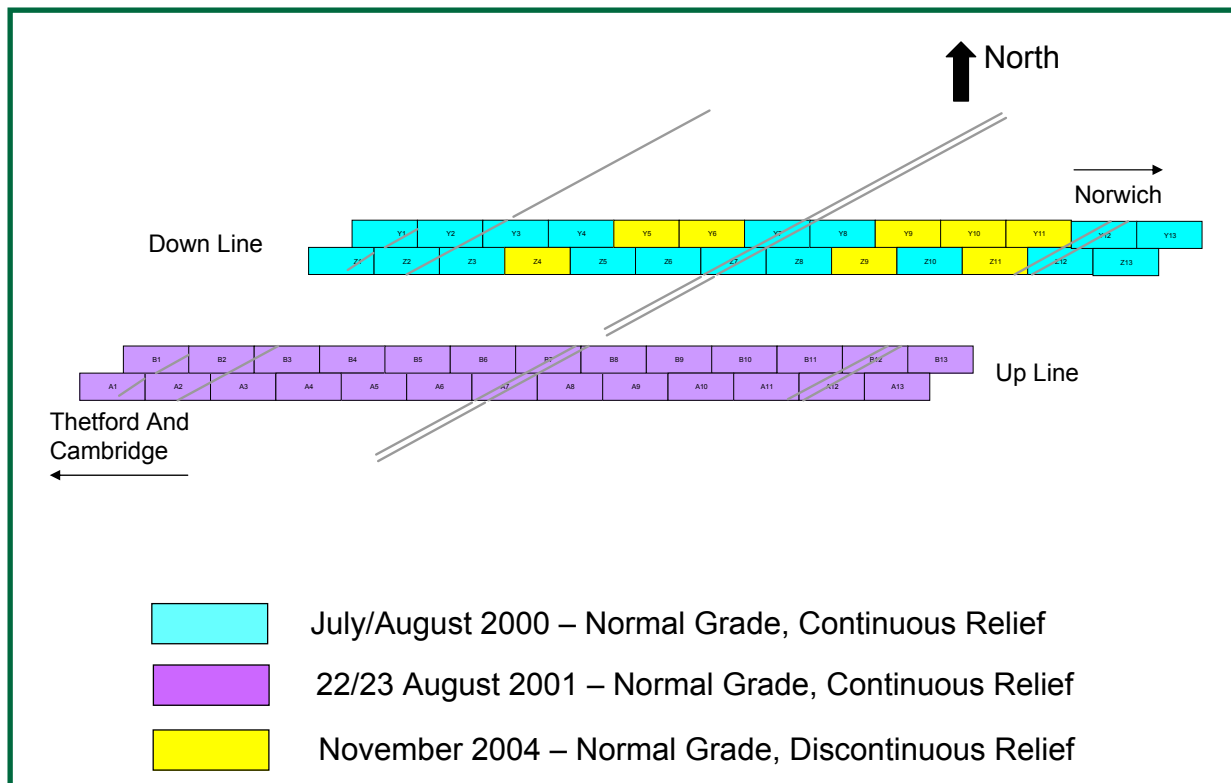
- 215 The rails had been renewed in 2005 (paragraph 50), and there is no evidence that their condition contributed to the derailment in any way.

- 231 In April 2006 an organisational change within Network Rail created dedicated level crossing teams responsible for both the inspection and maintenance of level crossings. In the Anglia area, there were three teams directed by a level crossing supervisor at Ely who reported to the service delivery manager at Tottenham. The supervisor had a level crossing assistant to support him in his duties.

Figure 34: Panel types ages and positions fitted at Croxton at time of accident
