Rail Accident Investigation Branch

Rail Accident Report

Runaway of two wagons from Camden Road Tunnel 19 July 2007

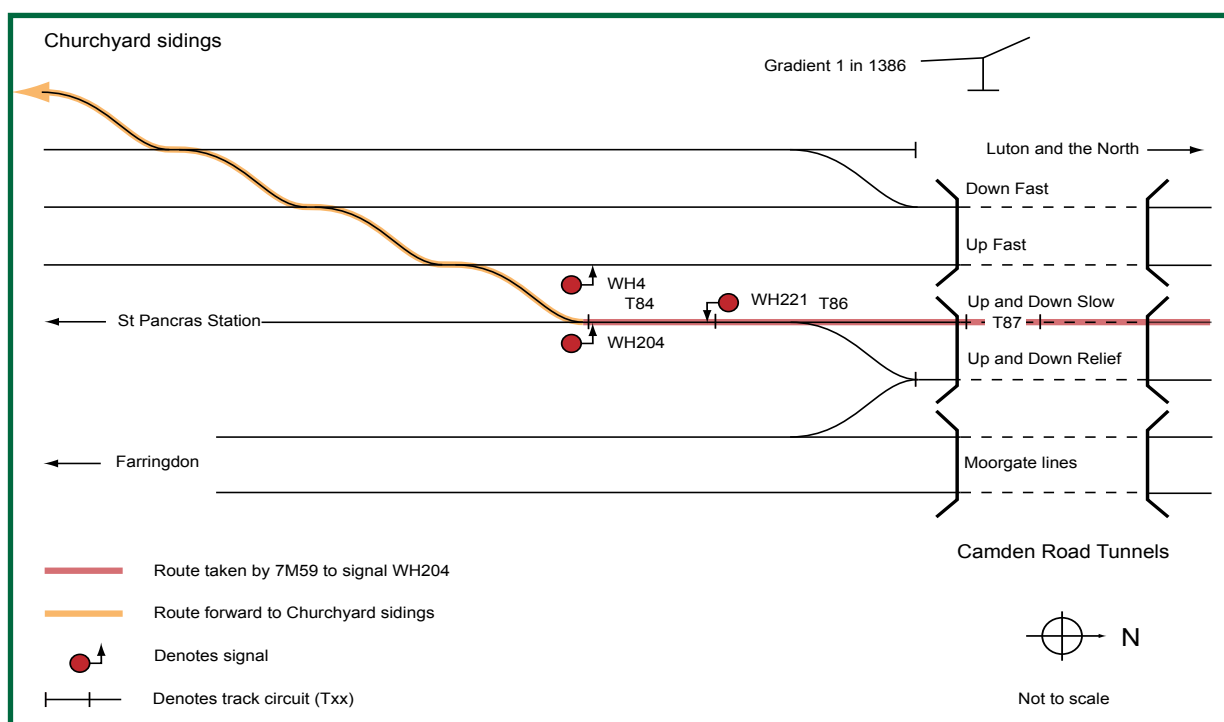
Figure 2: Key features of the incident location

- 18 At around 23:50 hrs, due to a combination of air leaking out of the brake cylinders of one wagon and incorrectly set slack adjusters on the other, the two detached wagons, loaded with stone, ran away southwards down the gradient out of Camden Road Tunnel. After travelling for 200 to 300 metres, the wagons changed direction due to a local reversal of the gradient, eventually coming to rest about 140 metres from where the runaway started. The key features of the incident location are shown in Figure 2.

- 33 At 23:41 hrs, the signaller noticed that track circuit 87 (see Figure 2), covering the southern end of Camden Road Tunnel, was still showing occupied. He contacted the driver and asked him to check his train was complete. The driver checked the train with the assistance of the shunter in Churchyard Sidings and found that the rear two wagons were missing.

- 34 Between 23:50 hrs and 00:05 hrs, the signaller saw track circuit 86 show occupied closely followed by track circuit 84 (Figure 2). This was followed by the *SPAD alarm* associated with signal WH221 sounding. These events indicated that railway vehicles were moving out of control and after having run towards St Pancras International station, stopped and reversed direction at a local change in gradient. From calculations, the RAIB believes that the speed of the runaway vehicles did not exceed walking pace.

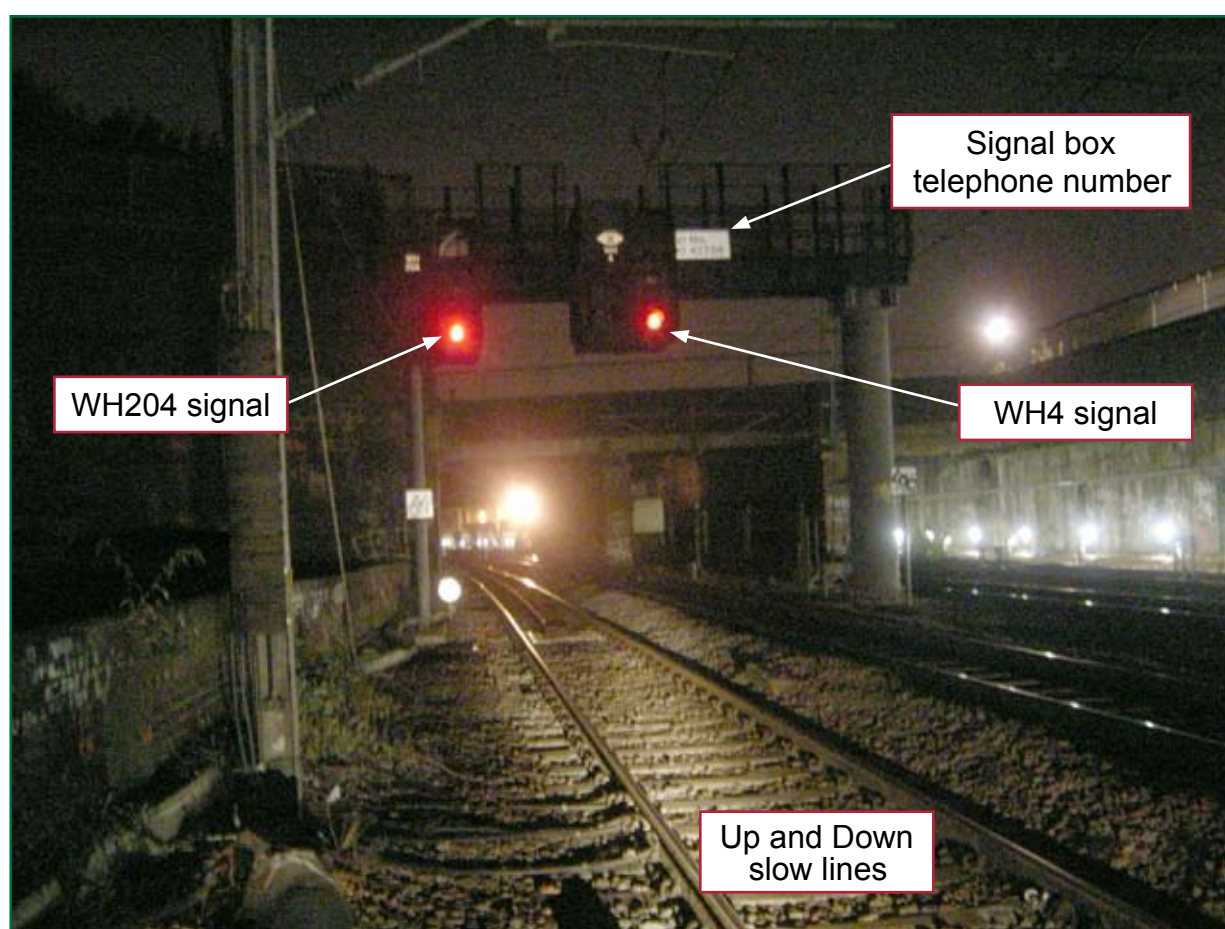
Figure 10: Signal WH204 and signal WH4

- 43 The distance between WH204 signal and the south portal of Camden Road Tunnel is 249 metres.
- 44 Signal WH204 is mounted on a gantry alongside signal WH4. The *signal post telephone* (SPT) for signal WH4 is in a *limited clearance* zone and an alternative means of contacting the signaller is displayed on a plate to the right of the signal head (see Figure 10).
- 45 The SPT for signal WH204 signal is located 20 metres before signal WH204. This is the normal stopping point for a train when the signal is at danger. Figure 10 shows signals WH204 and WH4 from the SPT for signal WH204.

- 80 When initially stopped at signal WH204, the driver's evidence is that he contacted the signaller using the telephone number displayed on a plate attached to the side of signal WH4 (Figure 10). This number had been recorded into his mobile phone the first time he used it to contact the signaller when initially stopped at signal WH204 (paragraph 44). The plate displaying the telephone number becomes progressively more difficult to read the closer a train draws up to the signal and provides evidence that he stopped at the correct stopping point, adjacent to the SPT, some 20 metres before the signal.

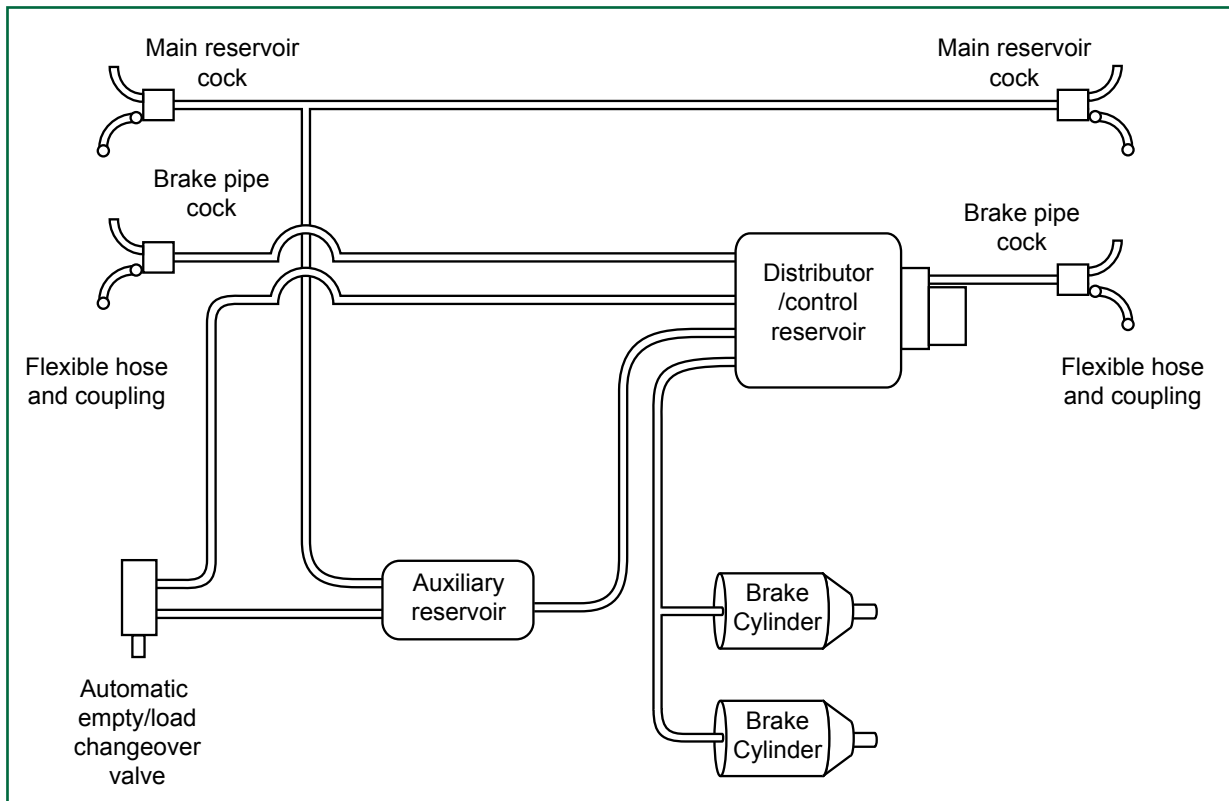
Figure 14: Schematic diagram of the brake system fitted to wagons MAR17712 and MAR17725

- 56 A schematic of the brake system is shown in Figure 14. The normal *running pressure* of 5 bar in the brake pipe is reduced when the driver operates the service brake in the driving cab. This is sensed by the *distributor* which operates to allow air pressure stored in the *auxiliary reservoir* to pass to the brake cylinders in proportion to the degree of reduction in brake pipe pressure. The runaway wagons were also fitted with automatic *empty/loaded changeover valves* which sense whether the wagon is loaded or empty. When the wagons are loaded, the brake cylinder pressure is increased in order to provide more brake force.
