Rail Accident Report

Collision with the gates at Lydney Town level crossing 15 August 2007

Collision with the gates at Lydney Town level crossing, 15 August 2007

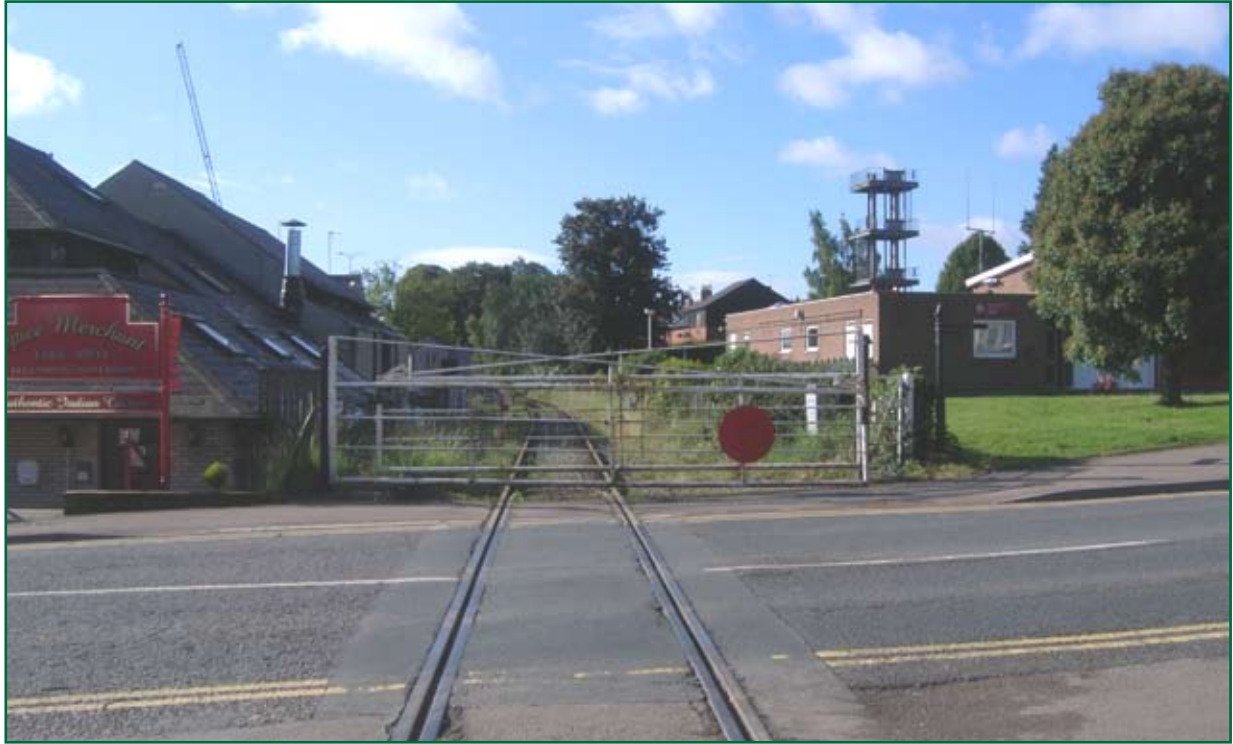
- 27 Because the road is wider than the single track rail line, requiring a width of gate to close the road significantly greater than that required to close the railway, the crossing gates overlap when closed to the railway. The gates which are closed across the road first to stop the traffic, hinged on the right hand side of the railway as seen from approaching trains, are known as the primary gates.

- 28 To operate the gates as swiftly as possible, the DFR normally allocates two crossing keepers; each one has to open both gates on the same side of the road. The primary gates are opened by the two keepers at the same time, stopping the road traffic in both directions. The other gates, known as secondary gates, are then closed to fully fence off the railway from the road.

Figure 3: Lydney town crossing looking south

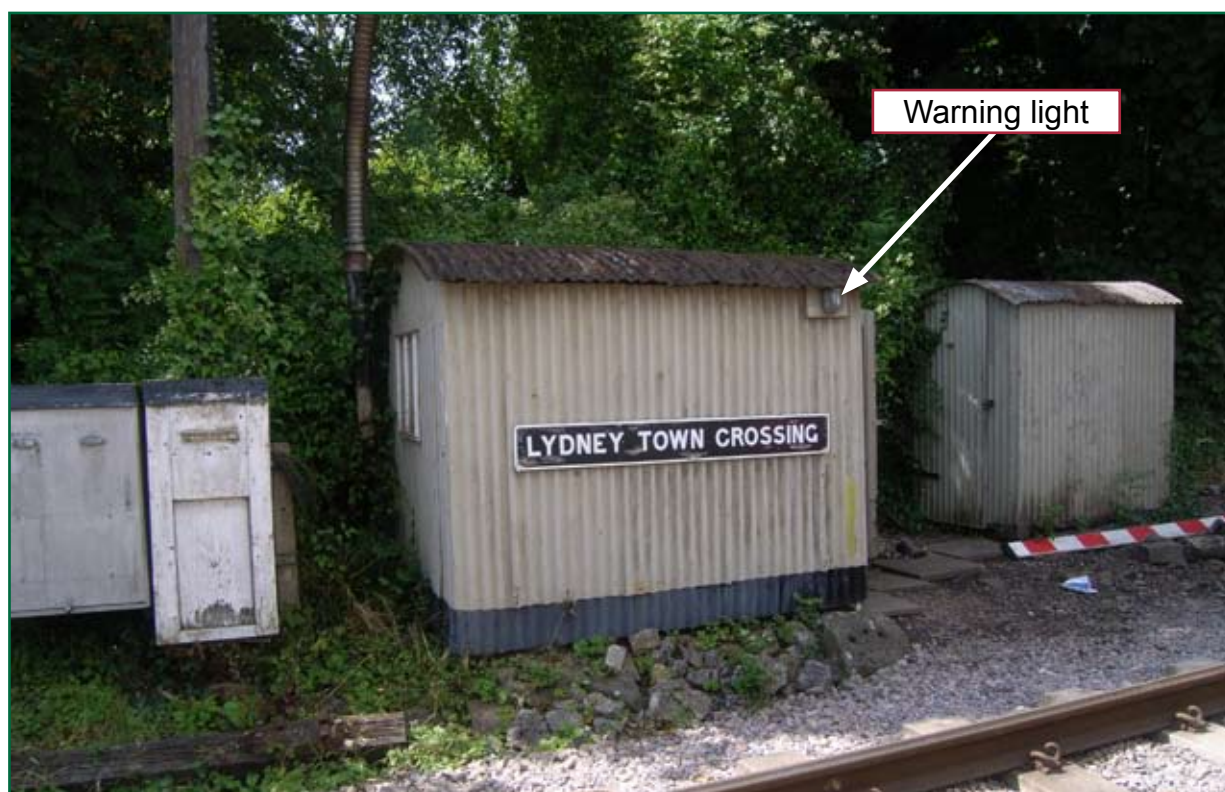
Figure 5: Crossing keeper's hut, showing warning light for approach of trains

- 32 In order to warn the crossing keepers of approaching trains there is a treadle placed 455 metres (500 yards) north of the crossing (Figure 6). Operation of this treadle by a train causes a buzzer to sound, and a light to flash, at the crossing keepers' hut.

- 47 The treadle operated warning buzzer at the crossing keepers' cabin had been failing intermittently for several months. Four days before the accident the signalman at Norchard had reported that it was not working, by making an entry in his signal box register. The DFR operations manager had discussed the matter with the signalling and telecommunications director. They had agreed that the treadle should be replaced, but this had not been done by the time of the accident because staff were not available.

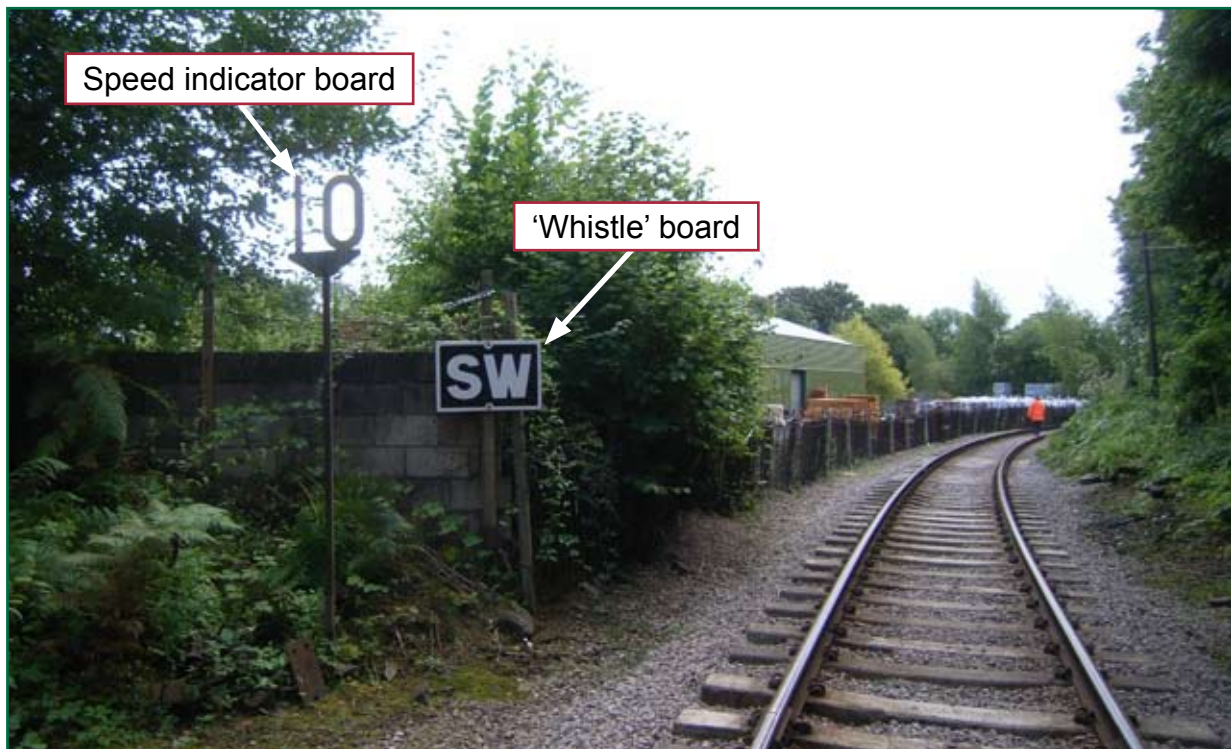
- Reduce speed to 10 mph (16 km/h) at a speed indicator board. This is located to the left of the line, as seen by a train driver, 183 metres (200 yards) from the crossing (Figure 7).

- Sound a warning at a 'Whistle' board (denoted by the letters 'SW') located close to the speed indicator board (Figure 7).
 - Look out for the crossing gates and any hand signal from the crossing keepers. The gates come into the driver's view when the train is 119 metres from the crossing.

Figure 7: Speed indicator board and 'Whistle' board

- 75 The train was estimated by witnesses to be travelling at a speed of approximately 20 mph (32 km/h) when it passed the speed restriction board. This cannot be corroborated further, as there is no speedometer or on-train data recorder fitted to the locomotive or autococh.

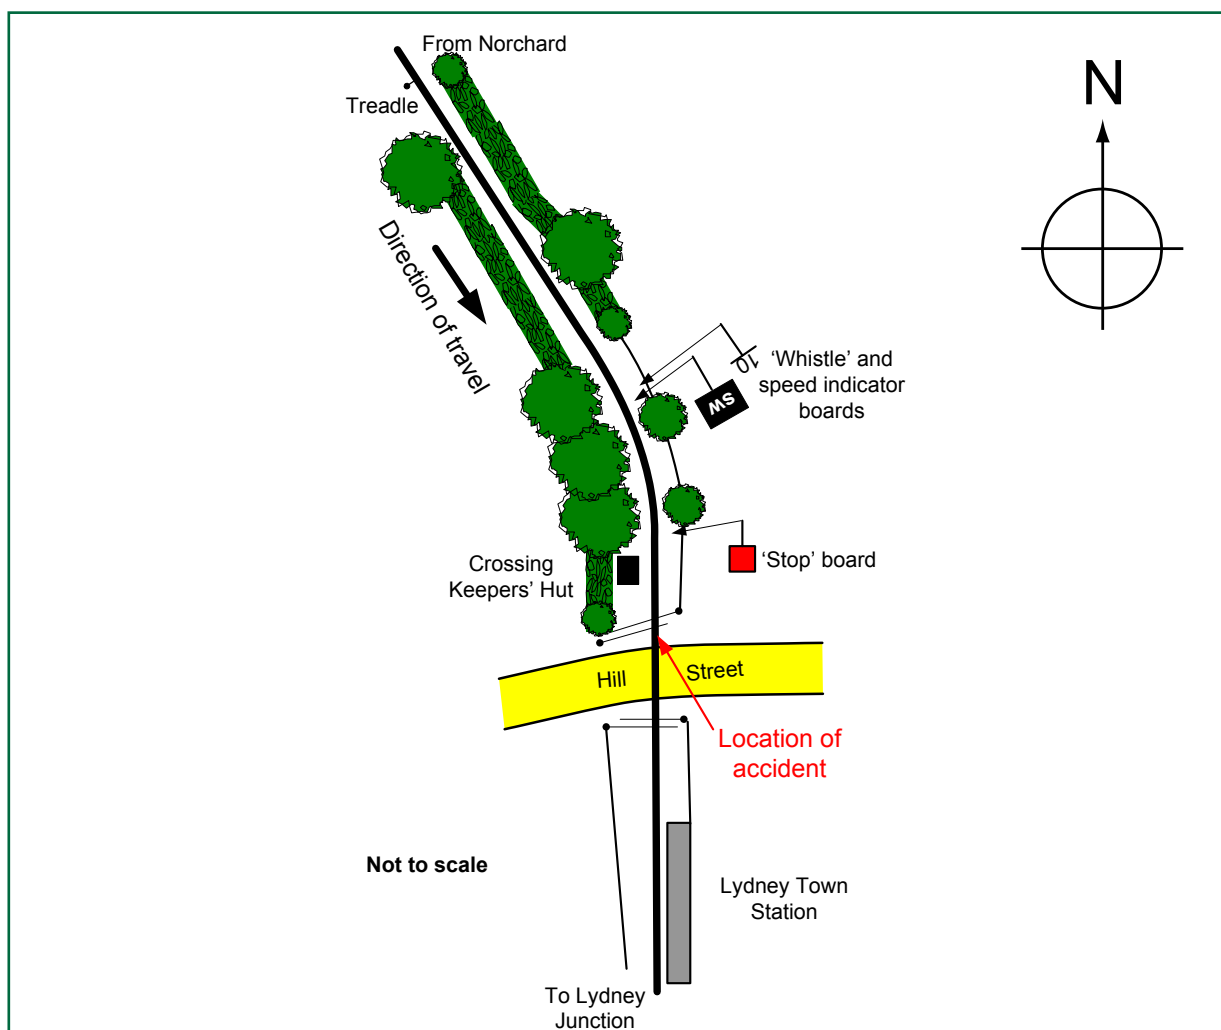
- 29 The line approaching the crossing from Norchard station (the north) is single track on a 1 in 128 falling gradient. There is a right hand, 300 metre radius, curve on the northern approach to the level crossing (Figure 9). There are trees intermittently in close proximity to both sides of the track throughout the approach to the crossing.
- 30 When they are on duty, but there is no train approaching, the crossing keepers occupy a small building immediately west of the line 15 m north of the crossing (Figure 5).
- 31 From the north crossing gates the crossing keepers can see a train approaching from the north a maximum of 128 m away.

- 34 Vegetation to the left of the line obstructs the view of the stop board until the driver is some 40 metres from it, but for a train travelling at 10 mph on a dry rail this provides sufficient stopping distance.
- 35 Figure 9 shows schematically the position of the features in relation to the crossing gates.

Figure 9: Plan of approach to Lydney town crossing

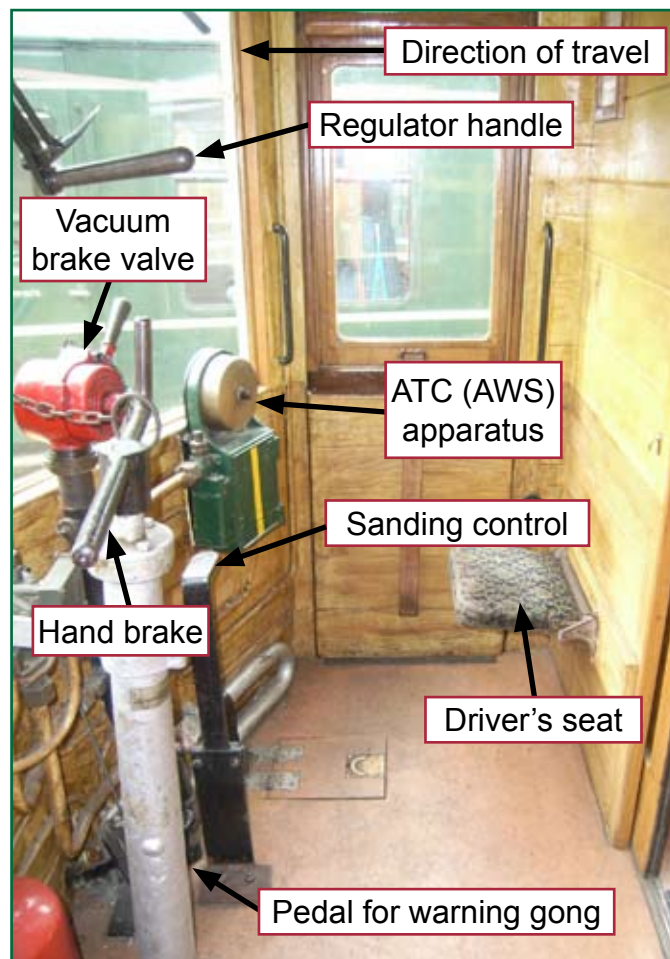
- 45 When the driver wishes the fireman to release the brakes by creating vacuum, he should give two rings on the electric bell between the autococh and locomotive to tell the fireman to release the brakes. The bell was not in working order on the day of the accident, so the engine whistle (operated by a wire from the cab of the autococh) was being used for communication instead.

Figure 13: Driver's position in Autococh. Bell and whistle controls are above front window, to left of picture

- 101 The autococh driving cab arrangement is shown in Figure 13. The driver is normally standing or seated towards the right hand side of the cab, looking forward. The views from the cab on the day of the accident were reported as being good with no observable windscreen contamination.
