# Rail Accident Report

**Fatal accident at West Lodge crossing, Haltwhistle  
22 January 2008**

This report is published by the Rail Accident Investigation Branch, Department for Transport.

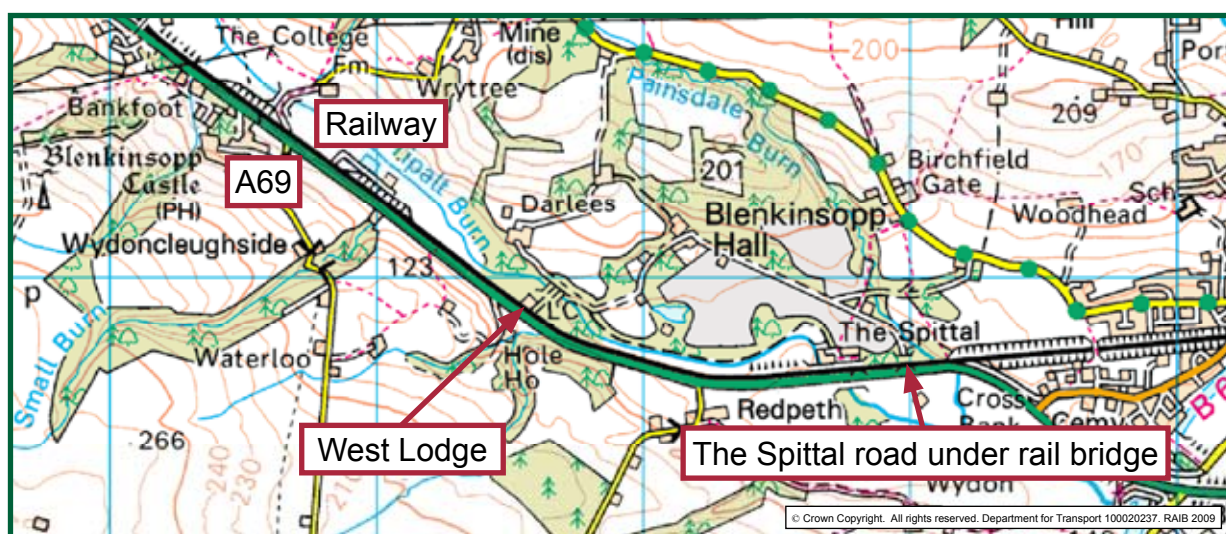
Figure 2: Access from the A69 to the Blenkinsopp estate and the alignment of the road and the railway

- 10 The railway and the A69 road converge at Bankfoot and run adjacent and aligned past West Lodge (Figure 2). At this location, the national speed limit of 60 mph (97 km/h) applies; on the railway, the line speed limit is 65 mph (105 km/h).

- 16 The nearest alternative route to West Lodge is via The Spittal, 0.93 miles (1.5 km) south-east along the A69, where the access road passes under the railway (Figure 2). This route involves a round trip of 2.8 miles (4.5 km) via the Spittal to West Lodge.

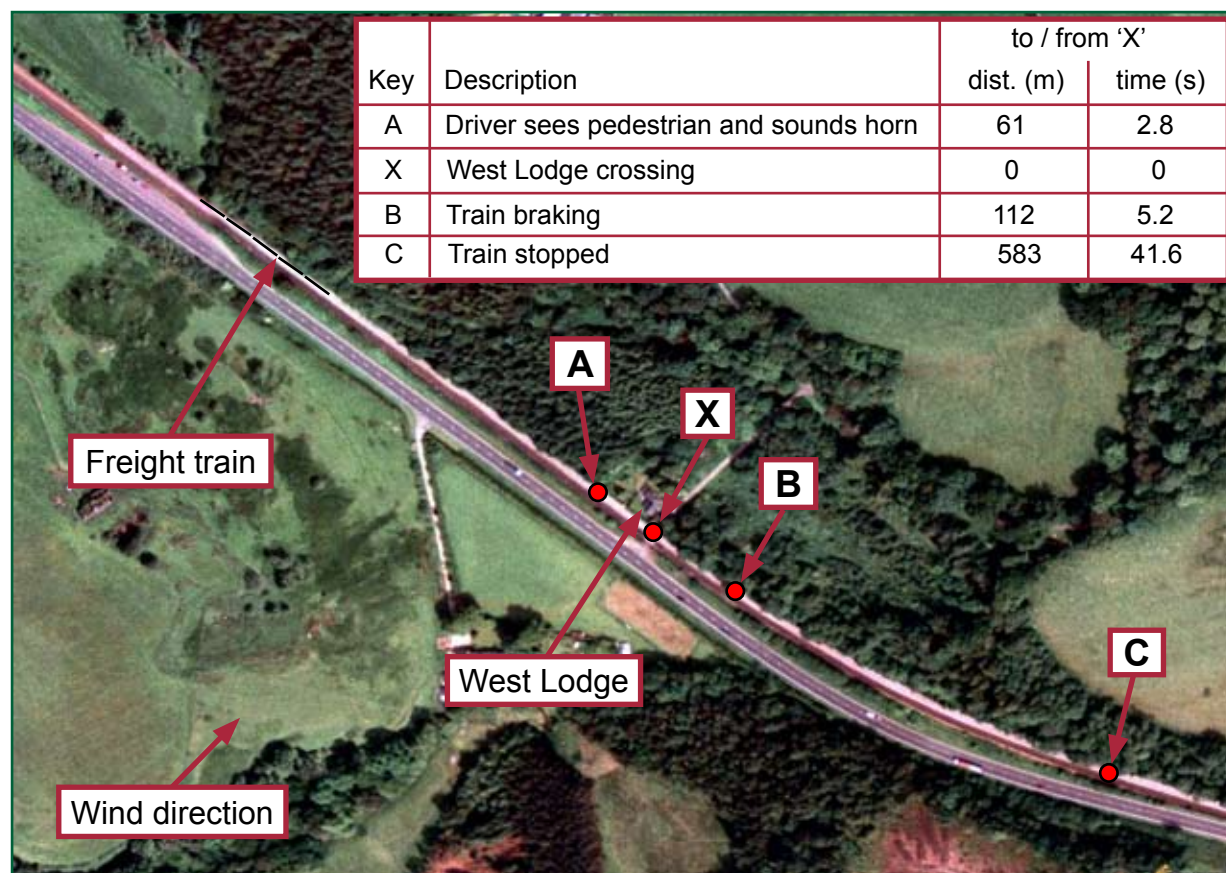
Figure 6: Aerial view of the accident location (image courtesy of getmapping.com)

- 26 The train came to a stand 583 metres beyond, and out of sight of, the crossing (Figure 6). From here, the train driver used his mobile phone to call the Network Rail signaller and report the accident. The signaller stopped all trains on the up and down lines and contacted the emergency services. The residents of West Lodge were aware of the accident and they too called the emergency services.
