Rail Accident Report

Freight train collision at Leigh-on-Sea 26 April 2008

Report 24/2009 September 2009 This investigation was carried out in accordance with:

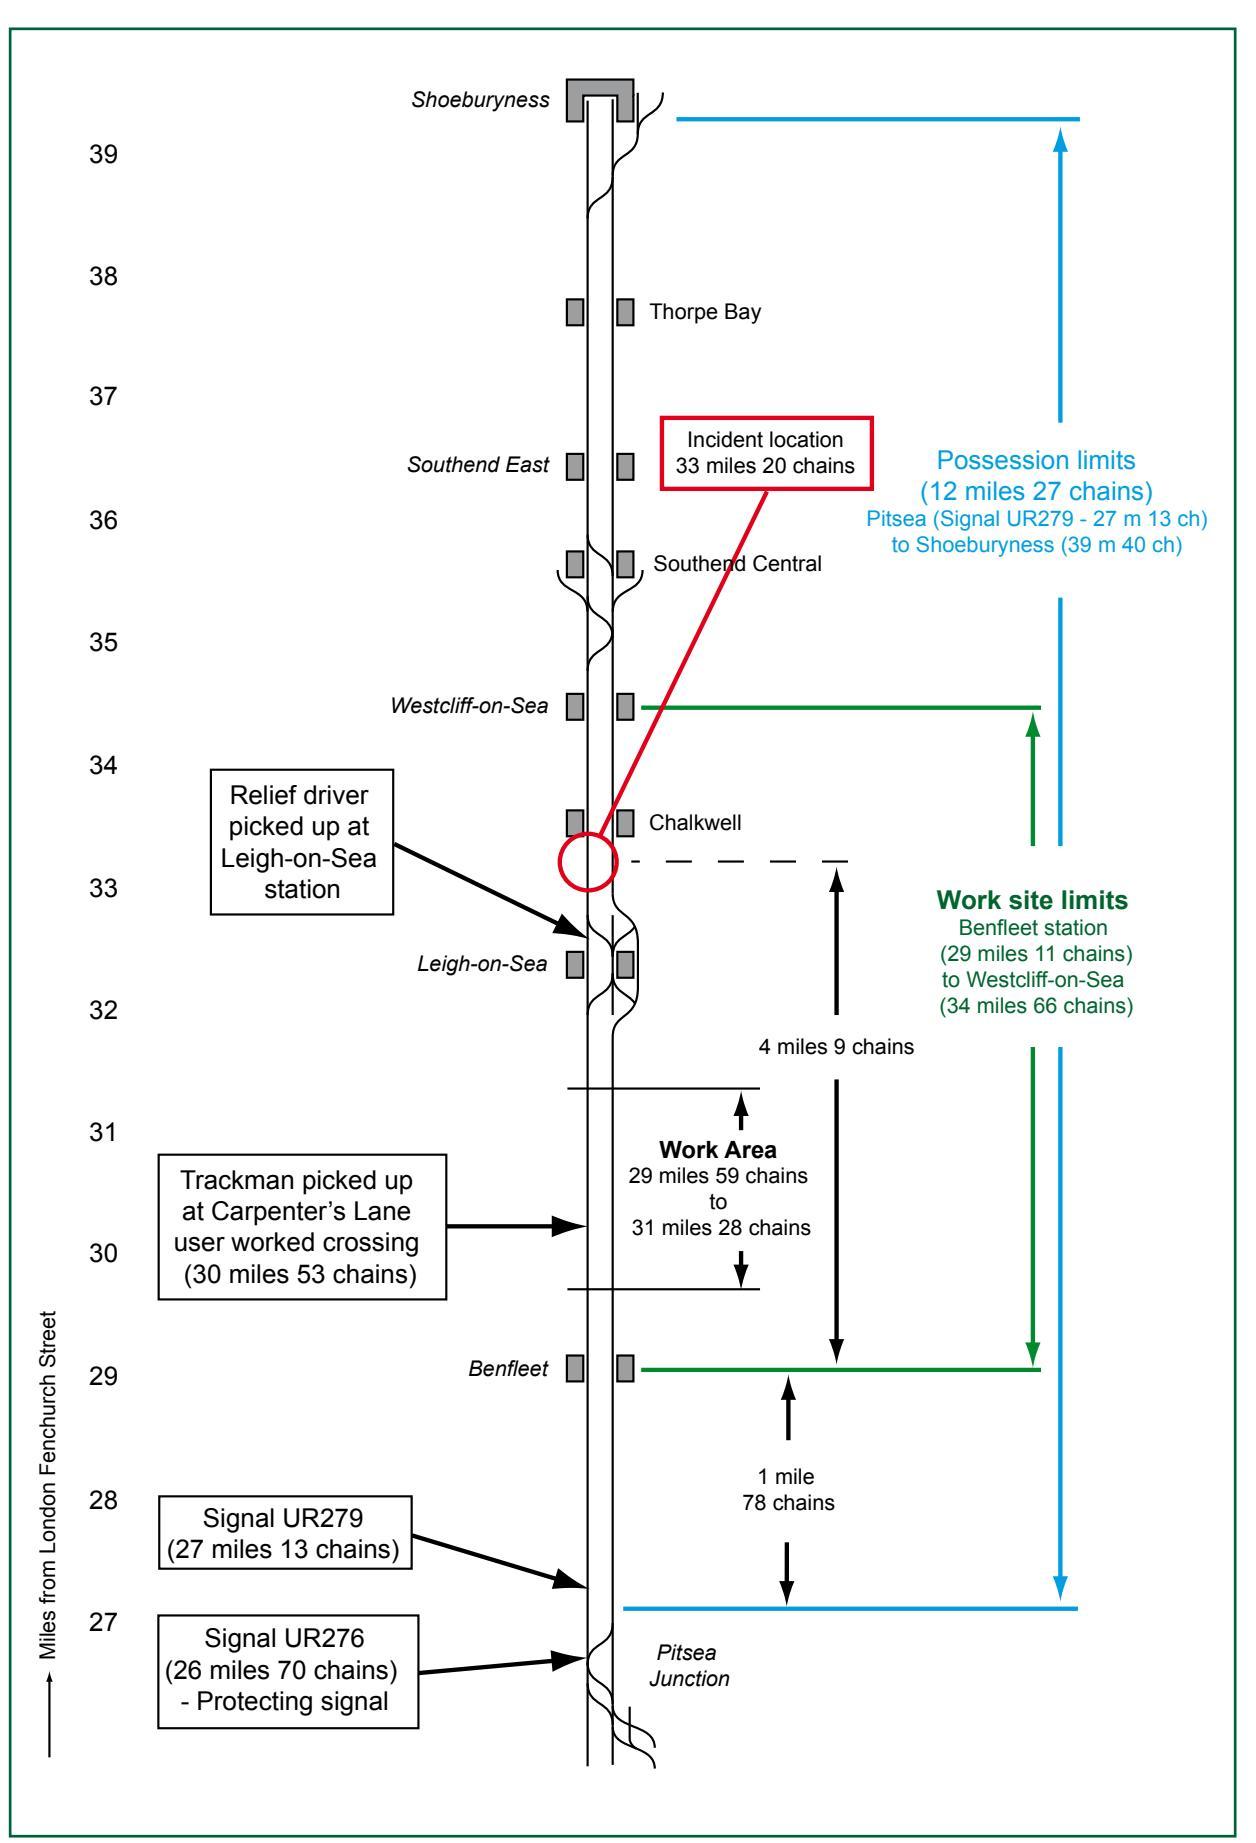
Figure 2: Location of Possession and work site limits

- 20 Engineering work for track renewals was planned for the 26 April to 28 April 2008 and listed in the *Weekly Operating Notice* (WON) 05, items 158 to 173 (Figure 2). The T3 possession limits were from signal UR 279 (27 miles 13 *chains*) to the buffer stops at Shoeburyness (39 miles 40 chains), a distance of 12 miles and 27 chains. The *protecting signal* was UR 276 located at Pitsea Junction (26 miles 70 chains).

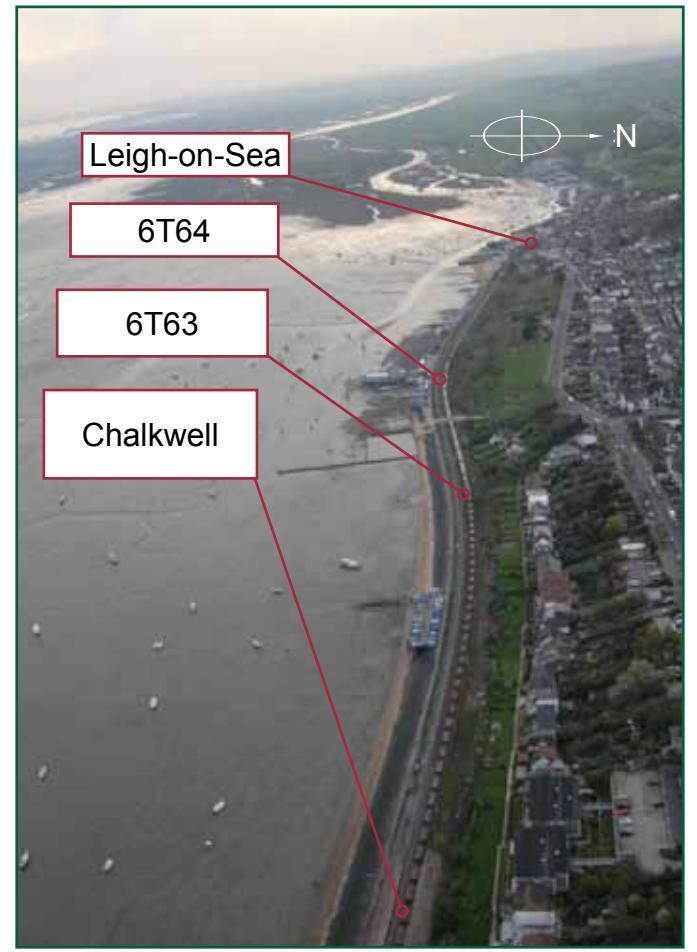
Figure 3: Aerial photo showing locations of station and train positions

23 The incident occurred on a left-hand curve on the approach to Chalkwell station.

- 36 Train 6T63 (train number 8) entered the possession and work site and was *stabled* on the approach to Chalkwell station. The locomotive was then detached from the rest of the train, and the brakes applied. This completed the movement of trains 1 to 8 into the work site without incident (Figure 3).

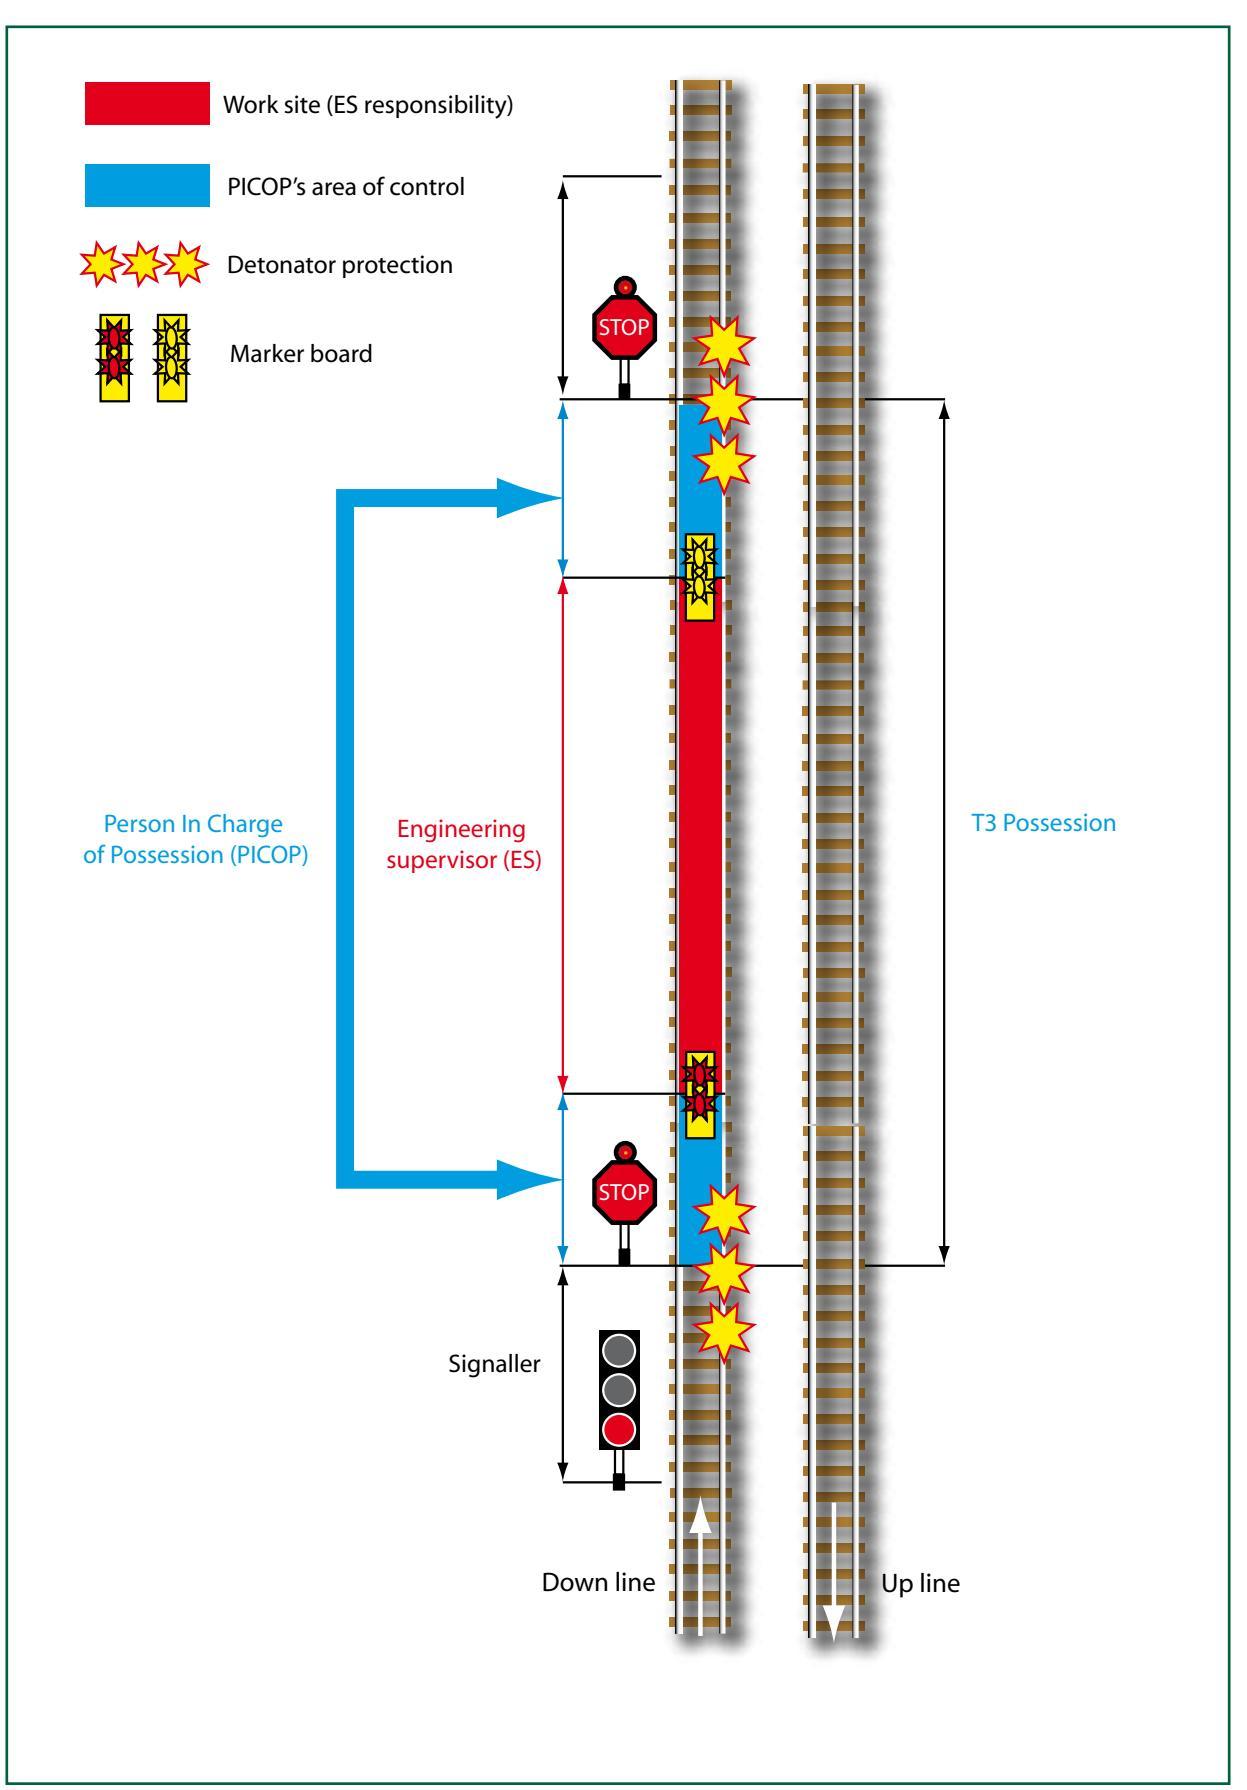
Figure 4: Diagram showing areas of responsibility of the Engineering Supervisor and PICOP

- 44 The driver was instructed by the Engineering Supervisor to enter the work site and travel to the rear of train 6T63 (Figure 4). Conflicting evidence means that it is uncertain whether a full safety briefing took place advising the driver of the location of train 6T63 and that he should travel at walking pace and stop short of any obstruction. The Engineering Supervisor advised the driver that he would accompany the driver in the train cab to Carpenters Lane user worked crossing (within the work site) where he would leave the cab and the trackman would join the train. The Engineering Supervisor also instructed the driver to make an additional stop at Leigh-on-Sea station platform where he was to pick up a relief driver. The Engineering Supervisor gave no details of the responsibilities of the other staff that would join the train.

- 90 The Network Rail company standard NR/SP/CTM/021 'Competence and Training in Track Safety' is the bespoke specification for the Engineering Supervisor's training. It includes instructions for those who present the training and assess the staff as competent to carry out Engineering Supervisor duties. The training plan shows the modules of the Rule Book which require the Engineering Supervisors involvement (Figure 4).

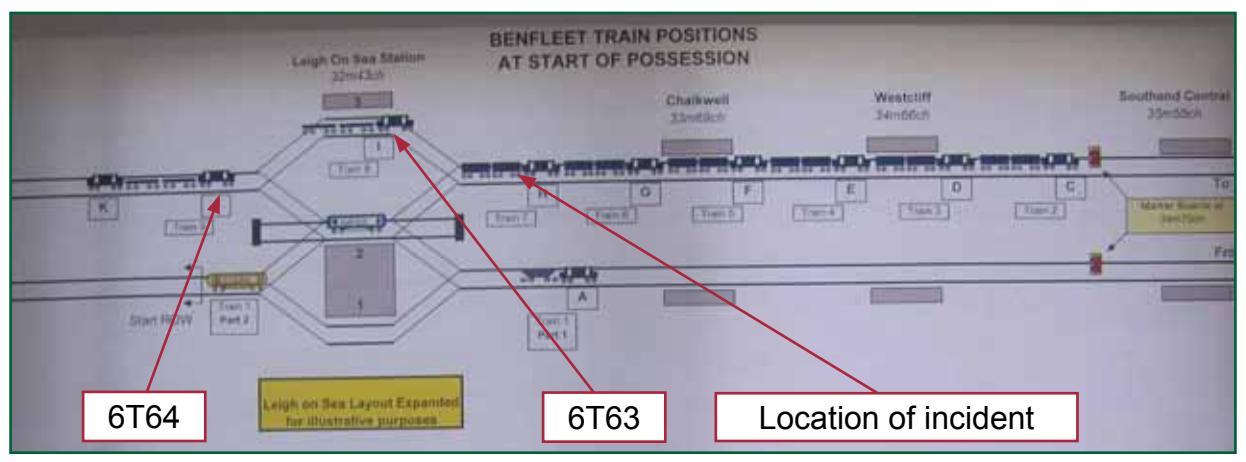
Figure 11: Photograph of the possession plan used for site briefings at the booking on point at Leigh-on-Sea

228 All staff arriving on site were instructed by Balfour Beatty to book on at the site offices at Leigh-on-Sea station. The train plan within the office was used as a visual aid to brief staff on the chronological order of train movements and the weekend possession. The diagram was endorsed 'not to scale' as it did not reflect the mileage, or the final positions of the trains in relation to the stations. The position of train 6T63 was shown as Leigh-on-Sea station when its actual physical location was beyond the curve on the approach to Chalkwell station. No guidance was given to staff on the location of the train and the visual briefing may have led some staff to wrongly assume the location of train 6T63 shown on the diagram was correct when it had actually been stabled further east towards Chalkwell station. However, in view of the train driver's fatigued state, and consequent inability to fully react to the instructions given to him, the train plan used for the briefing was neither causal nor contributory to the incident (Figure 11).

238 The train plan within the office was used as a visual aid to brief staff on the chronological order of train movements and the weekend possession. The diagram was not to scale and did not reflect the final positions of the trains in relation to distances in miles and chains, or to the stations. The visual briefing may have led some staff to wrongly assume the location of 6T63 was shown as correct, when it had actually been moved to a different location (paragraph 228 and Figure 11).
