Rail Accident Report

Derailment at St Peter's Square, Manchester **29 June 2008**

This report is published by the Rail Accident Investigation Branch, Department for Transport.

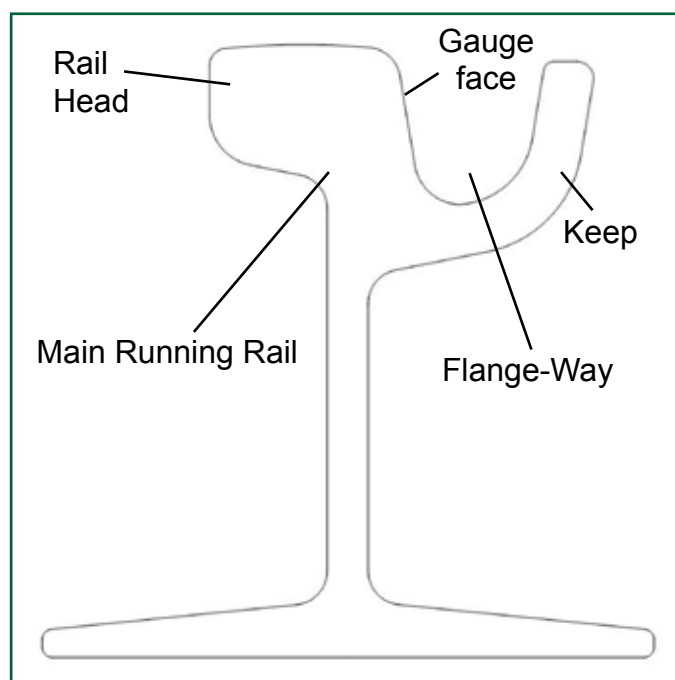
Figure 3: Ri 59 grooved rail cross section

- 26 In the *city zone* the track construction consists of rail embedded in a polymer block with no specific gauge retention other than that provided by the polymer and the road surface. The track consists of Ri 59 *grooved rail*; the cross section of which is shown in Figure 3. It consists of a main running rail and a keep, between which is the *flange-way*. The keep is provided to maintain a barrier between the flange-way and the road surface; it is not designed to provide rail guidance or be load bearing; there is no intention that the keep should be contacted by wheels.
