Rail Accident Report

**Fatal accident at Wraysholme crossing,
Flookburgh, Cumbria
3 November 2008**

Fatal accident at Wraysholme crossing, Flookburgh, Cumbria, 3 November 2008

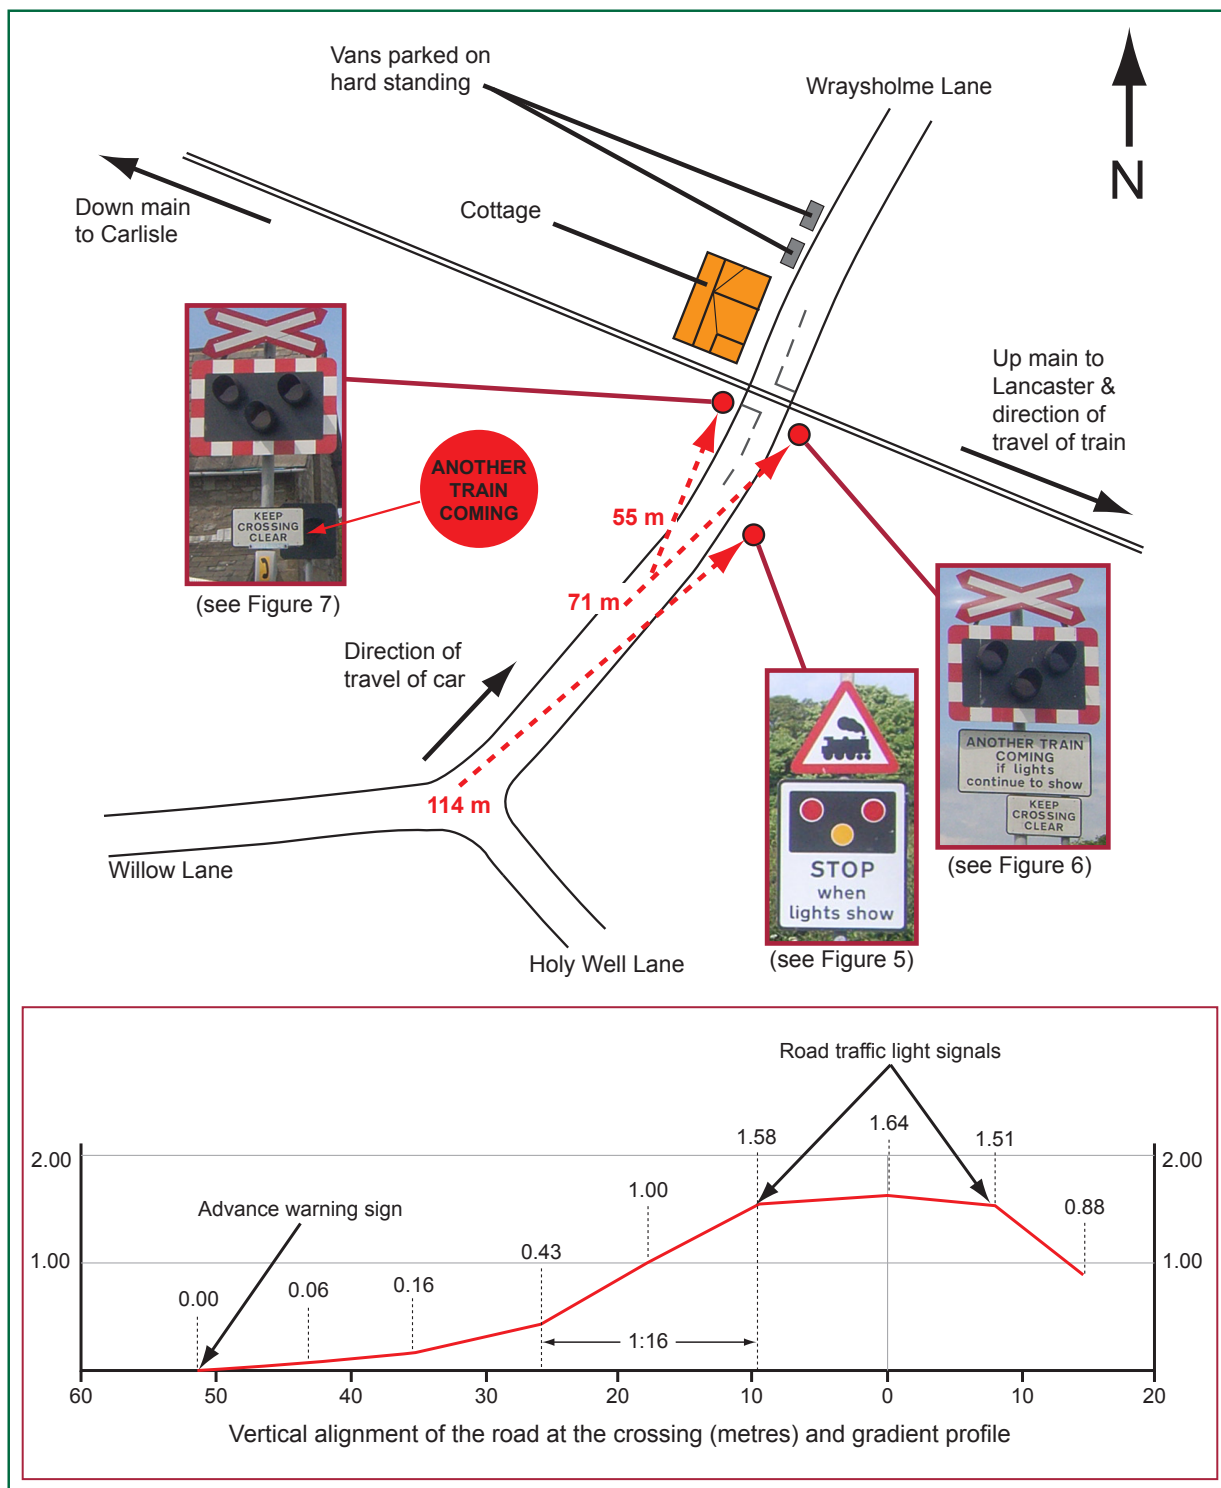
Figure 3: The crossing, its warning signs and road traffic signals

- 22 Advance warning signs on the road indicate the presence of the crossing and read 'STOP when lights show'. At the crossing, signs read 'KEEP CROSSING CLEAR' and 'ANOTHER TRAIN COMING if lights continue to show'. A solid white stop line and the 'STOP' road marking are painted on the road adjacent to the crossing (Figure 3).

- 128 In accordance with the Traffic Signs Regulations³³, road users must stop at the solid white line and give way each time they approach a 'STOP' road marking and octagonal 'STOP' sign (Figure 14). There is no octagonal 'STOP' sign at Wraysholme crossing and the 'STOP' road marking is there in error. It contradicts the normal instruction to proceed over the crossing, stopping only when the red lights show, and confuses road users.
- 129 The RAIB and the Office of Rail Regulation assessed the use of the crossing on several occasions; each time they observed road users who slowed or stopped at the crossing and then crept over it looking out for trains when they were required to proceed. Network Rail observed and recorded the same behaviour at the crossing while conducting site visits.

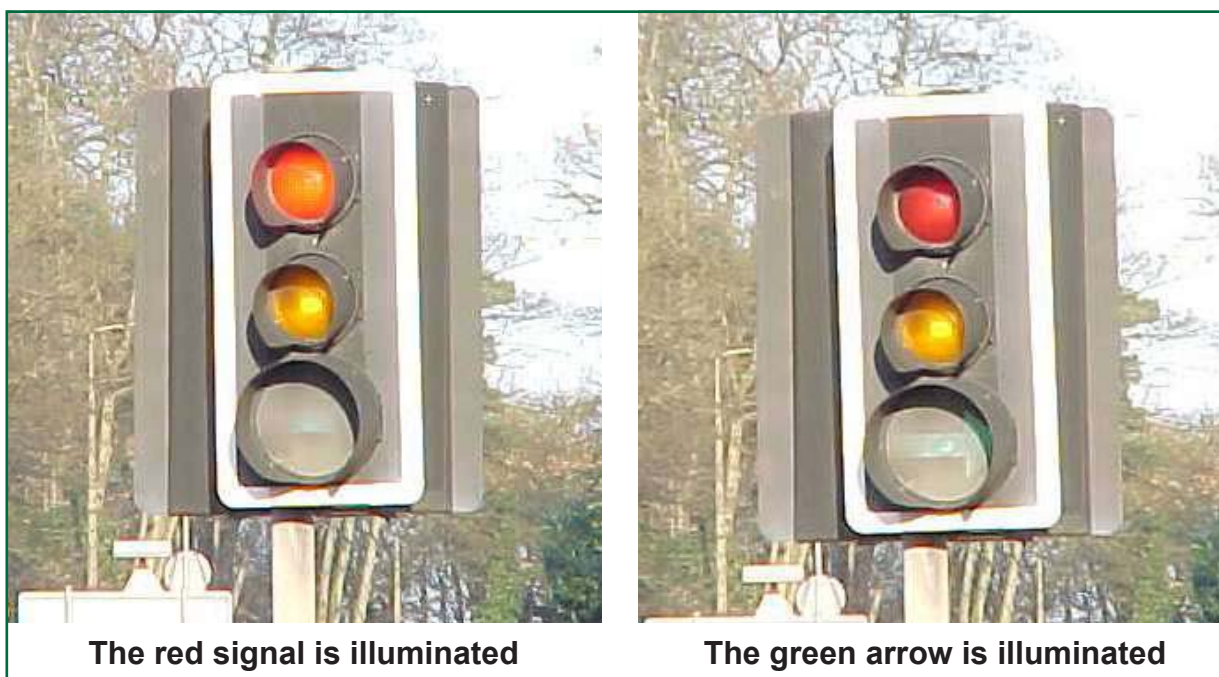
Figure 10: The effect of sunlight on signals (taken from *Traffic Control System Design for All Purpose Roads*, Department for Transport publication MCH 1969 published December 2003)

- 85 When the sun is bright, low in the sky and shining onto a signal, 'phantom' effects¹⁸, washout¹⁹, or reflection off the backboard may impair a person's ability to discern its aspect (Figures 9 and 10). All signals are fitted with hoods to reduce the sun's effects, and signals with an orientation that is susceptible to the sun's effects may be fitted with longer hoods. At the time of the accident, the Wraysholme signals were fitted with standard hoods.
