Rail Accident Report

Serious injury sustained by a signal technician at Kennington Junction 23 May 2008

Report 29/2009 November 2009 This investigation was carried out in accordance with:

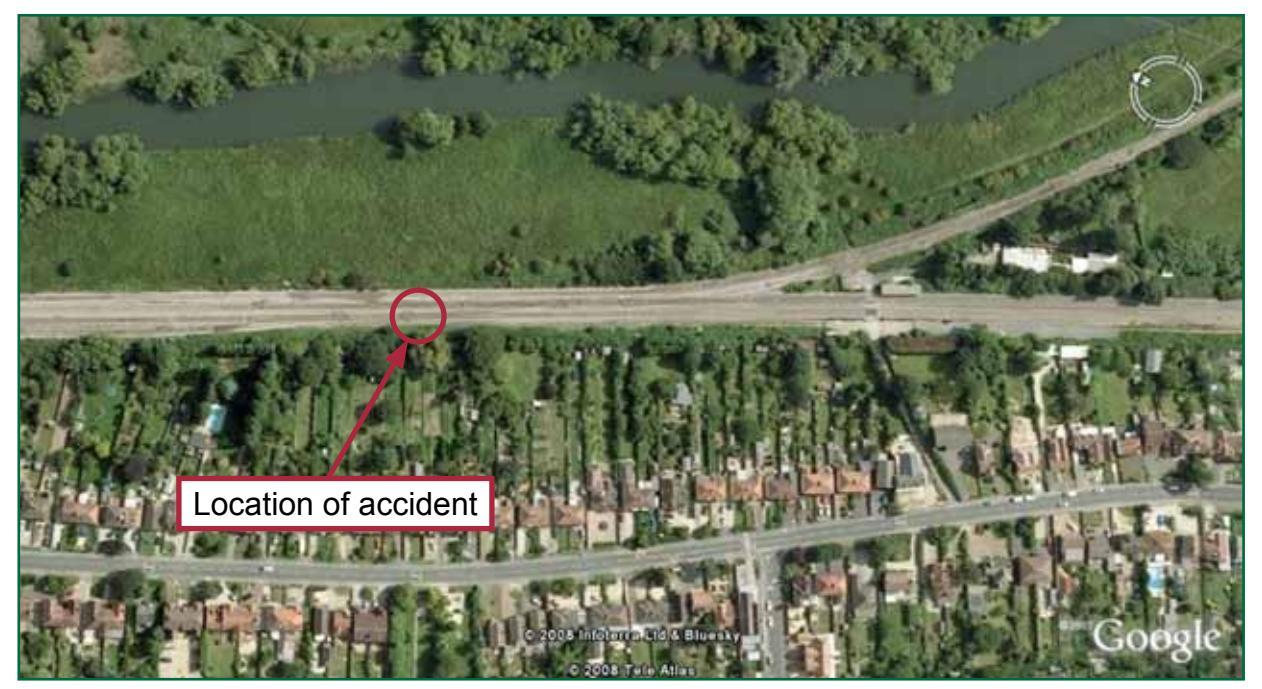
23. The highest permitted speed over the *crossover* between the up and down lines, and to and from the goods loops and the Cowley Branch is 25 mph (40 km/h). The crossover points on the Down Oxford line where the accident occurred have identification number 207A.

Figure 2: Aerial view of the accident site (image courtesy of Google Earth)

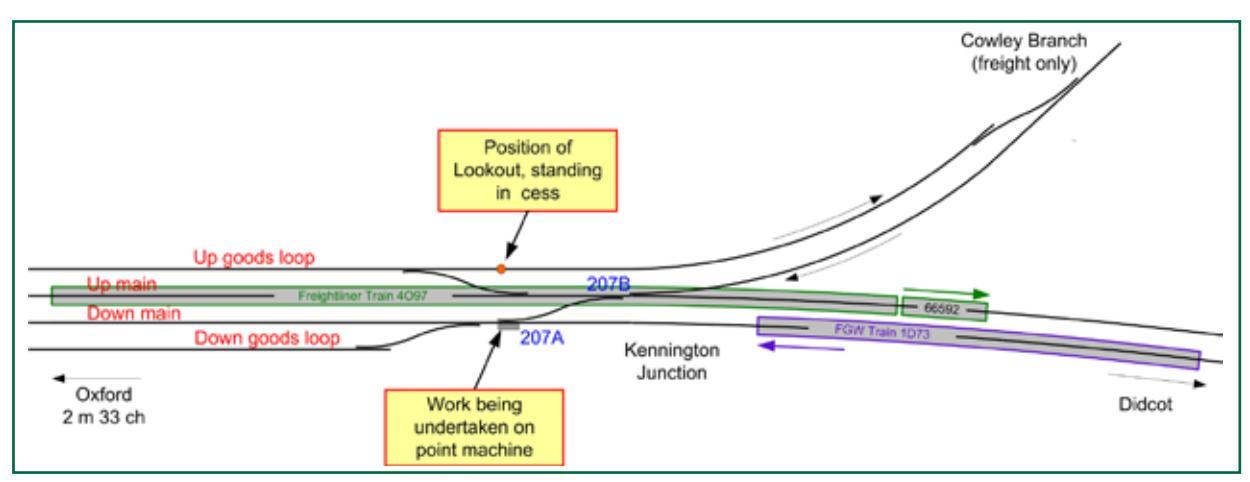
- 36. The team arrived at Kennington Junction at about 21:00 hrs when it was still daylight, and left their van close to the junction points. They planned to begin work by undertaking the facing point lock tests on the crossover between the up and down lines (207A and 207B points).

Figure 3: Track layout in the vicinity of Kennington Junction

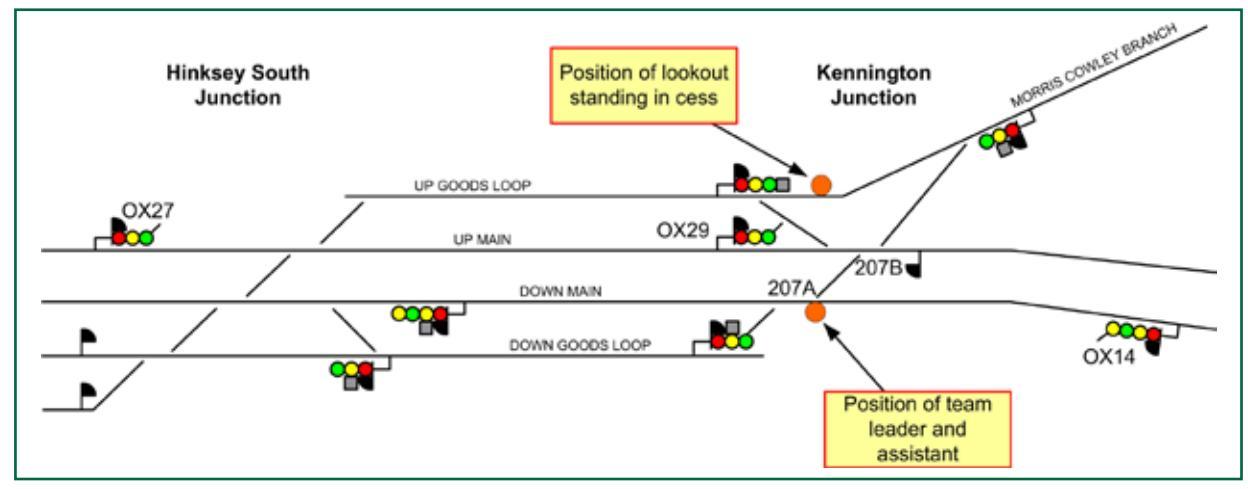
Figure 4: Track diagram showing signals used to protect the site of work

- 38. At 21:16 hrs the team leader (COSS) used his mobile phone to contact the signaller and requested permission to start work. When trains were clear of the site of work, the signaller responded by placing to danger signal OX14 on the down line and signals OX27 and OX29 on the up line (Figure 4) so as to prevent trains passing the site of work. He placed *reminder devices* (colloquially known as *collars*, see Figure 12 in Appendix F) on the controls for those signals and then advised the team leader (COSS) that work could commence.

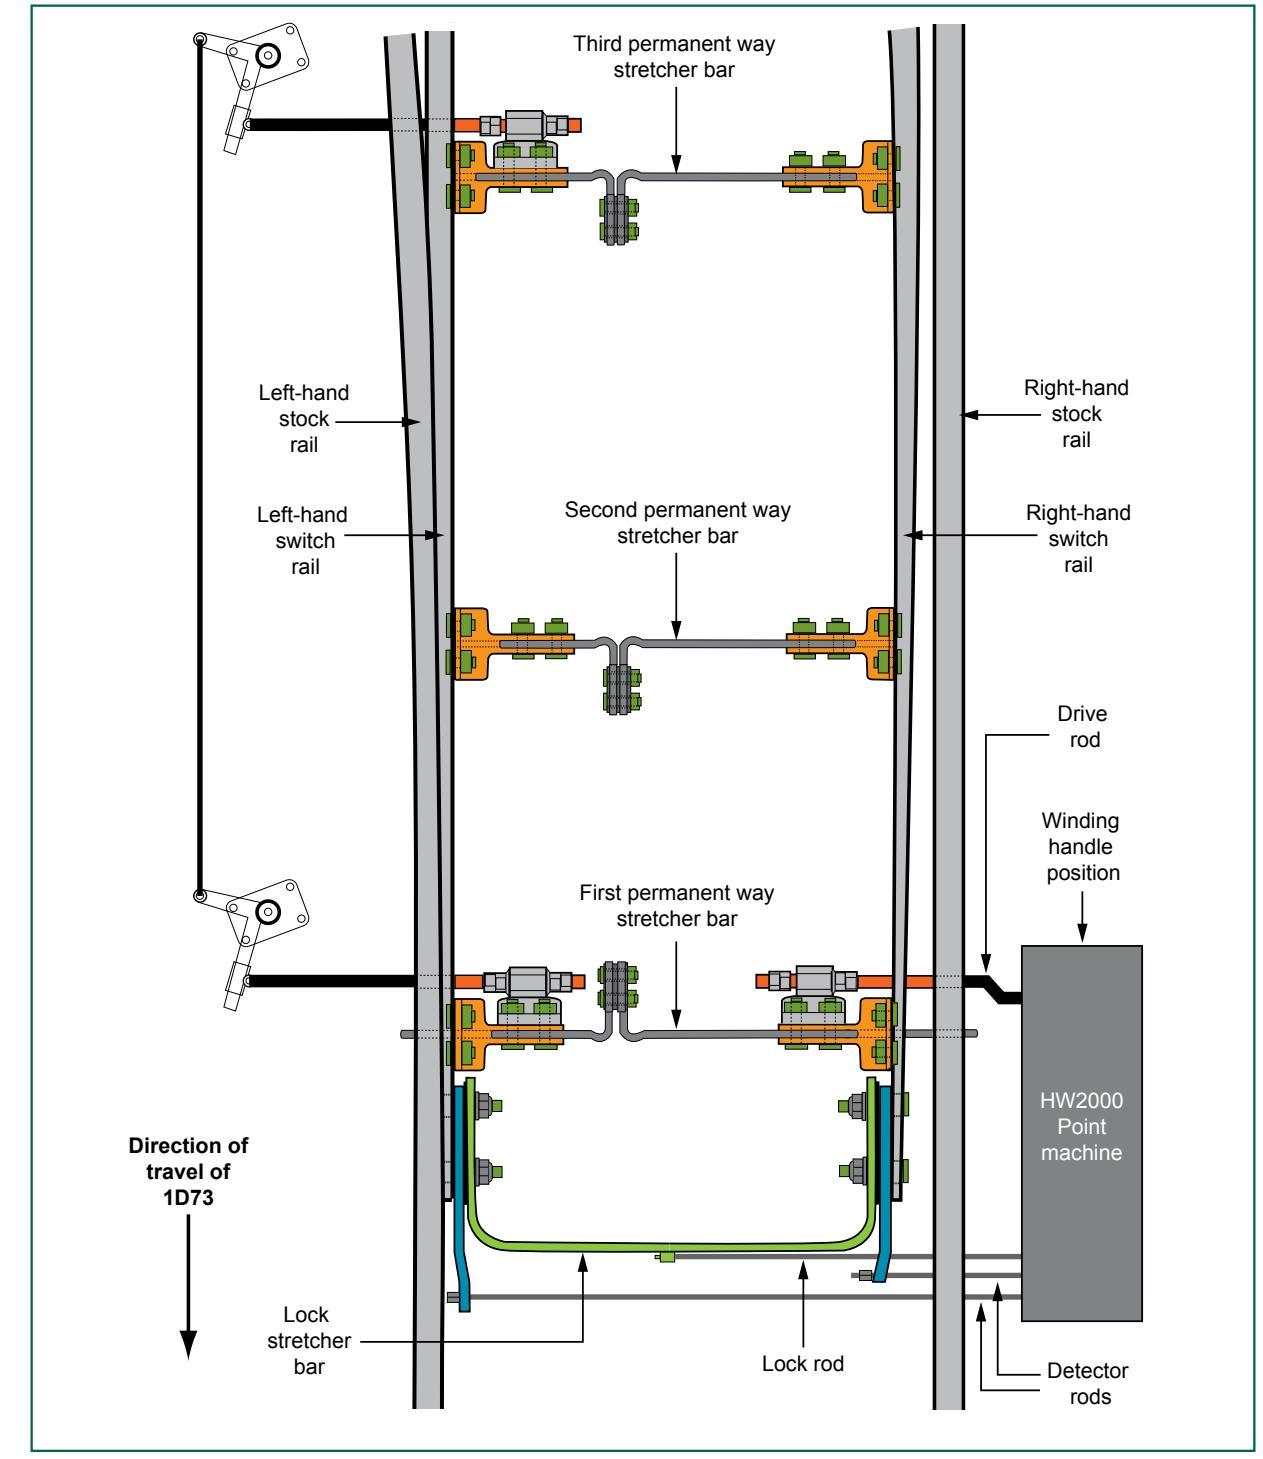
- 41. At 21:24 hrs the team leader (COSS) requested a further period in which to continue the test which the signaller provided. Soon after, the test unexpectedly failed with the switch rails in the *reverse* position (in this position the points were set for a route between the up and down lines). The team leader and his assistant were then faced with the task of adjusting one or more of the rods linking the point machine to the rails (Appendix F). They commenced this activity immediately.

Figure 7: Schematic diagram showing the parts of 207A points and the associated point machine.

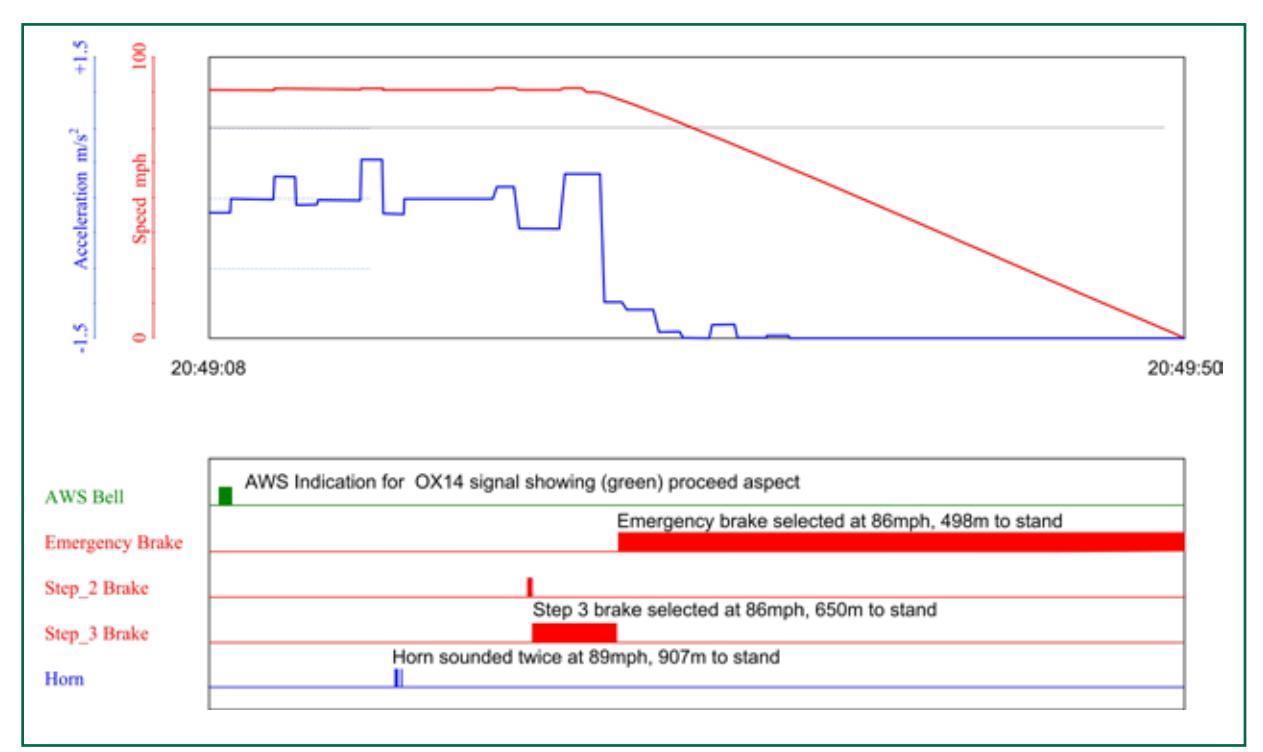
Figure 8: Diagram showing the key elements recorded by the OTDR

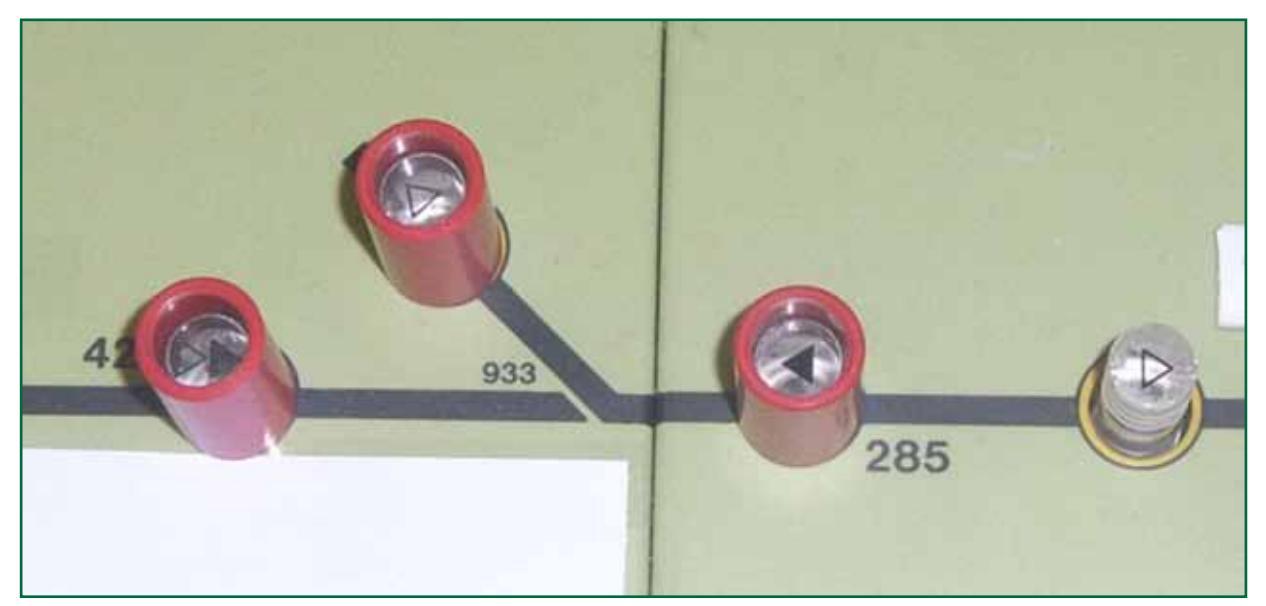
- F12 To protect any train driver from seeing an adverse change of aspect whilst a facing point lock test is underway and to maintain the safety of the railway, the signaller will place all the affected signals protecting the point to danger. The signaller's controls in Oxford signal box are push/pull buttons. As a reminder that the route must not be set or the signal cleared, the signaller will place a reminder device round the button preventing it from being operated.

Figure 12: Typical reminder devices (red tubes around the press button) used on a control panel. A press button without a reminder device is on the right-hand side of the picture
