Rail Accident Investigation Branch

Rail Accident Report

Derailment of a freight train at Marks Tey, Essex 12 June 2008

12 June 2008

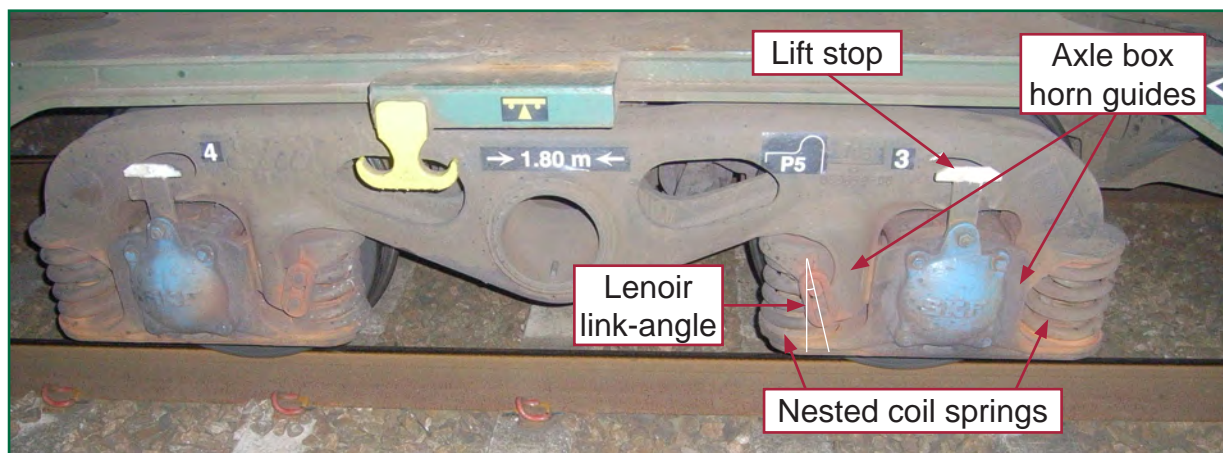
Figure 6: Y25 type bogies

- 83 The rear bogie leading wheelset showed contact marks indicating that the left-hand wheel had also ridden high on the wheel flange. The trailing wheelset of the rear bogie had contact marks on the tip of its left-hand wheel flange; this wheel also had a fresh mark on its tread that was indicative of it having dropped onto a rail head (figure 14). There was a possible contact mark on the right-hand wheel of this wheelset, and evidence of contact on the underside of the lift stop on the right-hand wheel of the trailing wheelset (figure 6), indicating that the bogie frame may have applied a lifting force to this wheel.

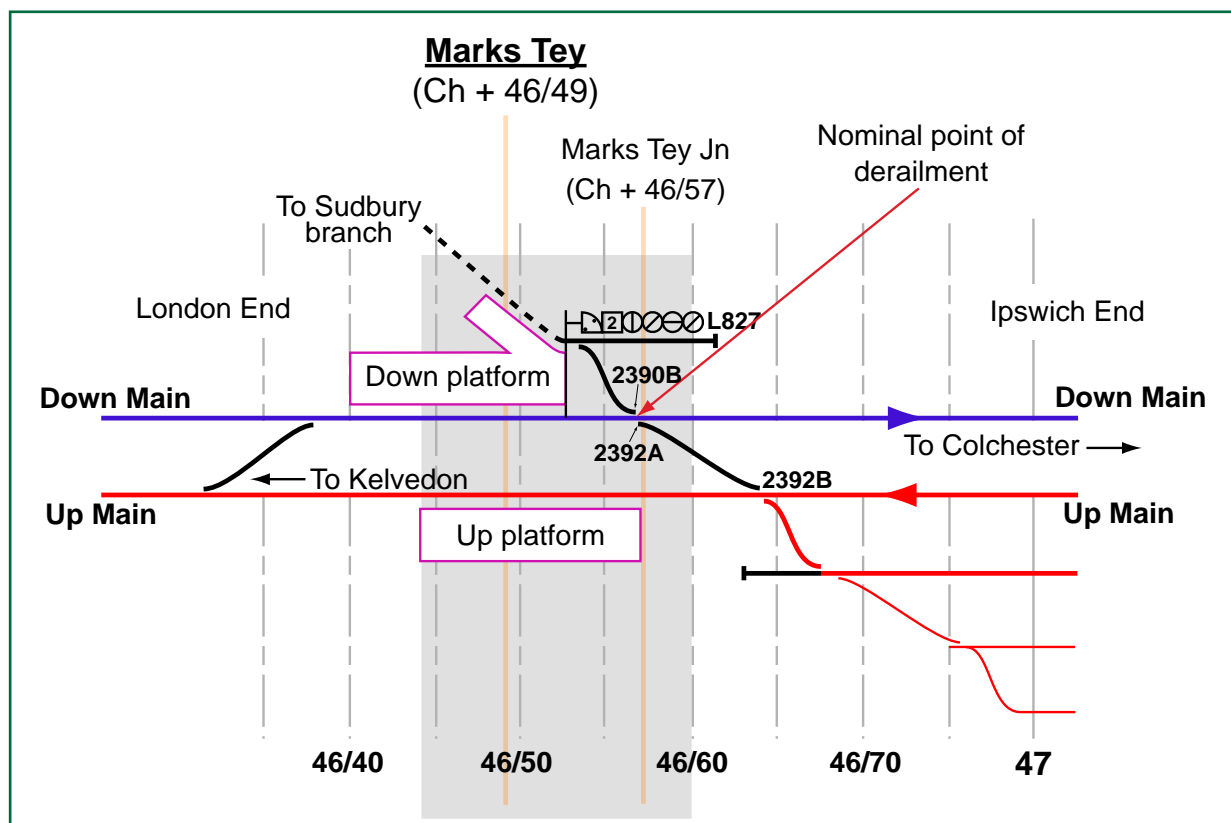
Figure 17: Extent of red zone prohibited area at Marks Tey

- 139 The diagrams for Patrol 5 identified that the line between 46 miles 44 chains and 46 miles 60 chains on both the up and down main lines were red zone prohibited. This meant that, for their own safety, patrollers following the diagrams were not permitted to walk on either line through Marks Tey station or Marks Tey junction under the red zone protection which they used for the remainder of the patrol¹² (figure 17).

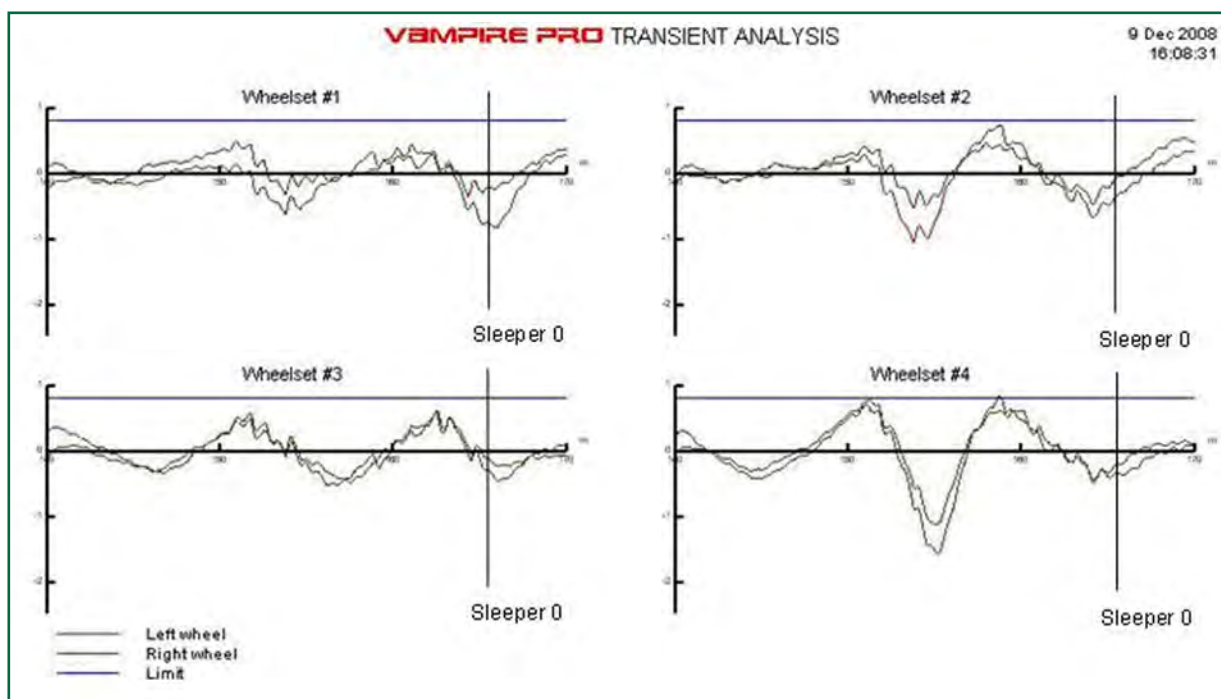
Figure 21: Filtered cycle of wheel unloading on compliant wagon on approach to nominal POD (image courtesy of Delta Rail)

- 209 The RAIB undertook further dynamic modelling to examine the reaction of a part-laden FSA/FTA wagon which complied with the vehicle vertical dynamic performance requirements of GM/RT 2141 Issue 2; this was done by changing the Marks Tey condition model solely in respect of its vertical dynamic performance. This model demonstrated that, although wheel unloading behaviour was still present in the compliant wagon model, the trailing bogie's rear right wheel only briefly exceeded the derailment limit for a sufficiently large distance (i.e. more than two metres) to be considered a derailment risk (figure 21). The risk of derailment was therefore reduced compared with the previous modelling of the non-compliant Marks Tey condition wagon. The FSA/FTA wagon design in the part-laden condition not meeting the requirements of GM/RT 2141 Issue 2 in respect of vertical dynamic performance was therefore a contributory factor in the derailment.
