Rail Accident Report

**Incident at Greenhill Upper Junction, near
Falkirk
22 March 2009**

Incident at Greenhill Upper Junction, near Falkirk, 22 March 2009

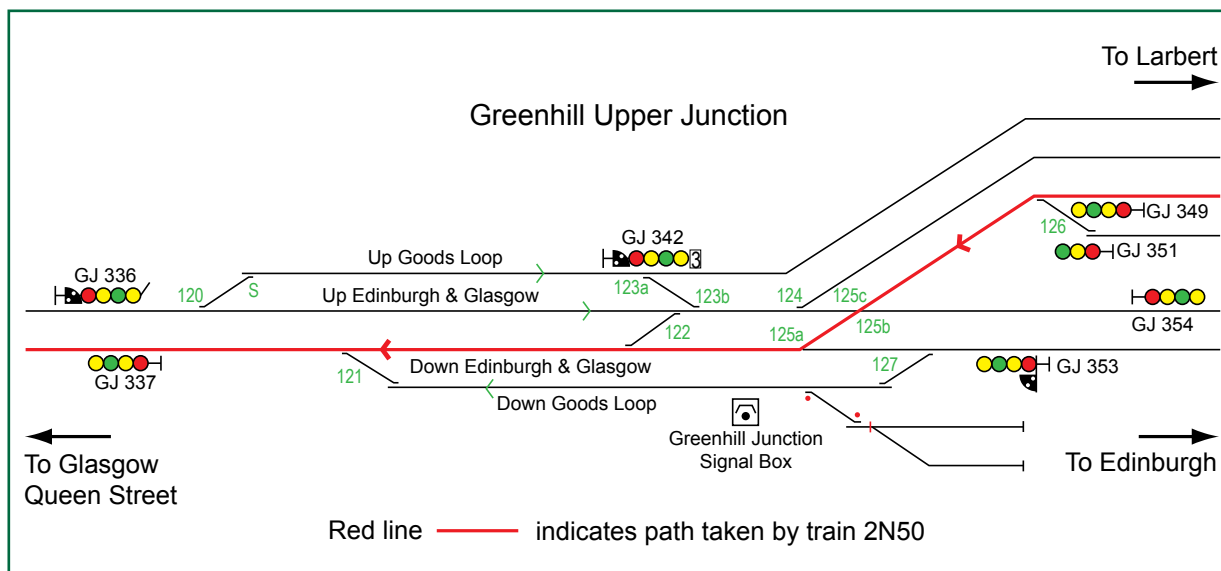
Figure 2: Track and signalling layout at Greenhill Upper Junction

- 17 At about 09:45 hrs on 22 March 2009, train 2N50, the 09:17 hrs from Alloa to Glasgow Queen Street, formed by a three-car class 170 *diesel multiple unit*, traversed Greenhill Upper Junction (figure 2) at 64 mph (103 km/h). One of the point ends, designated 125C, forming part of a set of switch diamonds, was in the incorrect position and the train trailed through them forcing them across to the correct position and damaging the mechanism as a result.

- 22 Greenhill Upper Junction is 17 miles 29 chains (28 km) from Glasgow Queen Street station on the main line between there and Edinburgh Waverley station. It is about 3 miles (5 km) west of Falkirk and is where the line from Larbert and Stirling joins the Edinburgh and Glasgow line (figure 2).
- 23 The permissible speed for trains crossing the junction to or from the Larbert direction is 70 mph (113 km/h); the permissible speed for trains on the Edinburgh and Glasgow line is 100 mph (161 km/h).
- 24 Trains crossing the junction from the Larbert direction must first pass over the switch diamonds consisting of 125C and 125B point ends on the up Edinburgh and Glasgow line, followed by the trailing point ends of 125A turnout, located where the line from Larbert joins the down Edinburgh and Glasgow line.

- 30 The first trains, following the completion of work on 21/22 March 2009, were along the Edinburgh and Glasgow main line requiring 125 points to be in the normal position. The failure to switch 125C point machine back onto power was therefore not apparent. However, when the Greenhill signaller set a route requiring all 125 points ends to be in the reverse position, 125C point ends remained in the normal position. The wiring fault in 125B point machine resulted in the signalling system not detecting that 125C point ends had remained in the normal position and the interlocking enabled the *protecting signal* GJ349 to clear (figure 2).

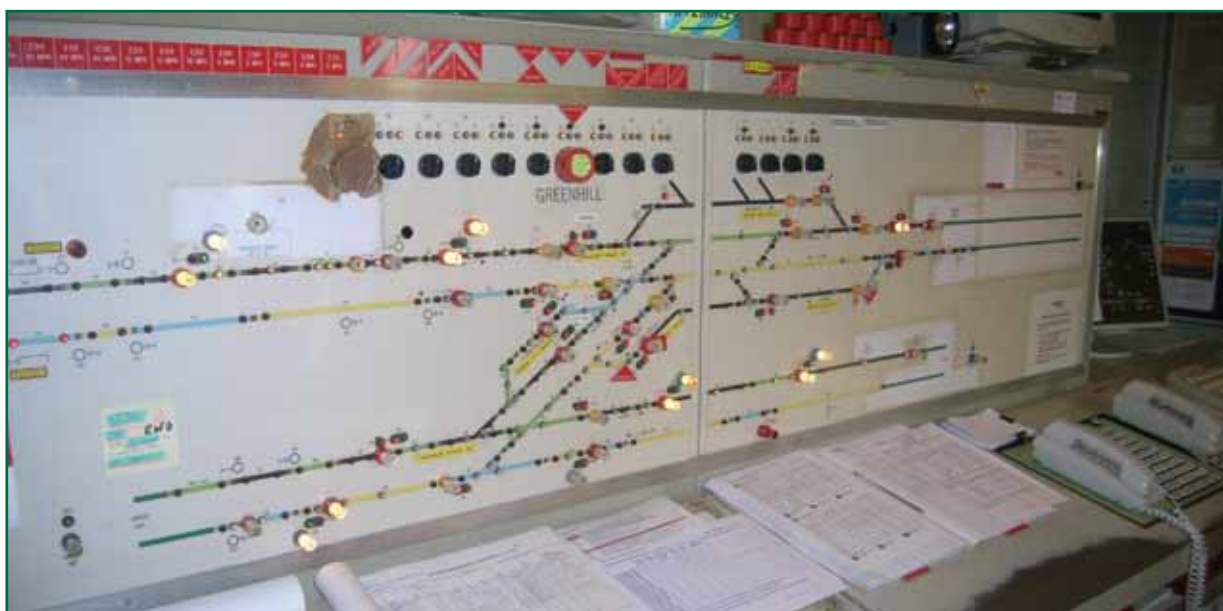
Figure 3: Greenhill Junction signal box signaller's panel

- 25 The signalling at Greenhill Upper Junction is controlled from Greenhill Junction signal box. This is located locally at Greenhill Upper Junction and is in the same building as the *interlocking*. The interlocking is of the GEC *geographical route relay interlocking* type dating from the early 1970s, and the signaller's interface is a small NX panel (figure 3). The signaller sets routes by pressing entrance and exit buttons on the panel, which – providing the required conditions in the interlocking are met – causes points to move to the correct positions and the appropriate signals to clear. The signaller can also operate the points during out-of-course working by using *individual point switches* located in a row along the top of the panel.

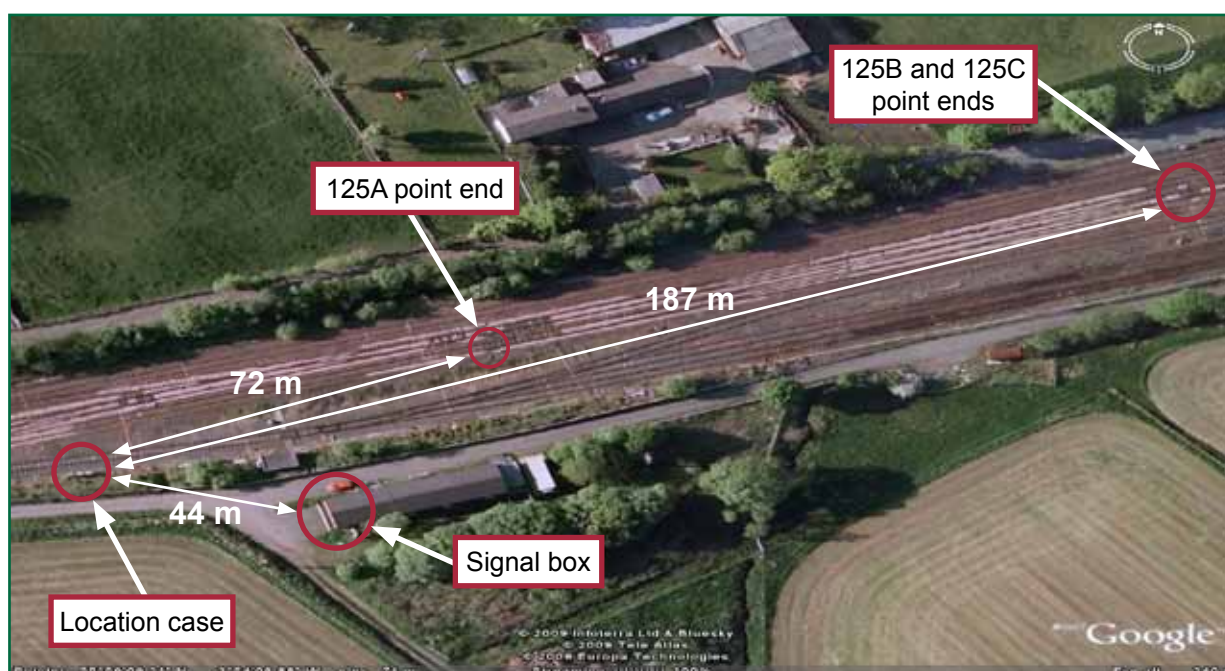
Figure 7: Site layout at Greenhill Upper Junction

- 108 The physical layout of the site is shown in figure 7. This shows that it is 187 m from location case 17/2C to the switch diamonds, 72 m to the point machine at 125A points and 44 m to the signal box.

- 109 Other than ‘face-to-face’ speech, the only means of communication between those present on site was by mobile phone between the tester and the person in the signal box; a third mobile phone had been available, but its battery had become flat. Evidence was given that the tester had to walk away from the location case on occasions to request the person at the switch diamonds to manually operate the point ends and to confirm when they had completed their travel.

- 178 The consequence of this was that, because of the long distances on the site (figure 7), the tester was not able to communicate verbally from his position at the location case with the person who was stationed to manually operate 125B/C point ends. The tester sometimes had to leave the location case where the detection relays are housed in order to speak to the person at the switch diamonds.

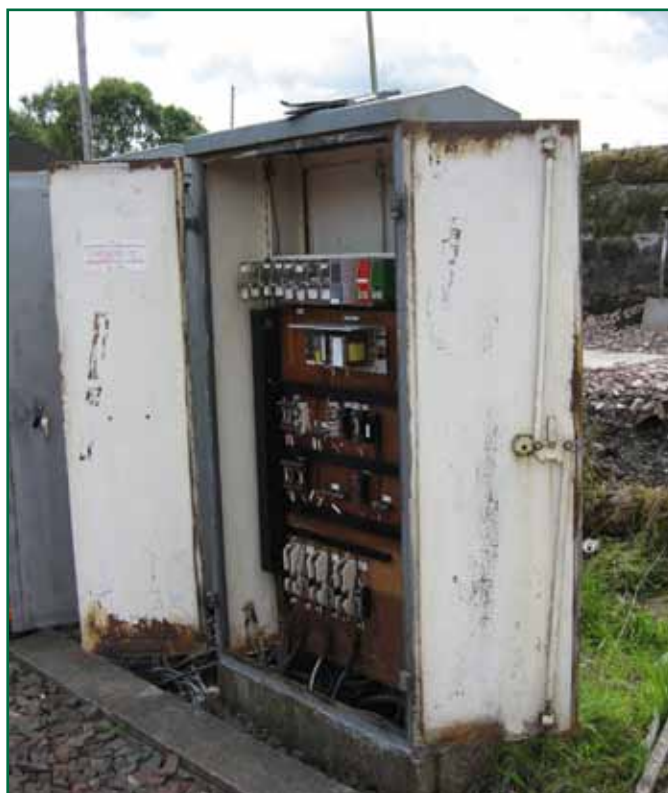
Figure 10: Location case 17/2C

Point detection and correspondence testing

1. When a signaller sets a route over 125 points by pushing the entrance and exit buttons on the panel, the required position of the points is commanded by the interlocking in Greenhill relay room and by equipment in location case 17/2C (figure 10). The command to change the position of a set of points is known as points calling.

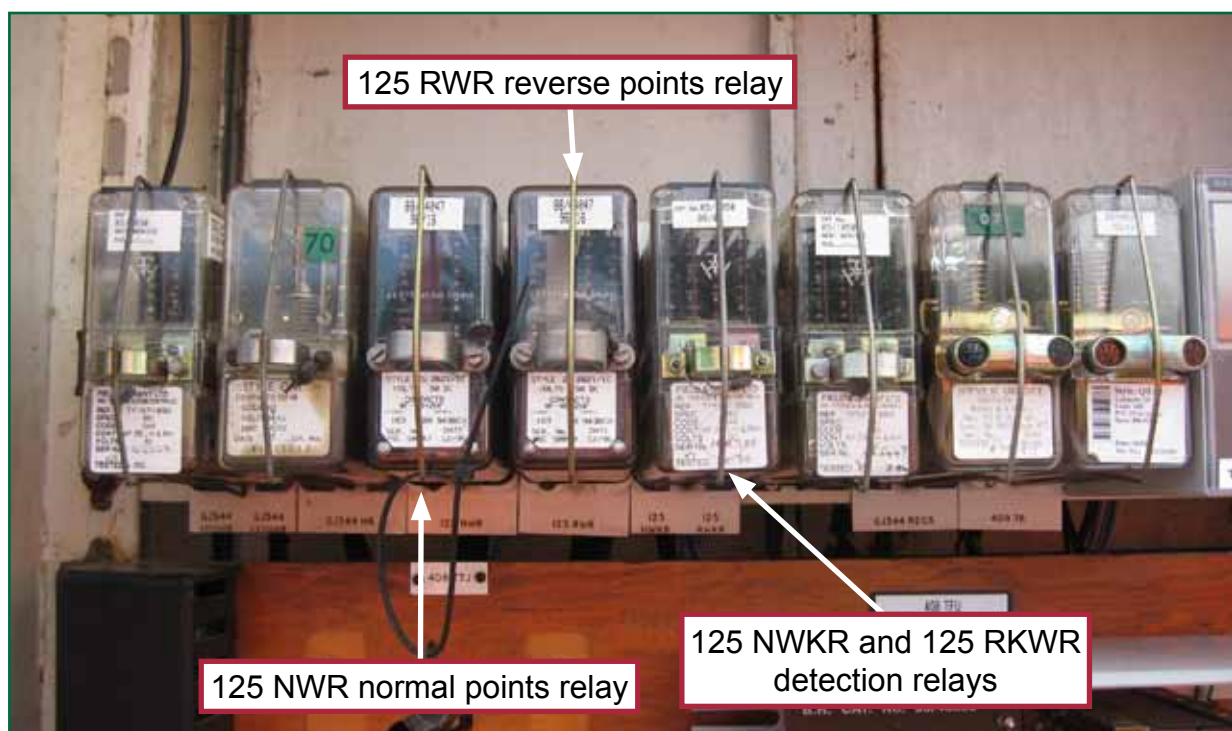
Figure 11: The relays associated with the control of 125 points

4. The relays in table 3 belong to the BR specification 930 series of 'miniature' relays and operate on 50 volts direct current. They are each enclosed in a clear plastic case to provide protection from the elements. The complete assembly plugs into a plugboard to which the various connections are wired. The relay is held in place by a retaining clip. Figure 11 shows the relays in table 2 in position in location case 17/2C.

5. The two detection relays, 125 NWKR and 125 RWKR, are both contained in a single plastic case and each has six front contacts and two back contacts. They are biased relays which only energise when direct current is flowing in one direction through their coil.
6. Figure 12 shows a simplified diagram of the detection circuit associated with 125 points. There are two detection contacts for each point end position to allow the circuits to be *double cut*. They are contained within each point machine (figure 13) and are wired in series between each of the 125 point ends. Each contact has to be closed, either normal or reverse, in order to energise the appropriate detection relay. This should only occur when all the associated switch rails are in the correct position.

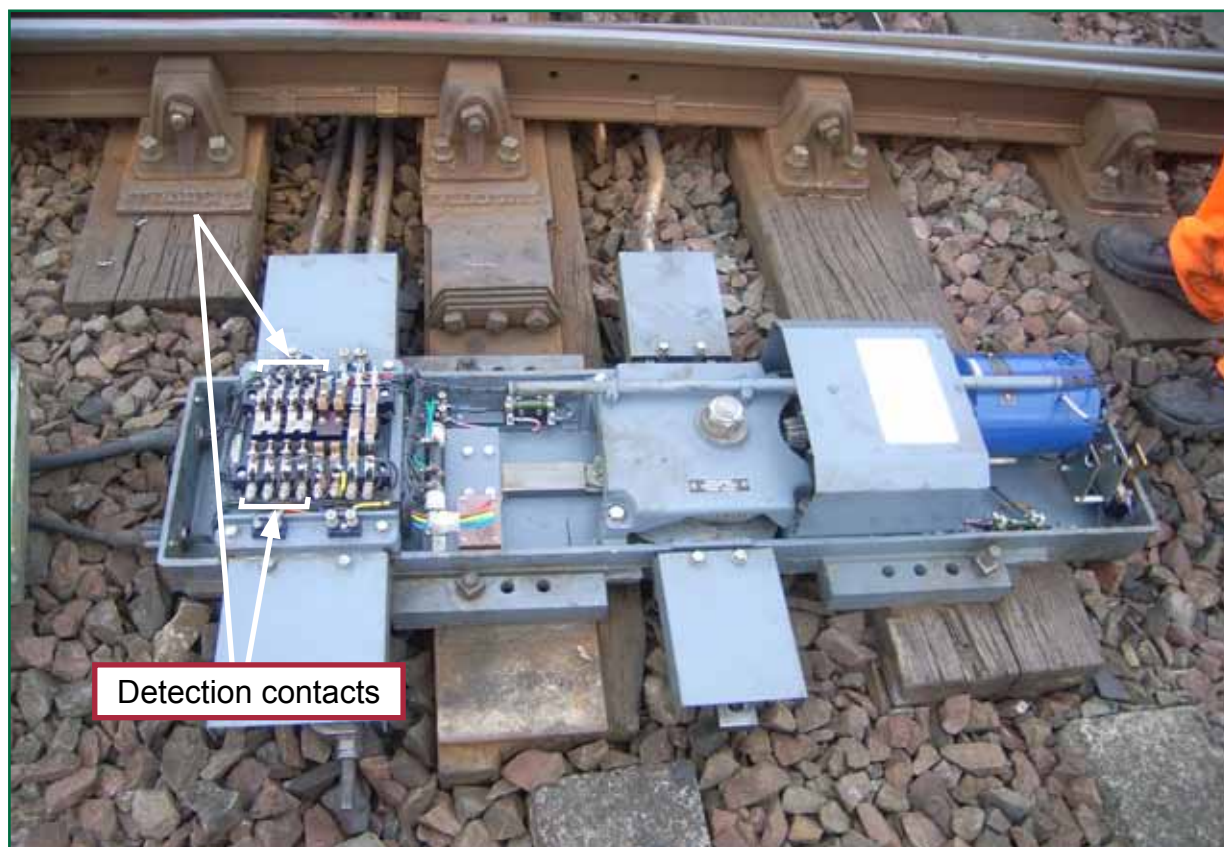
Figure 13: An HW2000 point machine with the cover removed

11. Each point machine is connected by two multi-core tail cables: one containing ten cores and the other containing four cores. The ten core cable contains the cores that feed the detection circuit and return it to the detection relays at the location case. The four core cable contains the feed to the motor that drives the machine.
