Rail Accident Report

Near-miss at Hanger Lane junction 27 March 2009

This report is published by the Rail Accident Investigation Branch, Department for Transport.

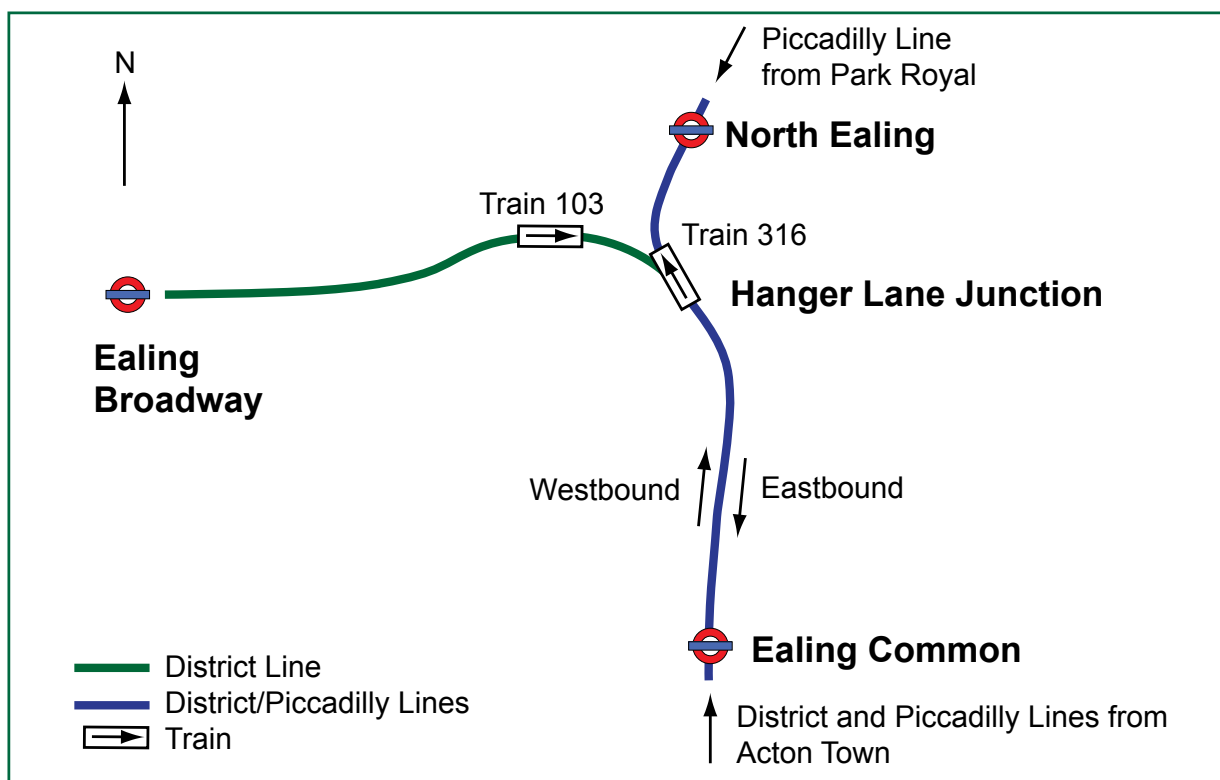
Figure 2: Simplified map of Hanger Lane junction showing position of trains during incident

- 17 Before the train operator had moved his train, he observed a westbound Piccadilly Line service (train 316) passing over Hanger Lane junction ahead of him on a conflicting path. Although the trains were separated by a distance of at least 115 metres, there was the potential for a collision to occur as one train was proceeding on clear signals and the other had authority from the signaller to proceed.

- 20 Hanger Lane junction is located between Ealing Broadway, North Ealing and Ealing Common stations where the District and Piccadilly lines converge. Having converged, both eastbound lines share the same track (figure 2). The junction is above ground.
- 21 All *powered points* and signals at Hanger Lane junction are controlled from the Piccadilly Line control room at Earls Court.

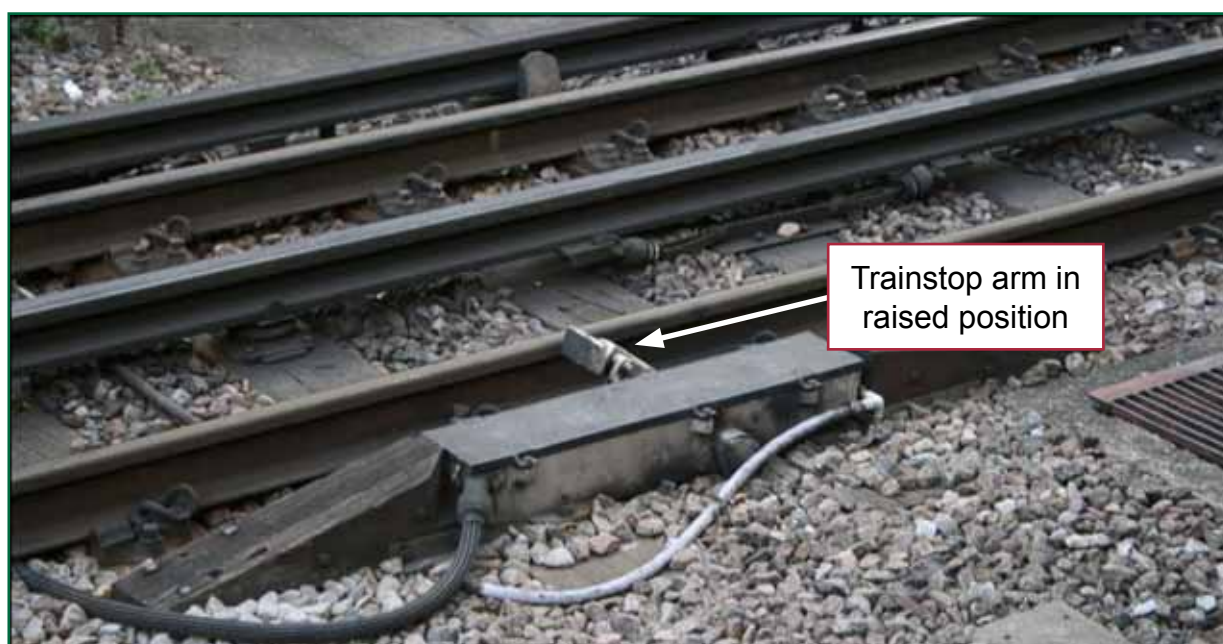
Figure 3: Trainstop in the raised (stop) position (photograph courtesy of LUL library)

- 24 Trains operating on the District and Piccadilly lines are fitted with *tripcock* equipment which works in conjunction with the signalling system. A *trainstop* is a device comprising a short arm which is raised when the signal is showing red (figure 3). If a train passes a signal at danger, the trainstop makes contact with the tripcock arm on the train which automatically applies the train's emergency brake. The tripcock equipment can be reset by the train operator following activation after the signaller has given authority to do so. After the tripcock has been reset, a timer limits the train to a maximum speed of 8 mph (13 km/h) for three minutes.

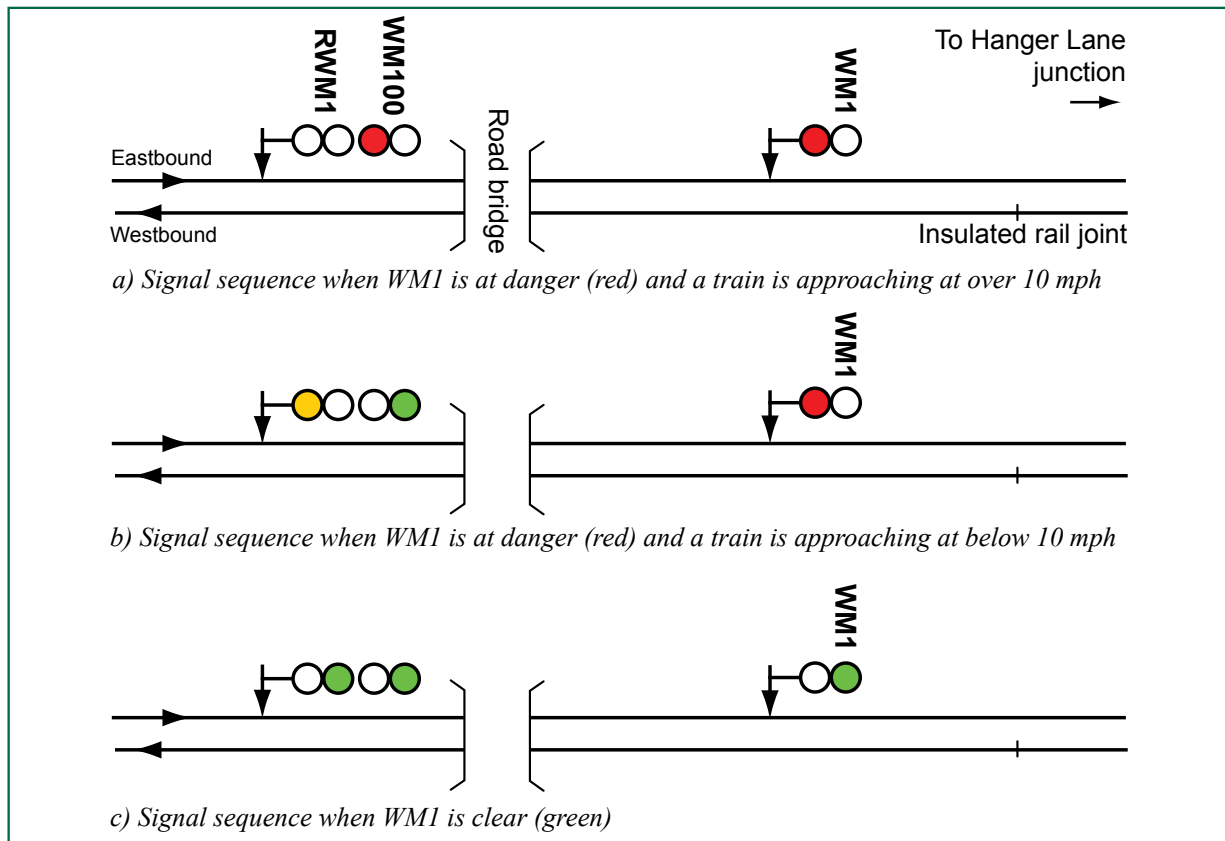
Figure 4: Signal sequence for an eastbound District Line train approaching Hanger Lane junction

- 26 Signal WM1 is preceded by signals WM100 and RWM1. Those two signals are located 74 metres before signal WM1 and mounted together (figures 4 and 5). They provide a train operator with information on the status of signal WM1:

- 36 At 17:21 hrs, train 103 departed from Ealing Broadway. As the train approached Hanger Lane junction, the train operator observed signal WM100 displaying a red aspect, which indicated that signal WM1 was also at danger. He slowed the train to below 10 mph (16 km/h). This was detected by the signalling system which allowed signal WM100 to clear to a green aspect and signal RWM1 to yellow (figure 4).

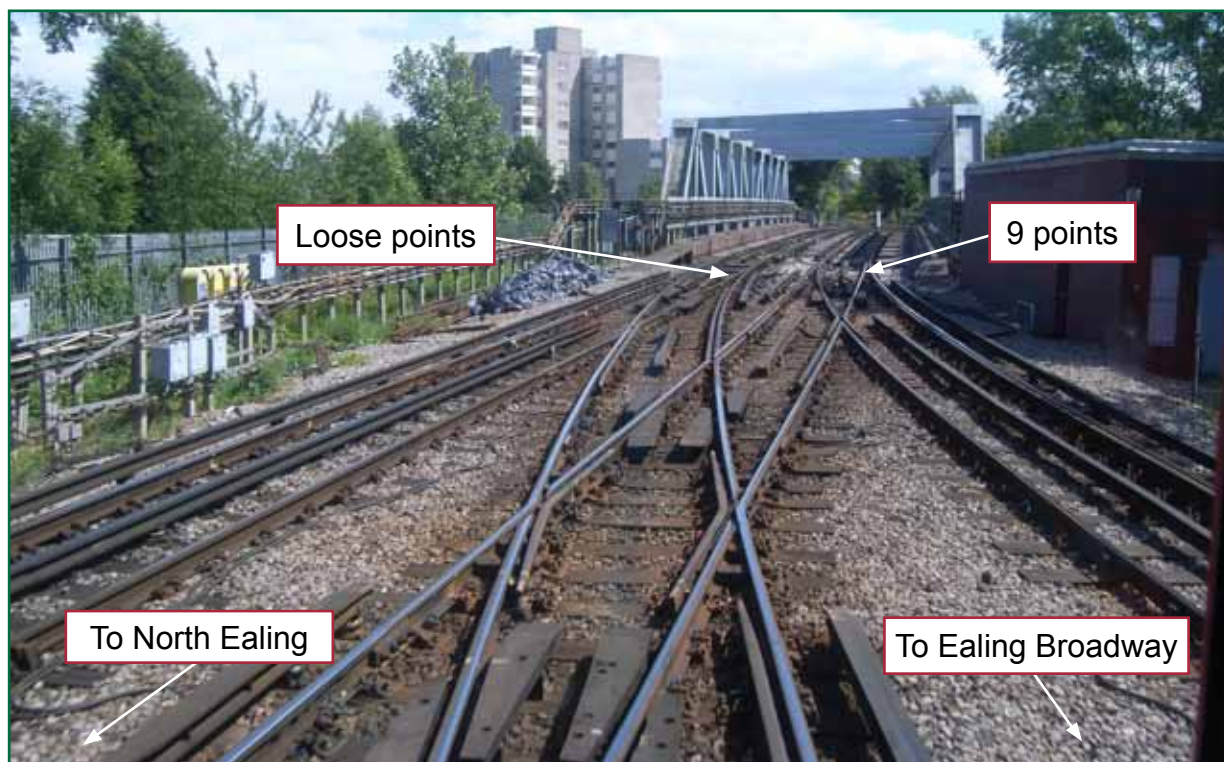
Figure 7: Hanger Lane junction viewed from eastbound District Line

- 28 The line speeds on the approach to the junction are 20 mph (32 km/h) over the eastbound District Line and 25 mph (40 km/h) westbound for both the Piccadilly and District Lines. The eastbound District Line, used by train 103, is on a rising gradient of 1:76 approaching the junction.

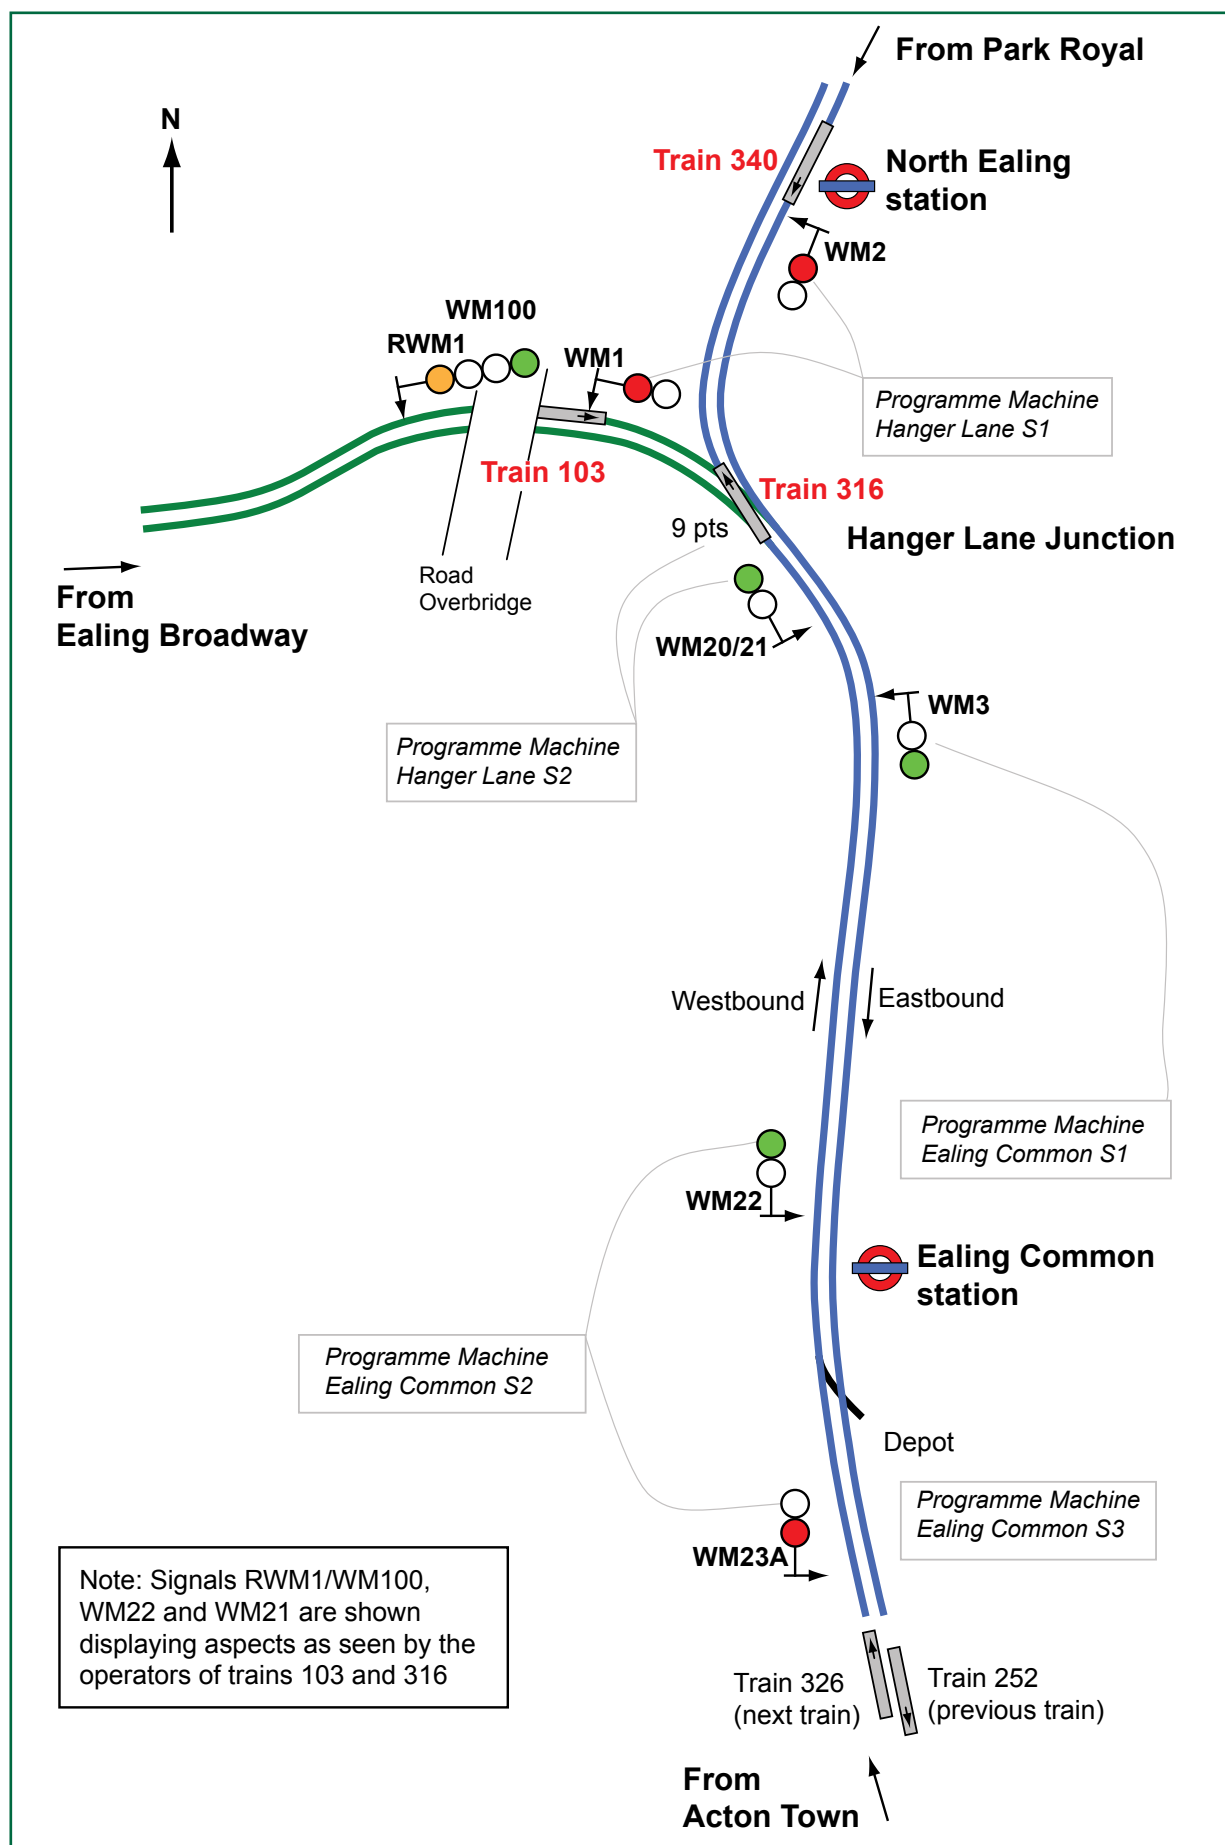
Figure 8: Schematic map showing layout of junction and location of trains at 17:28:34 hrs (during incident)

- 29 Trains approaching the junction in the westbound direction are controlled by semi-automatic signal WM22 at Ealing Common station (see figure 8). Semi-automatic signals WM20 and WM21 control the junction, the signal used depending on the route being taken. A Piccadilly Line train crossing the junction towards North Ealing would encounter signal WM22 and then WM21.

- 44 The signaller also put programme machine Ealing Common S2, controlling westbound traffic, into push-button mode in order to stop westbound Piccadilly Line train 326 at signal WM23A on the approach to Ealing Common station (figure 8).

- b. first-come first-served, indicated by a yellow lamp; and
 - c. push-button (ie manual), indicated by a red lamp
- 72 Hanger Lane junction is equipped with two programme machines: S1 controls eastbound train movements via signals WM1 and WM2, and S2 controls westbound movements via signals WM20/21 and 9 points. Ealing Common is equipped with three programme machines with S1 controlling eastbound movements via signal WM3, S2 westbound via signals WM22 and WM23A and S3 the adjacent depot (figure 8).

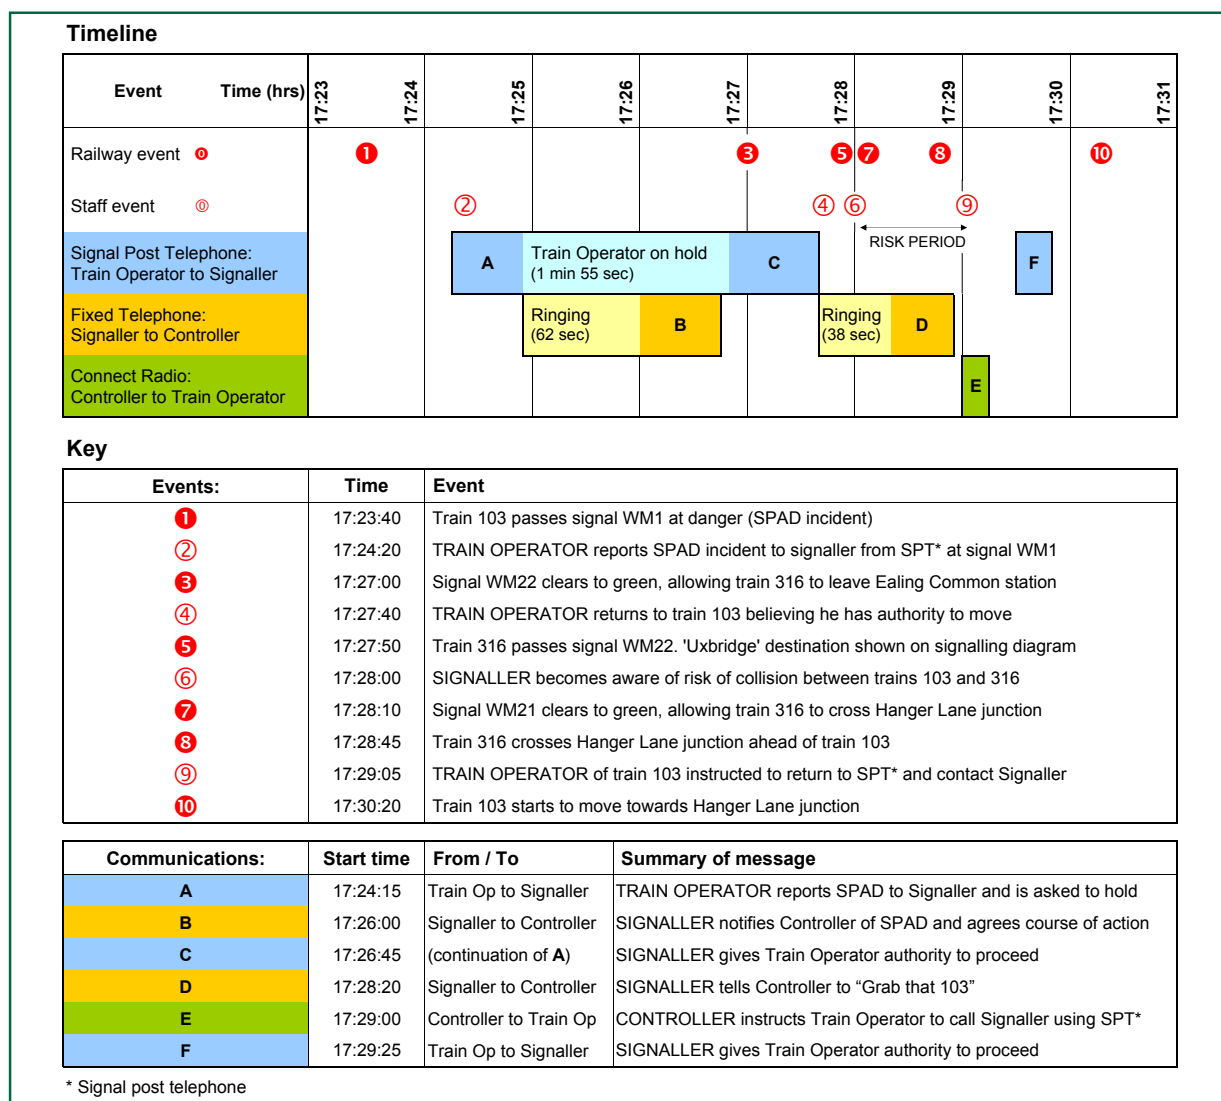
Figure 9: Time-line diagram showing chronological relationship between key events

- 47 The train operator returned to the cab of train 103 and reset the train's tripcock apparatus before preparing to move his train.
- 48 At 17:27:40 hrs, the signaller instigated a second telephone call to the District Line controller to confirm the actions taken and conclude the incident. The controller was still busy with the Sloane Square incident and did not answer for 38 seconds (figure 9).
