Rail Accident Report

Derailment at Hampton Loade, Severn Valley Railway 28 September 2009

Derailment at Hampton Loade, Severn Valley Railway, 28 September 2009

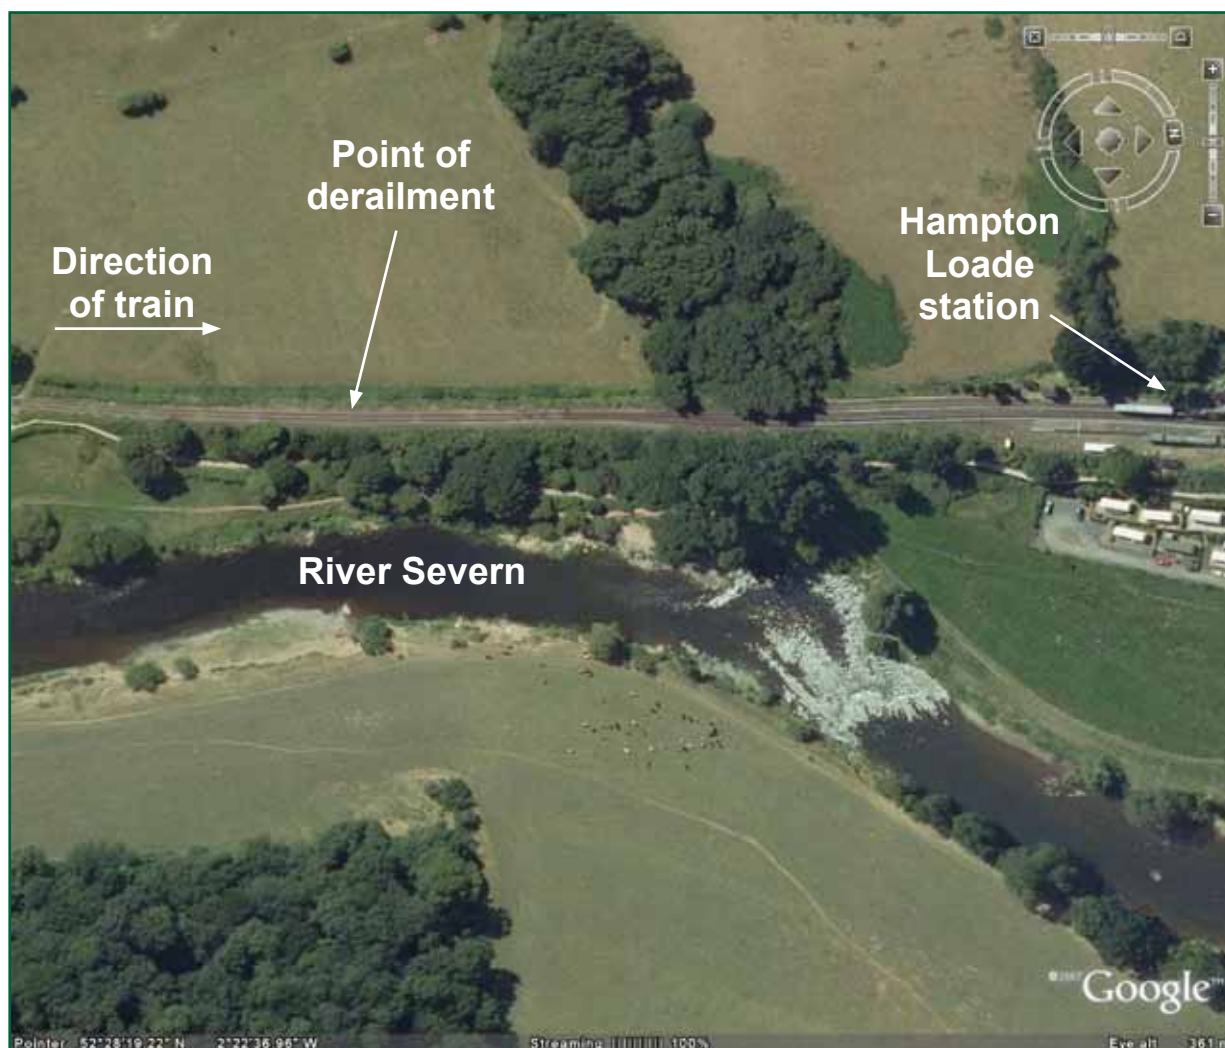
Figure 2: Aerial view of the site (courtesy of Google Earth)

- 7 The train was slowing down to stop and was travelling at less than 10 mph (16 km/h) at the time the derailment occurred on *plain line* to the south of the station (figure 2). Significant damage was caused to the track and the tender. The *points* at the south end of the loop at Hampton Loade were damaged beyond repair and the line was closed for five days while repairs were carried out to reinstate a single line through the station. This prevented trains from passing at this station pending replacement of the points.
