Rail Accident Investigation Branch

Rail Accident Report

Fatal accident at Fairfield crossing, Bedwyn, 6 May 2009

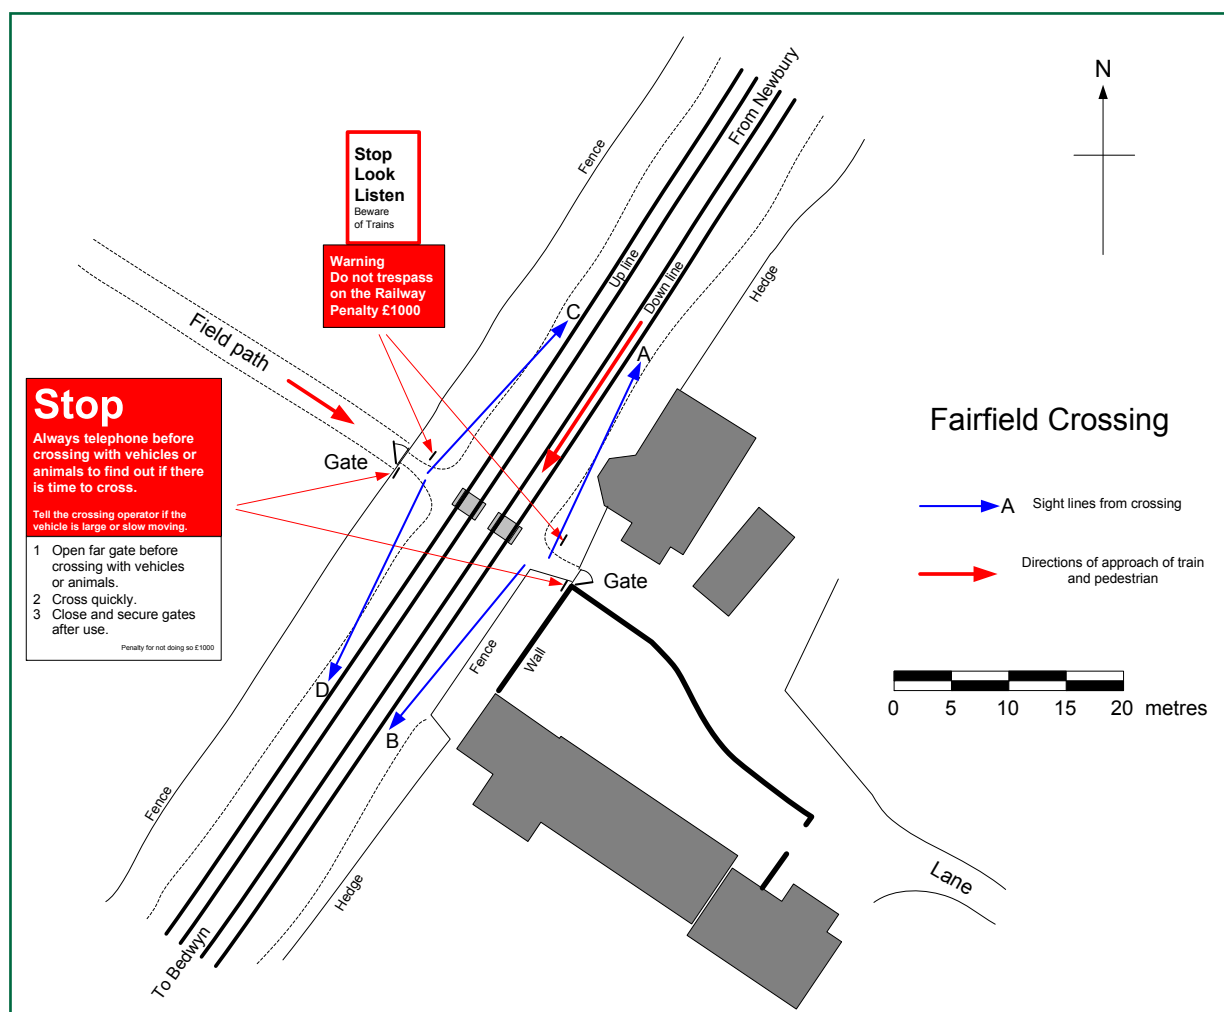
Figure 3: Plan of Fairfield crossing

- 32 The gate on the north-west (up) side of the crossing is 5.7 metres from the nearest rail. There is a 'Stop – Look – Listen' notice inside the gate, 4 metres from the nearest rail (figures 3 and 4).

- 74 The telephones at the crossing were intended for use by horse riders, those herding animals on the hoof and people with vehicles. The signs advising these categories of user to telephone for information on whether it is safe to cross (figures 3 and 4) are of a standard design. They are not clear as to what sort of animals are meant (ie whether dog walkers should use the phones) and contain irrelevant references to long or slow vehicles which could not possibly use the crossing in its present state.
