Rail Accident Report

Fatal accident at Norbreck, Blackpool 5 August 2009

Fatal Accident at Norbreck, Blackpool

5 August 2009

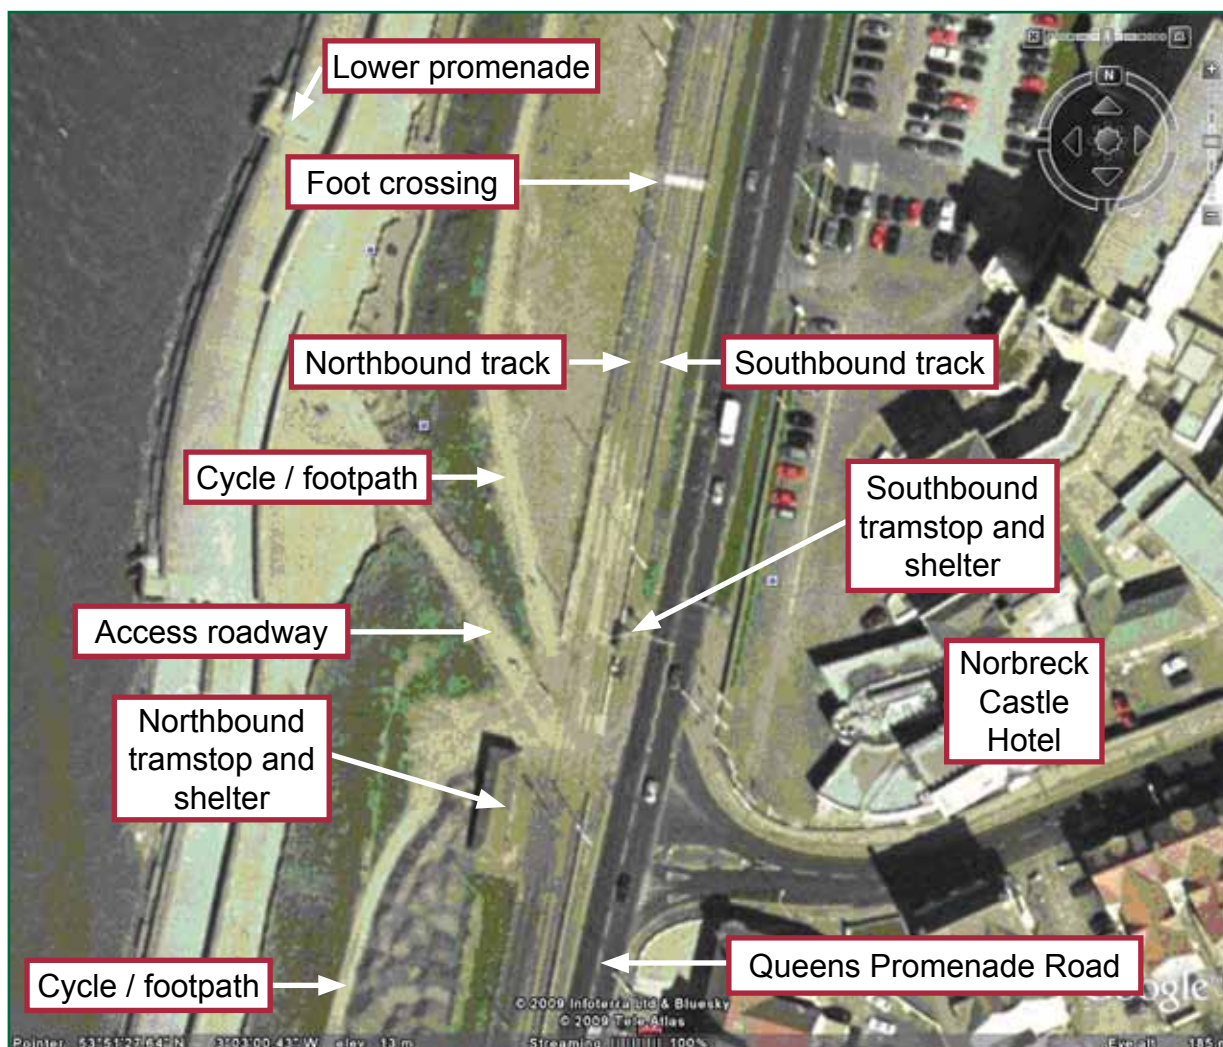
- 10 The roadway crossing at Norbreck provides vehicle access for permit holders from Queens Promenade Road to the lower promenade. It also allows cyclists and pedestrians to cross the tracks. The northbound tram-stop is to the south of the crossing and the southbound tram-stop to the north of it (figure 2). Around 90 metres to the north of the roadway crossing is a separate foot crossing.

Figure 2: Aerial photograph of the site (image courtesy of Google Earth). The tramway crossover to the north of the tram-stop was removed before the accident
