Rail Accident Report

Overhead line failure, St Pancras International 23 September 2009

Overhead line failure, St Pancras International

23 September 2009

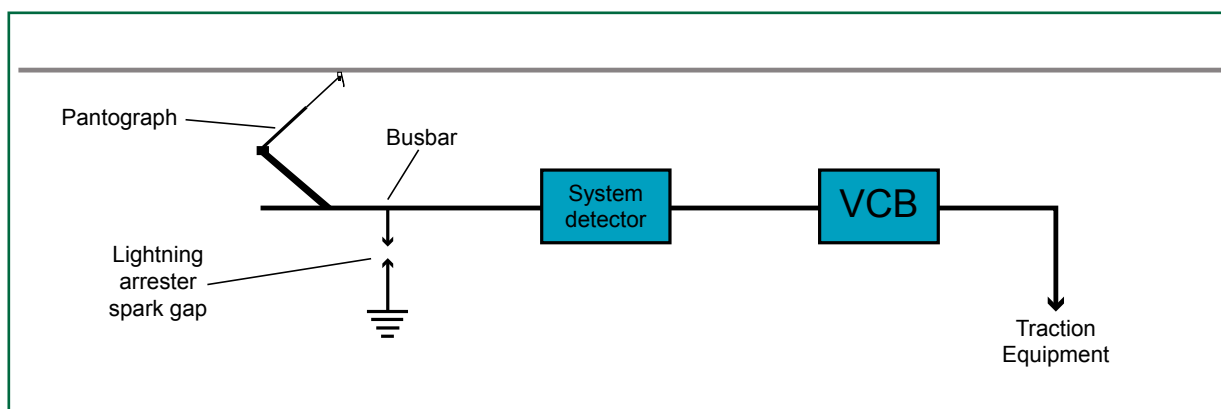
Figure 4: Diagram of roof equipment

- 31 The pantograph collects the current from the OHLE. The current then passes along a *busbar*, through the voltage detector and through the vacuum circuit breaker (VCB), before entering the equipment inside the power car. All these items are mounted on the roof of the power car (figure 4).

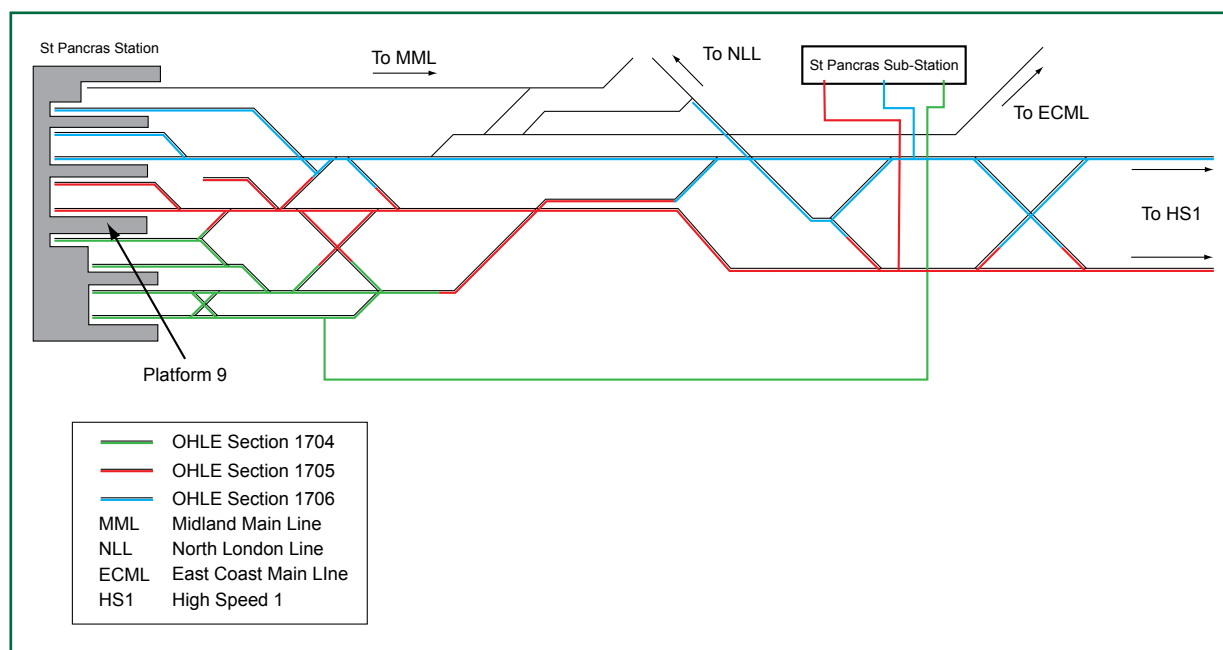
Figure 5: Diagram of the feeding arrangements

- 35 *Tramway OHLE* is installed at St Pancras and under the Barlow trainshed it is supported by transverse *headspans*. This system and the differences between it and the type of OHLE used on the rest of HS1 are described in paragraphs 116 – 118.
- 36 The power supply to the OHLE is fed with alternating current at 25kV 50Hz through *circuit breakers* located in a feeder station outside St Pancras International. These are controlled from the Control Room at Ashford and open automatically in the event of a fault in the overhead line (figure 5).
