Rail Accident Investigation Branch

Rail Accident Report

Collision on the Great Orme Tramway 15 September 2009

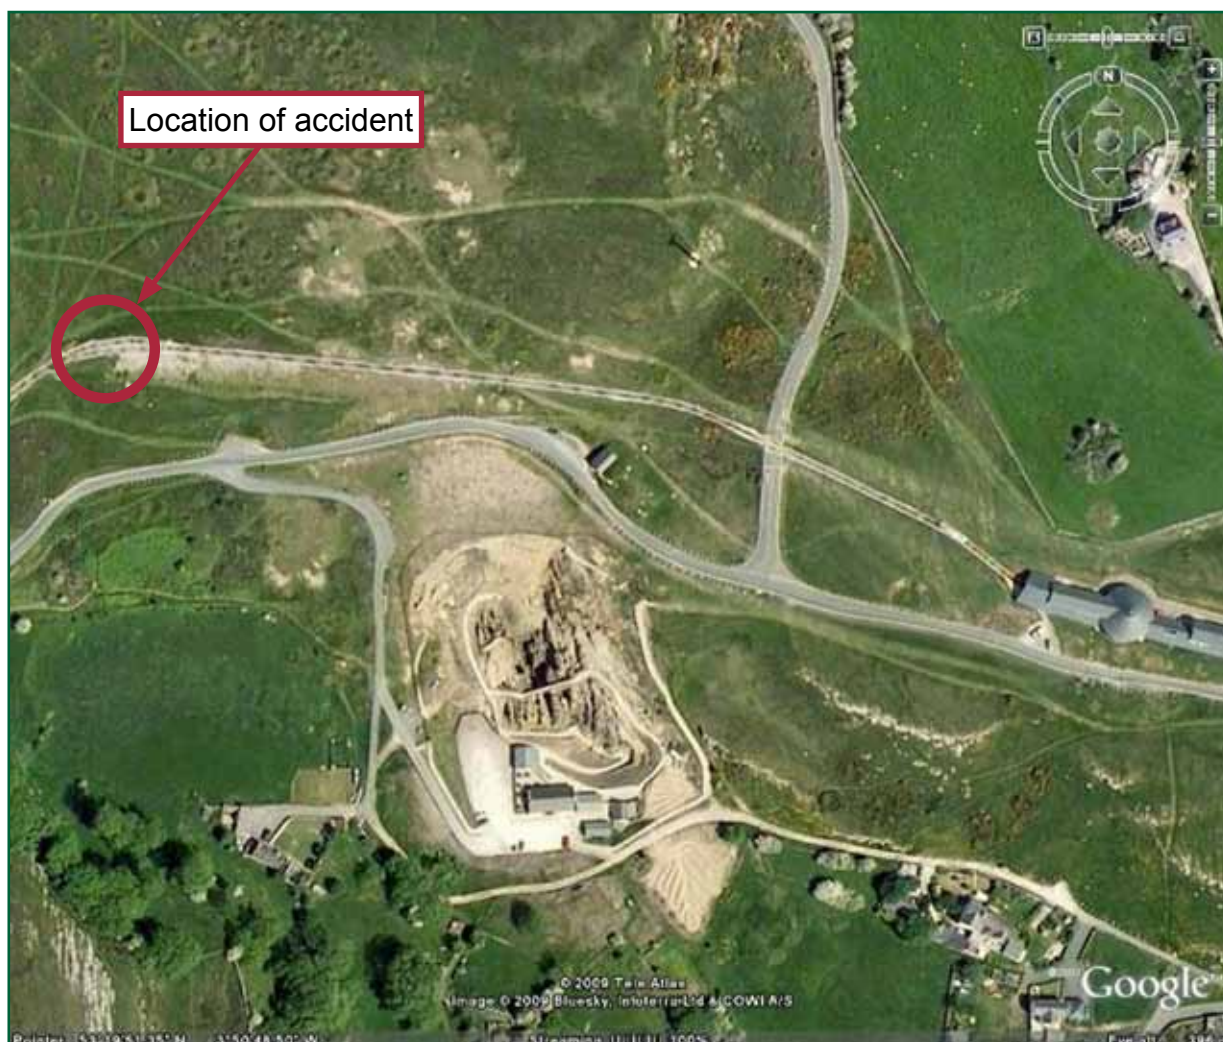
- 4 At 12:15 hrs on 15 September 2009 two trams travelling in opposite directions collided at the passing loop on the upper section of the Great Orme Tramway, Llandudno (figure 1). One person suffered minor injuries in the collision.

Figure 1: Aerial view of accident site showing location of accident (courtesy of Google Earth)

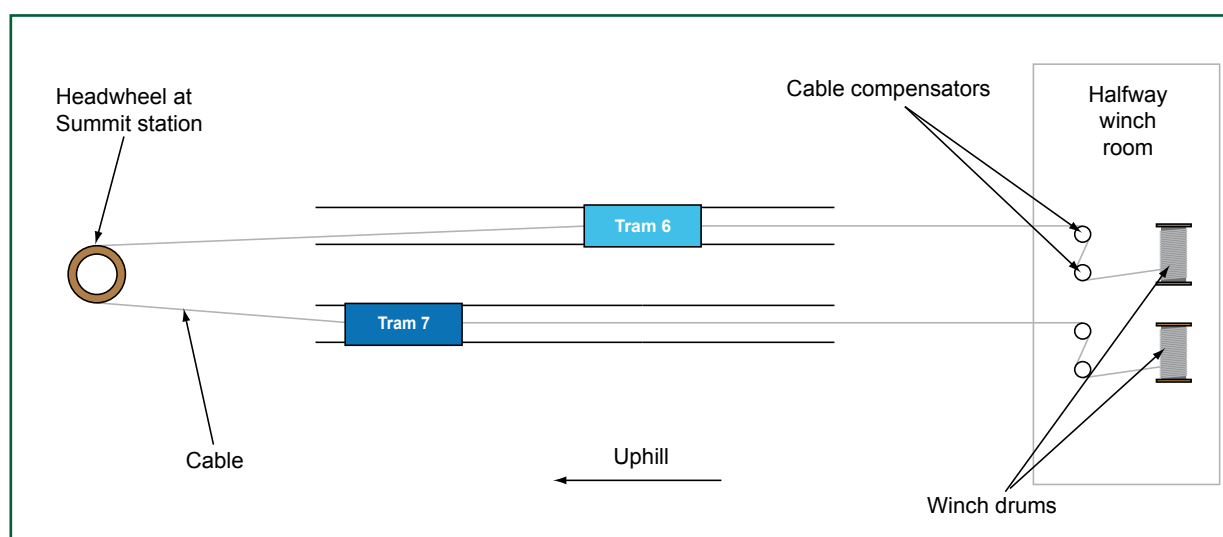
- 9 Each section has its own winch and the two sections are functionally independent. Trams 6 and 7 operate on the upper section of the tramway and are connected by a cable running uphill from the trams which passes via the headwheel at the Summit station. Each tram also has a cable between it and a winch drum at Halfway station (figure 4). The trams are operated by a combination of the winchman and an attendant in each tram. The winchman controls the cable winch drums at Halfway station and the tram attendants control the manually operated tram brakes. There are cable compensators close to the winch drums which ensure that any cable slack is managed and protect the cable against shock loads.

Figure 4: Schematic showing operation of the upper section

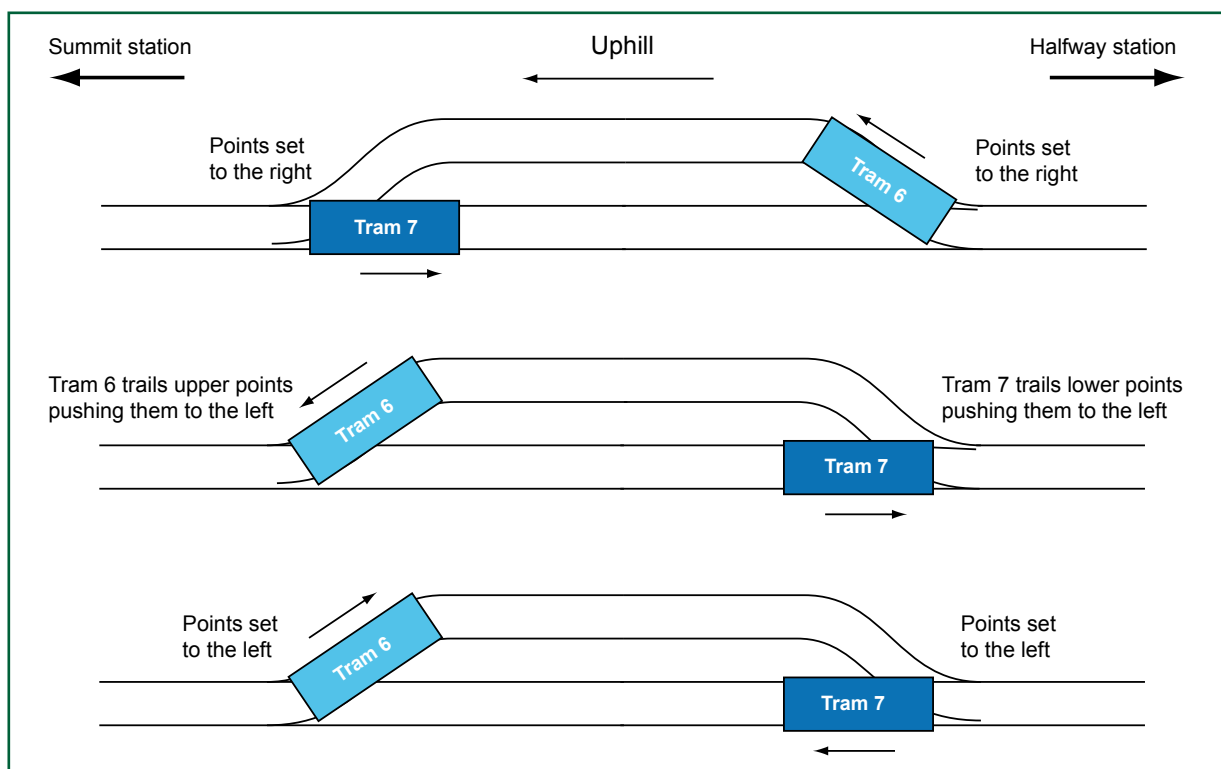
- 11 As the trams leave the loop the action of their wheels moves the points across. The points are then set in the correct positions for directing the trams to their correct tracks in the loop for their next return journeys (figure 5).

Figure 5: Operation of the upper section passing loop
