Rail Accident Report

**Fatal accident at Moreton-on-Lugg,
near Hereford,
16 January 2010**

Fatal accident at Moreton-on-Lugg, near Hereford, 16 January 2010

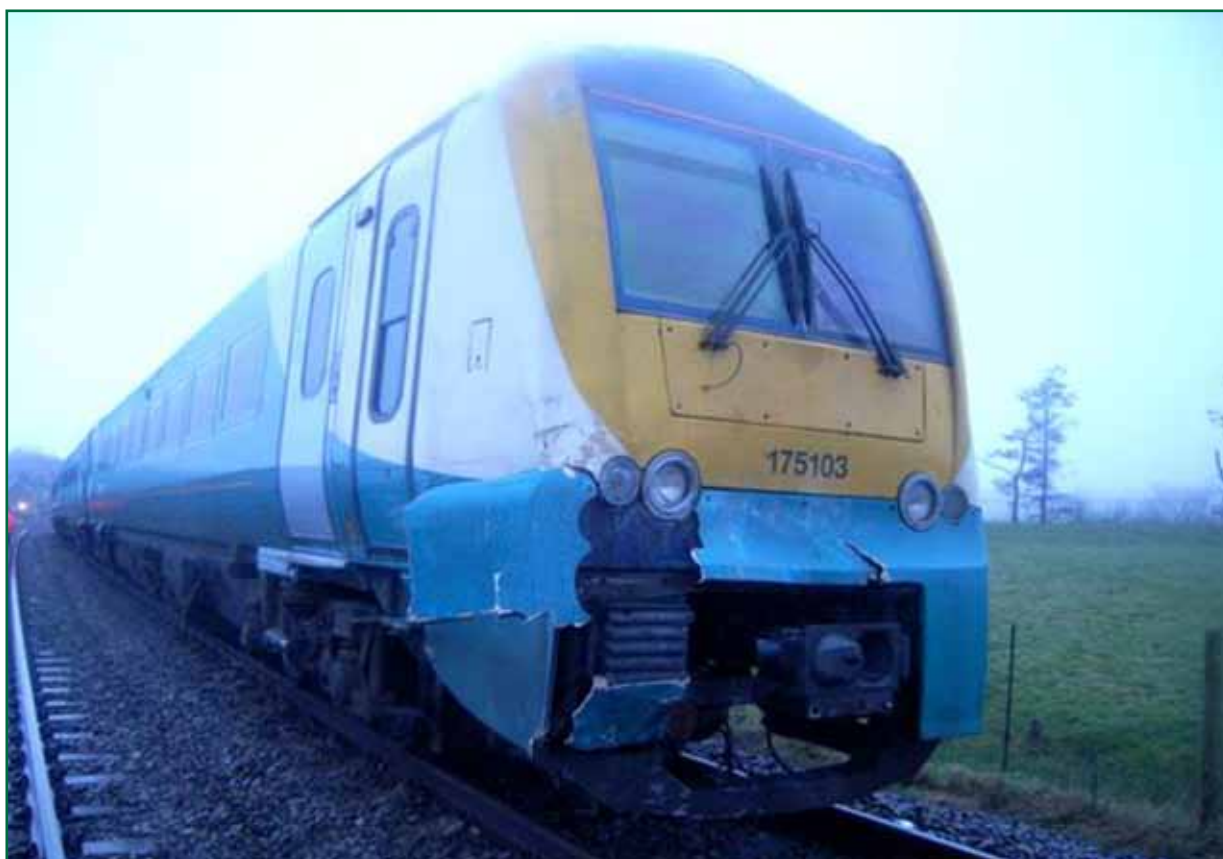
Figure 4: The train involved in the accident

- 21 Train 1V75 was formed of a 3-car class 175 diesel multiple unit, number 175 103 (figure 4). There were 32 passengers on board and a train crew of three.
- 22 The train was designed, built and maintained by Alstom. It entered service in 2000.

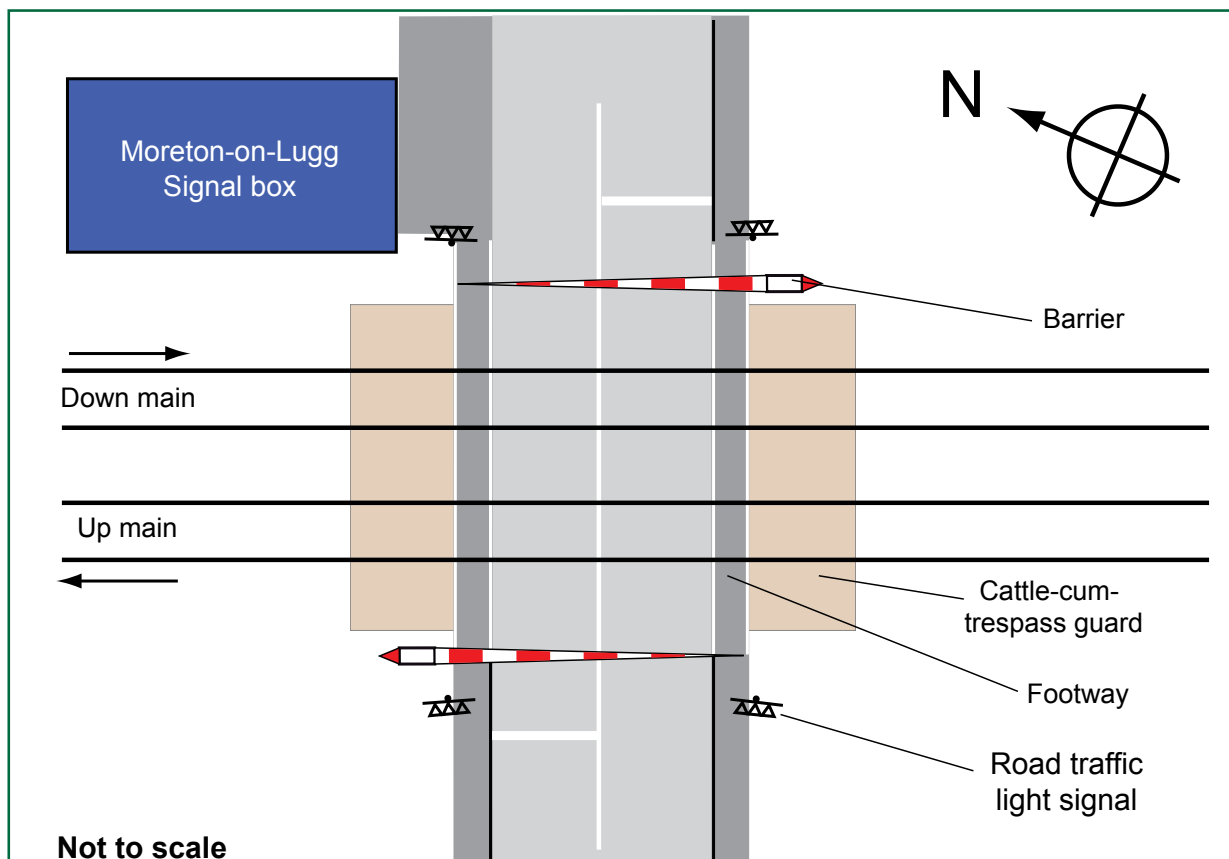
Figure 6: Plan view layout of Moreton-on-Lugg level crossing

- 23 The level crossing at Moreton-on-Lugg (figure 5) has two *BR 843 Mk 2 barrier units*, one on each side of the railway. When lowered, the barriers extend across the full width of both the road and adjacent footways. There are two sets of road traffic light signals in front of each barrier, one on each side of the road. The traffic light signals have *light emitting diode* (LED) light units. Stop lines, on the approach side of the road, are marked 2 metres in front of each pair of traffic light signals. There is an audible warning for pedestrian users. Figure 6 is a plan view of the crossing.

- 29 The signal box at Moreton-on-Lugg is located on the east side of the railway, figure 6. Normally it is operated by a single signaller, working a 12-hour shift. Routine shift handovers are at 06:00 hrs and 18:00 hrs each day.

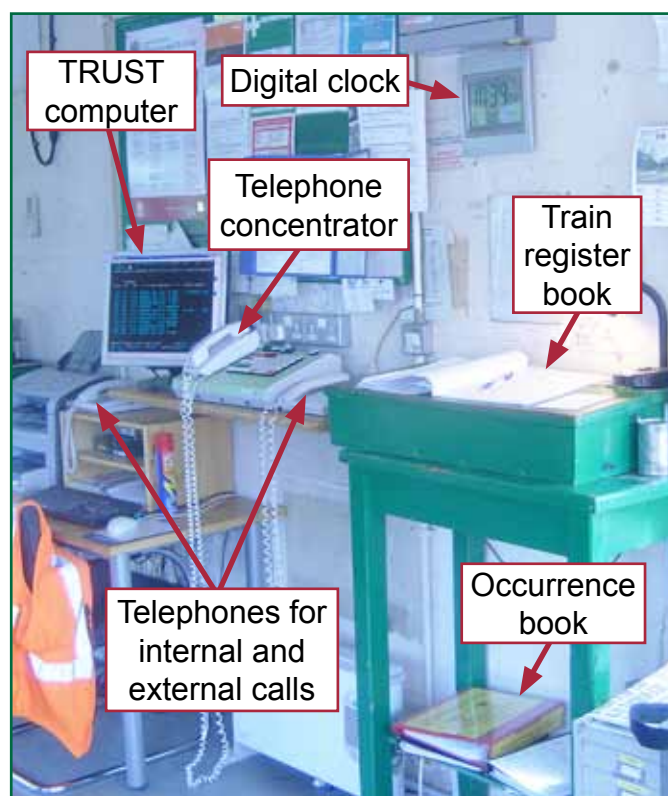
Figure 8: Desk, telephones and other equipment on east side of signal box

- 114 He took the call, and, rather than turning and looking at the block instruments behind him to determine the status of approaching trains, he consulted the TRUST computer that is directly adjacent to the telephone concentrator (figure 8). It seems it was then that he became conscious of the significance of train 1W85, and that, because it was not far away, there might not be enough time for the sheep to cross. TRUST information at the time showed that train 1W85 was delayed passing Tram Inn, and had not yet arrived at Hereford. He thought that there could be enough time if the caller could cross quicker than his estimate (he was aware that the occurrence book showed that three previous requests for crossing sheep had been achieved in less than five minutes, figure 10). However, he was also mindful that the TRUST information might not be accurate, and wasn't certain if 1W85 had, by now, arrived at Hereford.
