Rail Accident Investigation Branch

Rail Accident Report

Runaway of an engineering train from Highgate 13 August 2010

13 August 2010

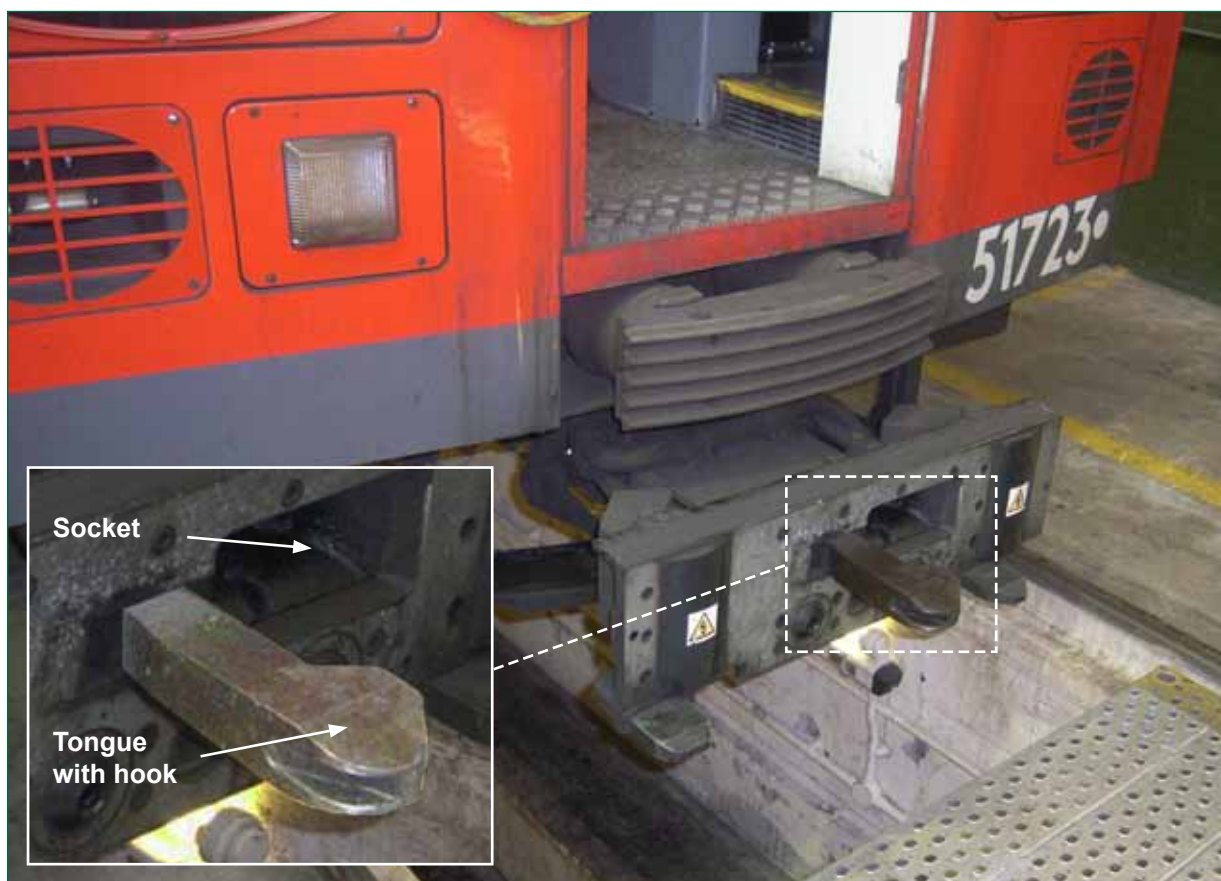
Figure 10: Wedgelock coupler.

119 The wedgelock coupling is the standard coupling for London Underground passenger trains. When coupled to another passenger train, the faces of these couplers are fixed rigidly to each other using hooked tongues inserted into sockets (figure 10). Two horizontal hinges (ie hinges allowing horizontal rotation) are needed to allow vehicles to negotiate horizontal curves and two vertical hinges are needed for vertical curves (figure 11). Each wedgelock/car body connection provides one horizontal hinge and one vertical hinge. The nominal centre of a wedgelock coupler is 395 mm above the *running rail*.

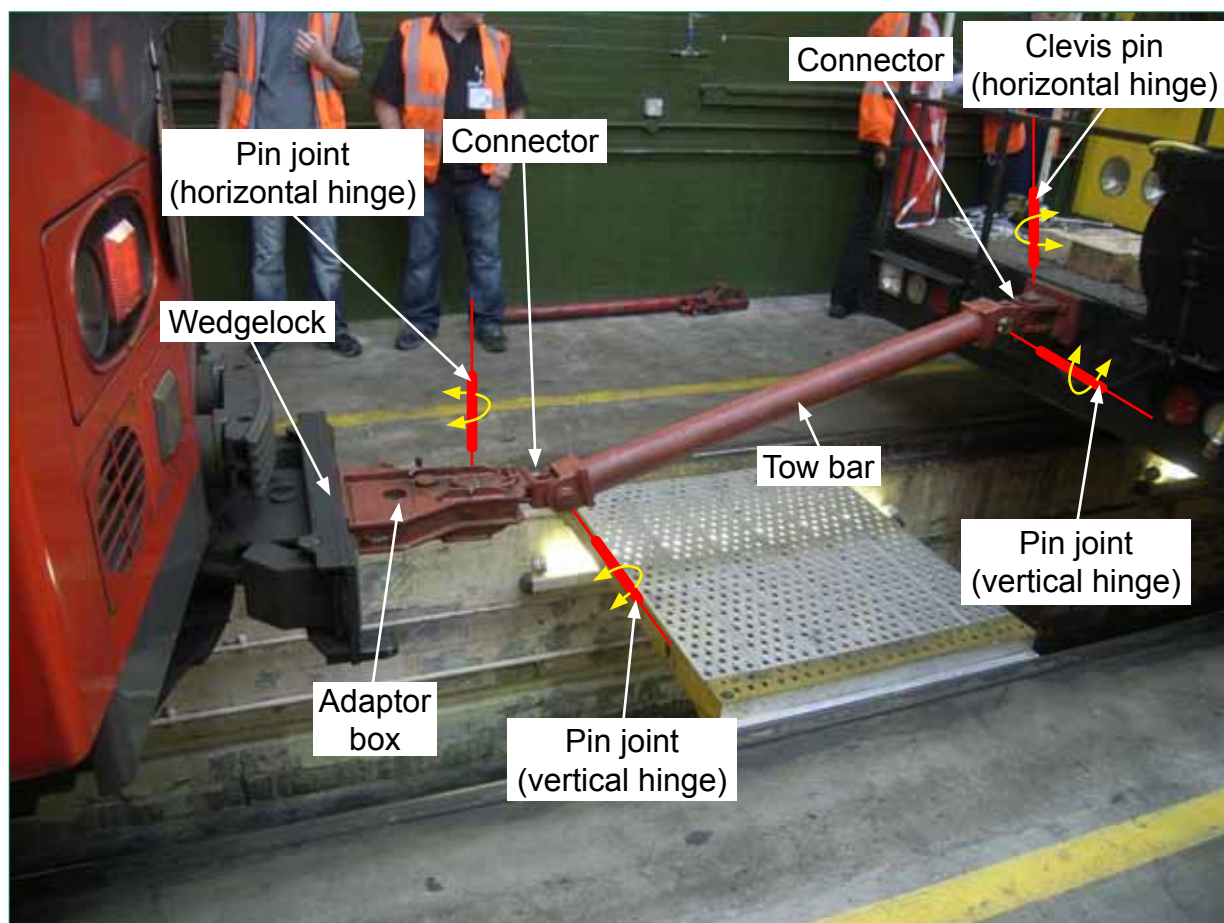
Figure 12: Emergency coupler components.

- 121 The emergency coupler comprised an adaptor box and a tow bar with hinged connectors at each end (figure 12). In use, the adaptor box was rigidly connected to the wedgelock coupler on the assisting train. A hinged connector linked the adaptor box to the tow bar. Horizontal rotation was permitted at the pin linking the connector to the adaptor box; vertical rotation was permitted by the pin linking the connector to the tow bar. The second hinged connector linked the tow bar to the clevis pin on the RGU. The pin linking the connector and tow bar allowed vertical rotation; the connection to the clevis pin allowed horizontal rotation.

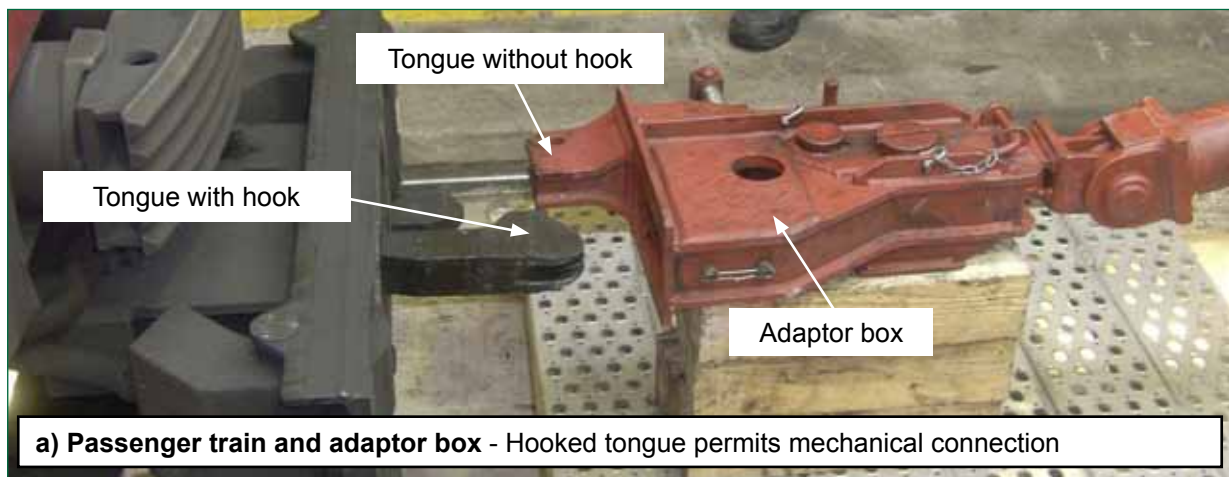
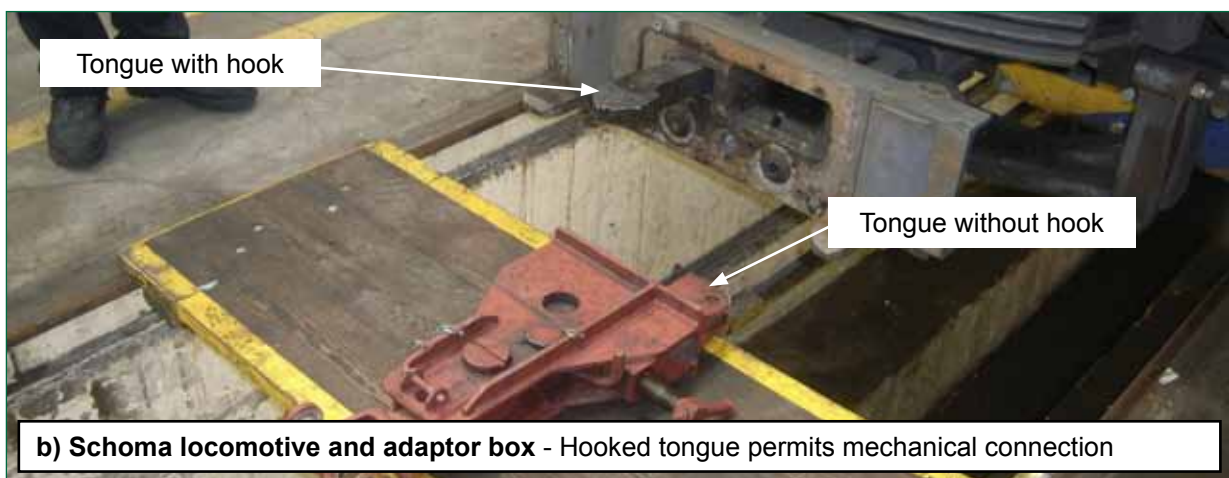
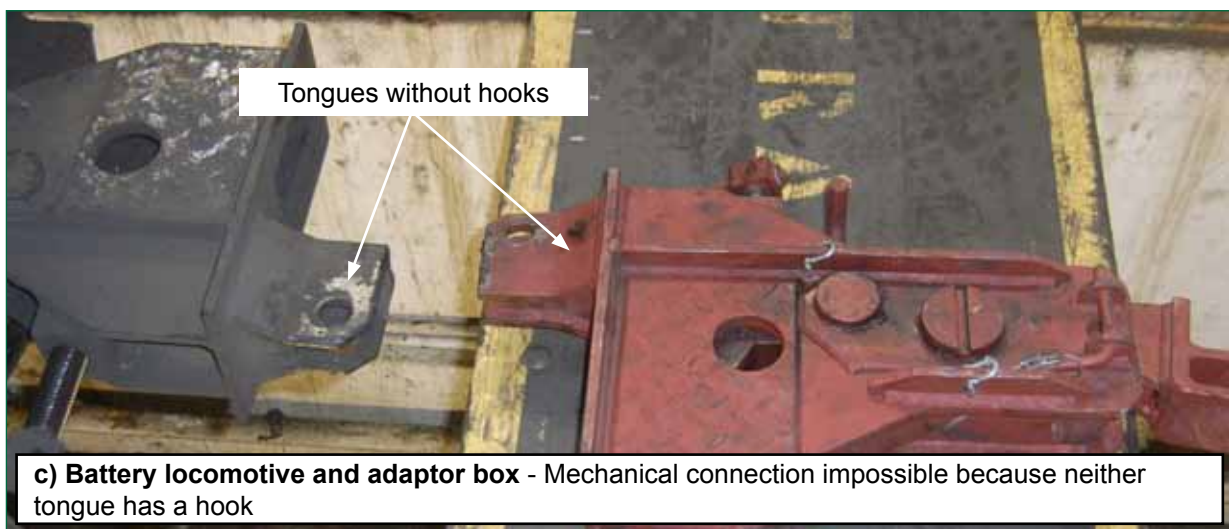
Figure 19: Coupler compatibility.

- 145 The Rolling Stock Project Engineer summarised his work in a memo dated 22 October 2002 and addressed to Rolling Stock Asset Engineer 1. This stated "A tow bar is carried at either end of the vehicle to facilitate emergency rescue of the vehicle. This has been tried at Lillie Bridge depot using a Schoma locomotive. In operation, a battery loco will be held on permanent standby at the nearest possible location." Investigations by RAIB have shown that this would not have been practicable – all battery locomotives in service during, and since, 2002 have lacked the hooked tongue necessary to couple with the emergency coupler's adaptor box (figure 19).

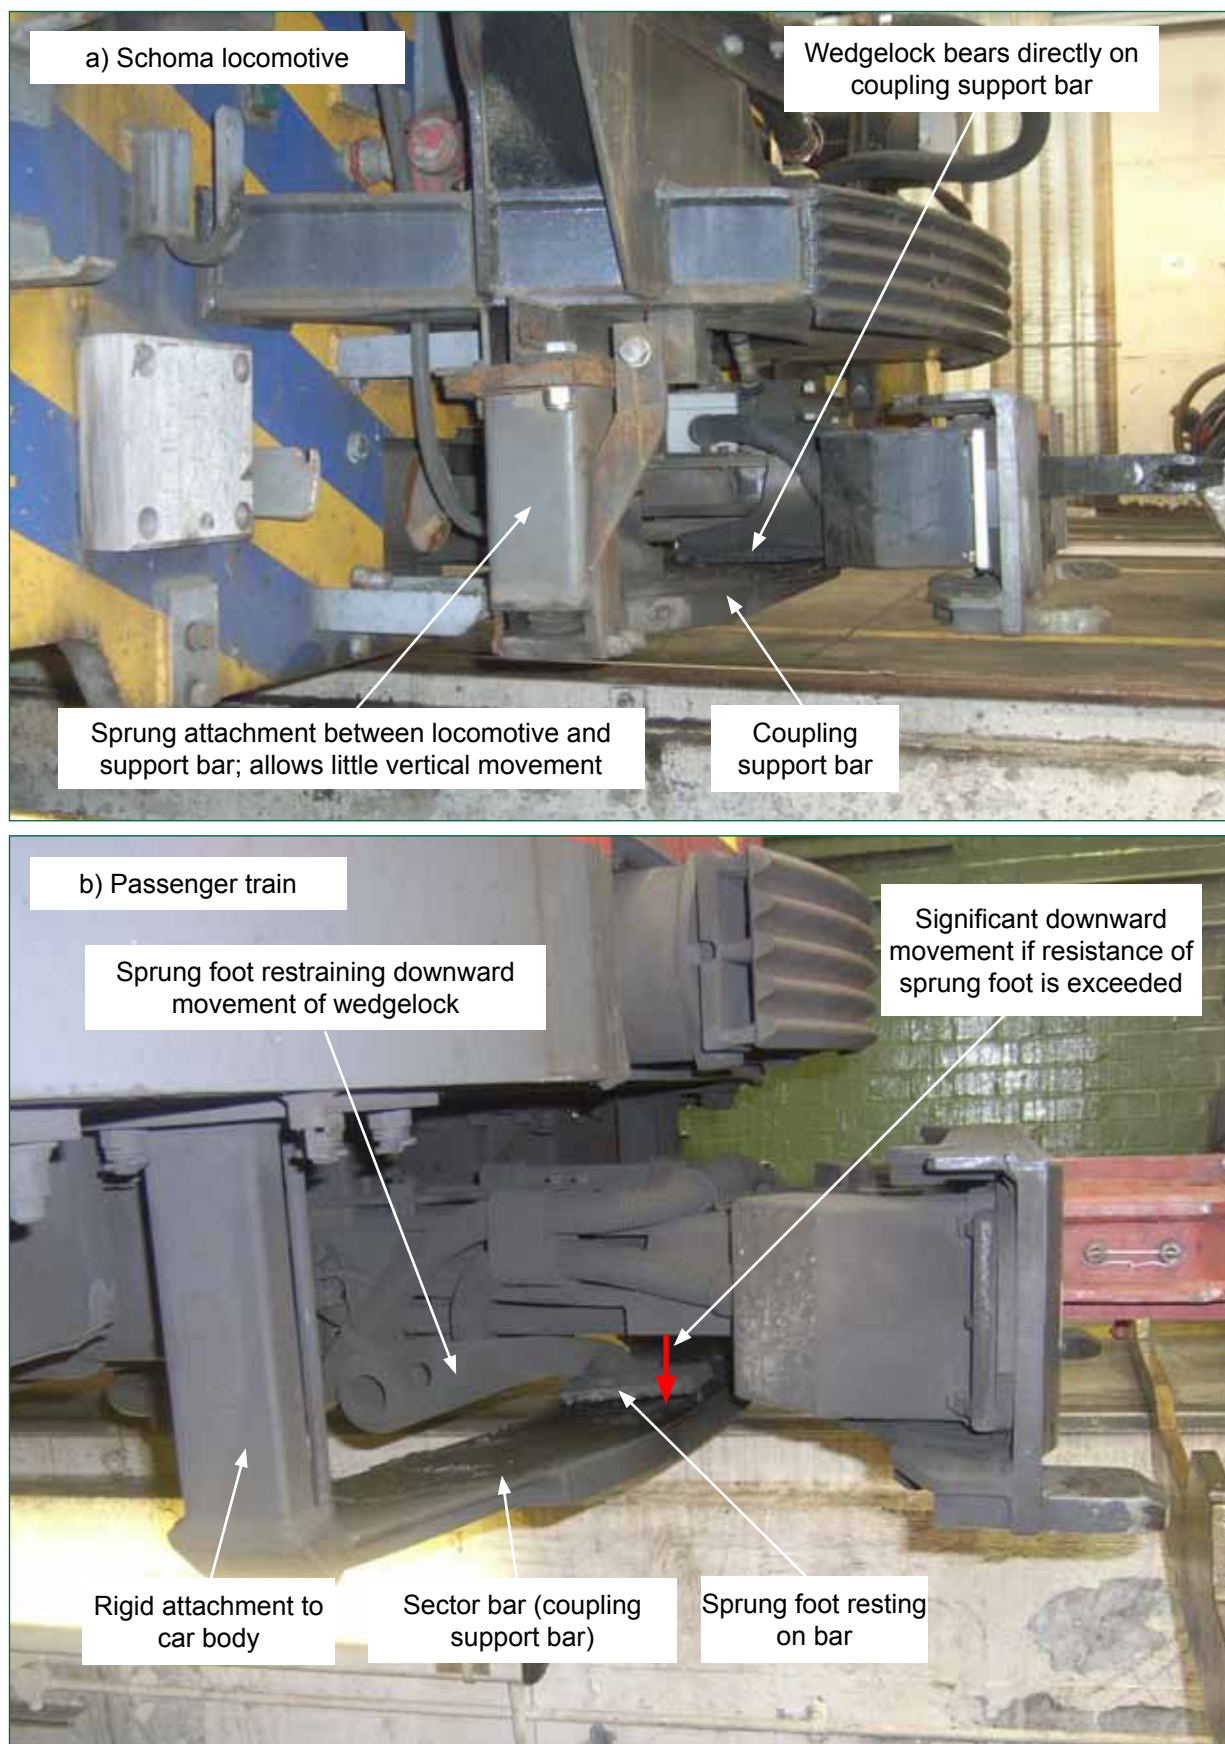
Figure 20: Wedgelock vertical rotation.

- 161 The excessive downward movement of the emergency coupler when used with passenger rolling stock (paragraphs 125 and 167) did not occur during the acceptance testing. This is because the wedgelock on the Schoma was prevented from significant downward rotation by direct contact with a horizontal bar immediately beneath the coupler. The bar is relatively stiff and is supported on springs attached to the locomotive body (figure 20). The springs allow only the relatively small downward coupler movement needed when negotiating vertical curves (paragraph 119).

- 162 On a passenger train, spring loaded feet are attached to the wedgelock. These bear on a horizontal sector bar which is less stiff than the corresponding horizontal bar on the Schoma locomotive. The spring loaded feet and the horizontal sector bar are intended to carry the weight of the wedgelock when the coupling is not being used (figure 20). They provided less resistance to downward coupling movement than the corresponding arrangement on a Schoma locomotive.
