Rail Accident Report

Accident at Falls of Cruachan, Argyll 6 June 2010

Report 11/2011 July 2011 This investigation was carried out in accordance with:

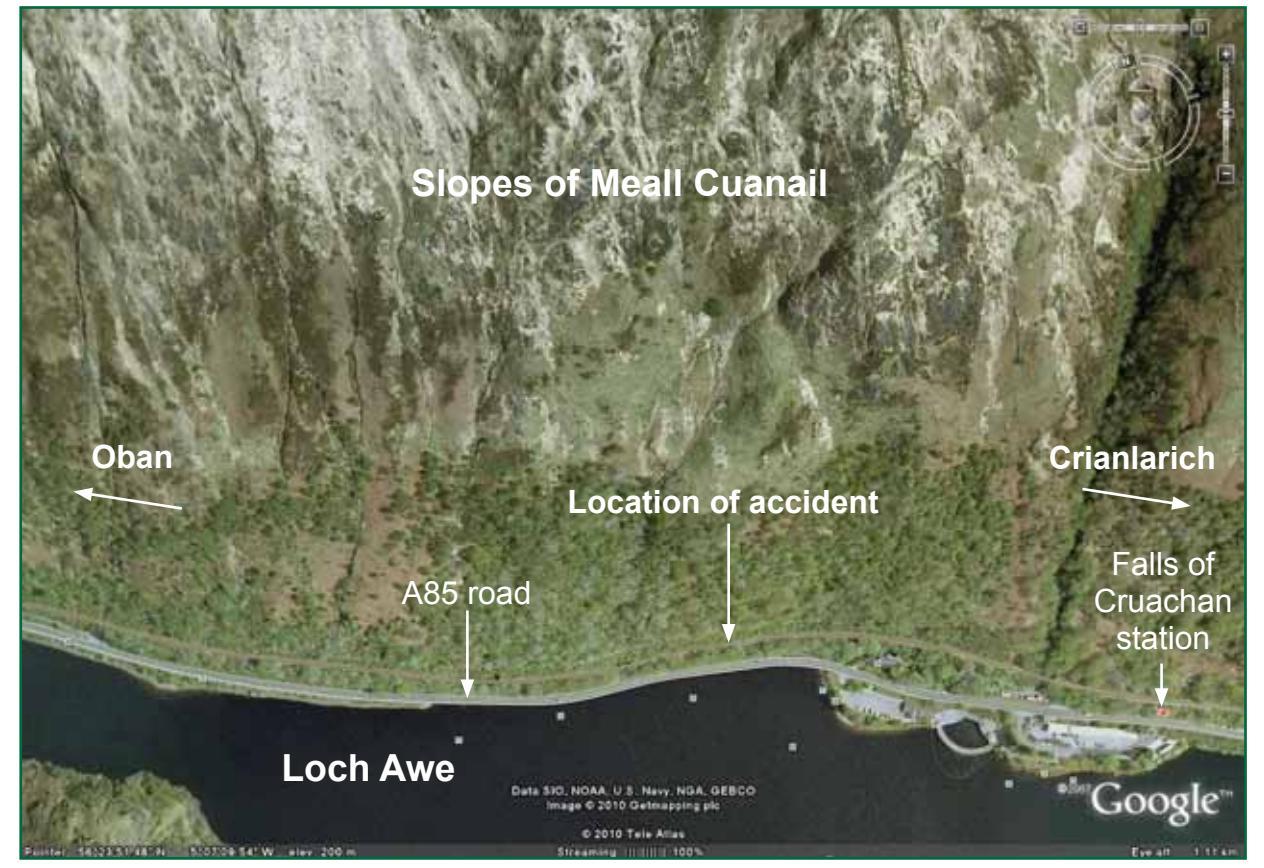
Figure 4: Overview of the accident site (image courtesy of Google Earth)

16 Immediately north of Falls of Cruachan, the natural hillside rises from the railway to the summit of Meall Cuanail (918 metres), an outlying top of Ben Cruachan. On the south side of the railway, a slope leads down to the A85 road and Loch Awe. The Pass of Brander extends from 51 miles 1320 yards to 56 miles (figure 4).

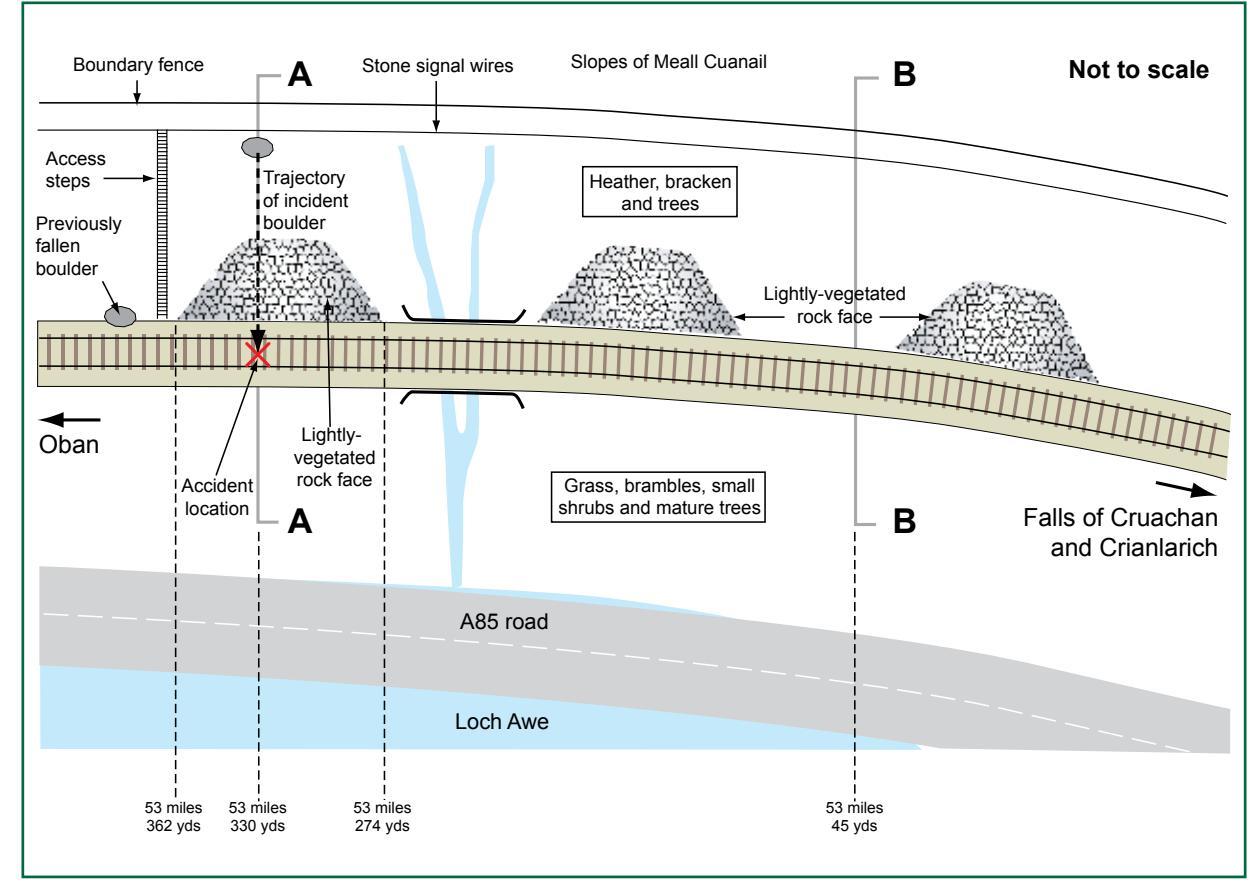
Figure 5a: Plan view of the accident location

- 18 The cutting slope on the north side of the railway is dotted with boulders and generally rises at between 30 and 35 degrees towards the railway boundary, about 15 metres above the foot of the slope. Beyond the railway boundary, the slope rises at an angle of 25 to 35 degrees. In some areas, the railway passes near exposed vertical rock faces up to four or five metres in height (figures 5a and 5b).

- 19 As a result, the slope on the north side of the railway comprises:
 - areas of exposed rock face with *blocks* that could potentially fail and break away from the face (failed blocks seen beside the track were evidence that this had occurred) (figure 6); and, above and between these rock faces,

- areas of soil slope dotted with isolated boulders (figure 7).

Between the areas of exposed rock face adjacent to the railway, the soil slope extends to track level.

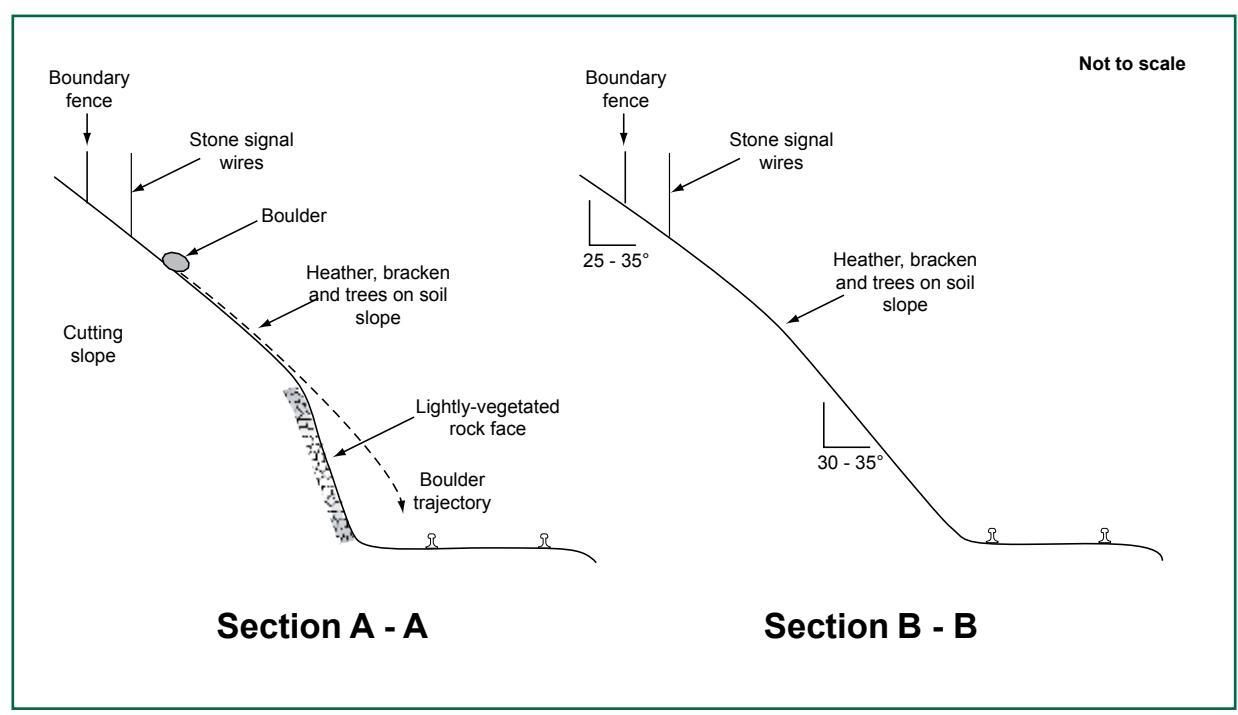
Figure 5b: Profiles of the slope at sections A-A and B-B

- 78 The results of the examinations carried out up until the accident are presented in table 2. This differentiates between:
 - the combined rock face and soil slope between 53 miles 274 yards and 53 miles 362 yards, a length that includes the location of the accident at 53 miles 330 yards (figure 5, section A-A); and
 - the area immediately west of this, beyond 53 miles 362 yards, where the soil slope reaches track level.

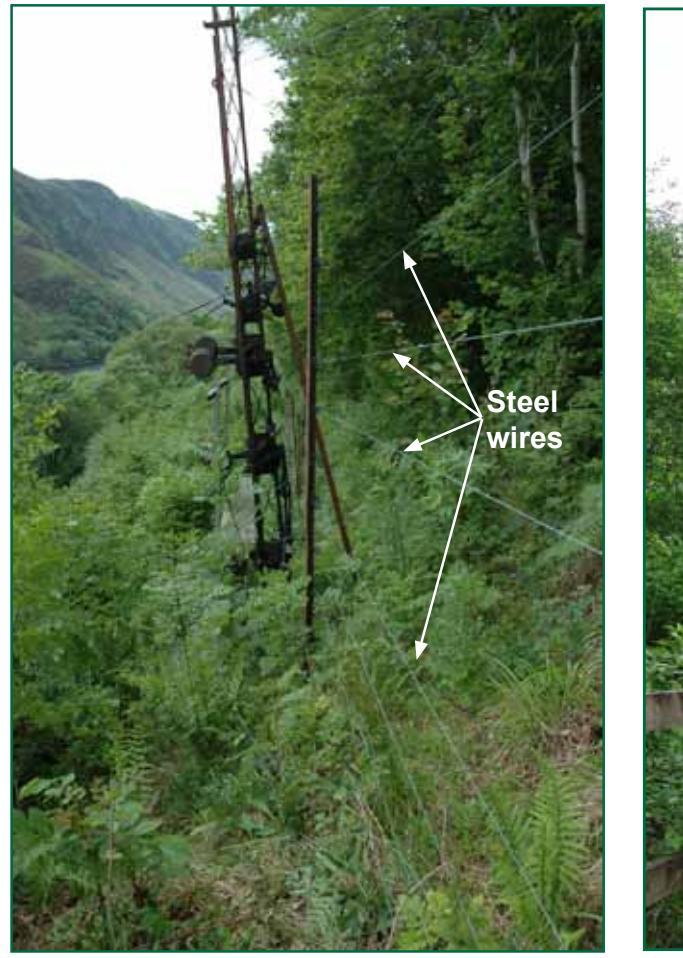
Figure 9: Steel wires that operate the automatic stone signals when broken

- 22 Located just below the railway boundary fence is a vertical screen of ten single strand horizontal steel wires (figure 9). If any of these are broken, semaphore signals either side of the break are automatically replaced to *danger* alerting the driver of an approaching train to a possible blockage ahead (figure 10). In these circumstances, the driver must

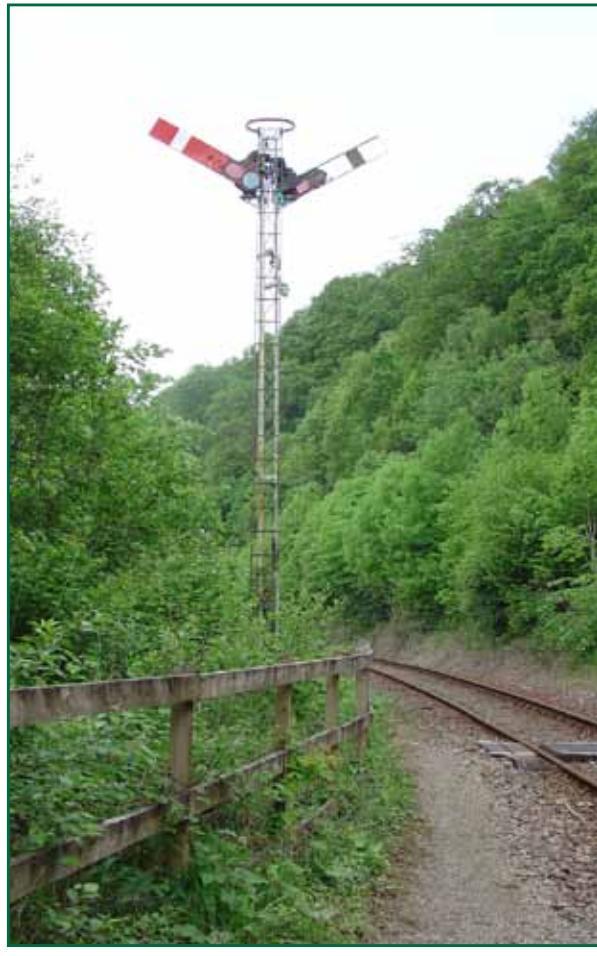
Figure 10: One of the automatic stone signals

- reduce the speed of the train;
 - pass the signal at danger;
 - proceed cautiously to examine the line; and
 - continue at this speed to the second clear signal (because there could be a clear signal between two signals at danger) indicating that it is safe to proceed at normal speed.
