# Rail Accident Report

**Train passed over Lydney level crossing with  
crossing barriers raised  
23 March 2011**

# **Train passed over Lydney level crossing with crossing barriers raised, 23 March 2011**

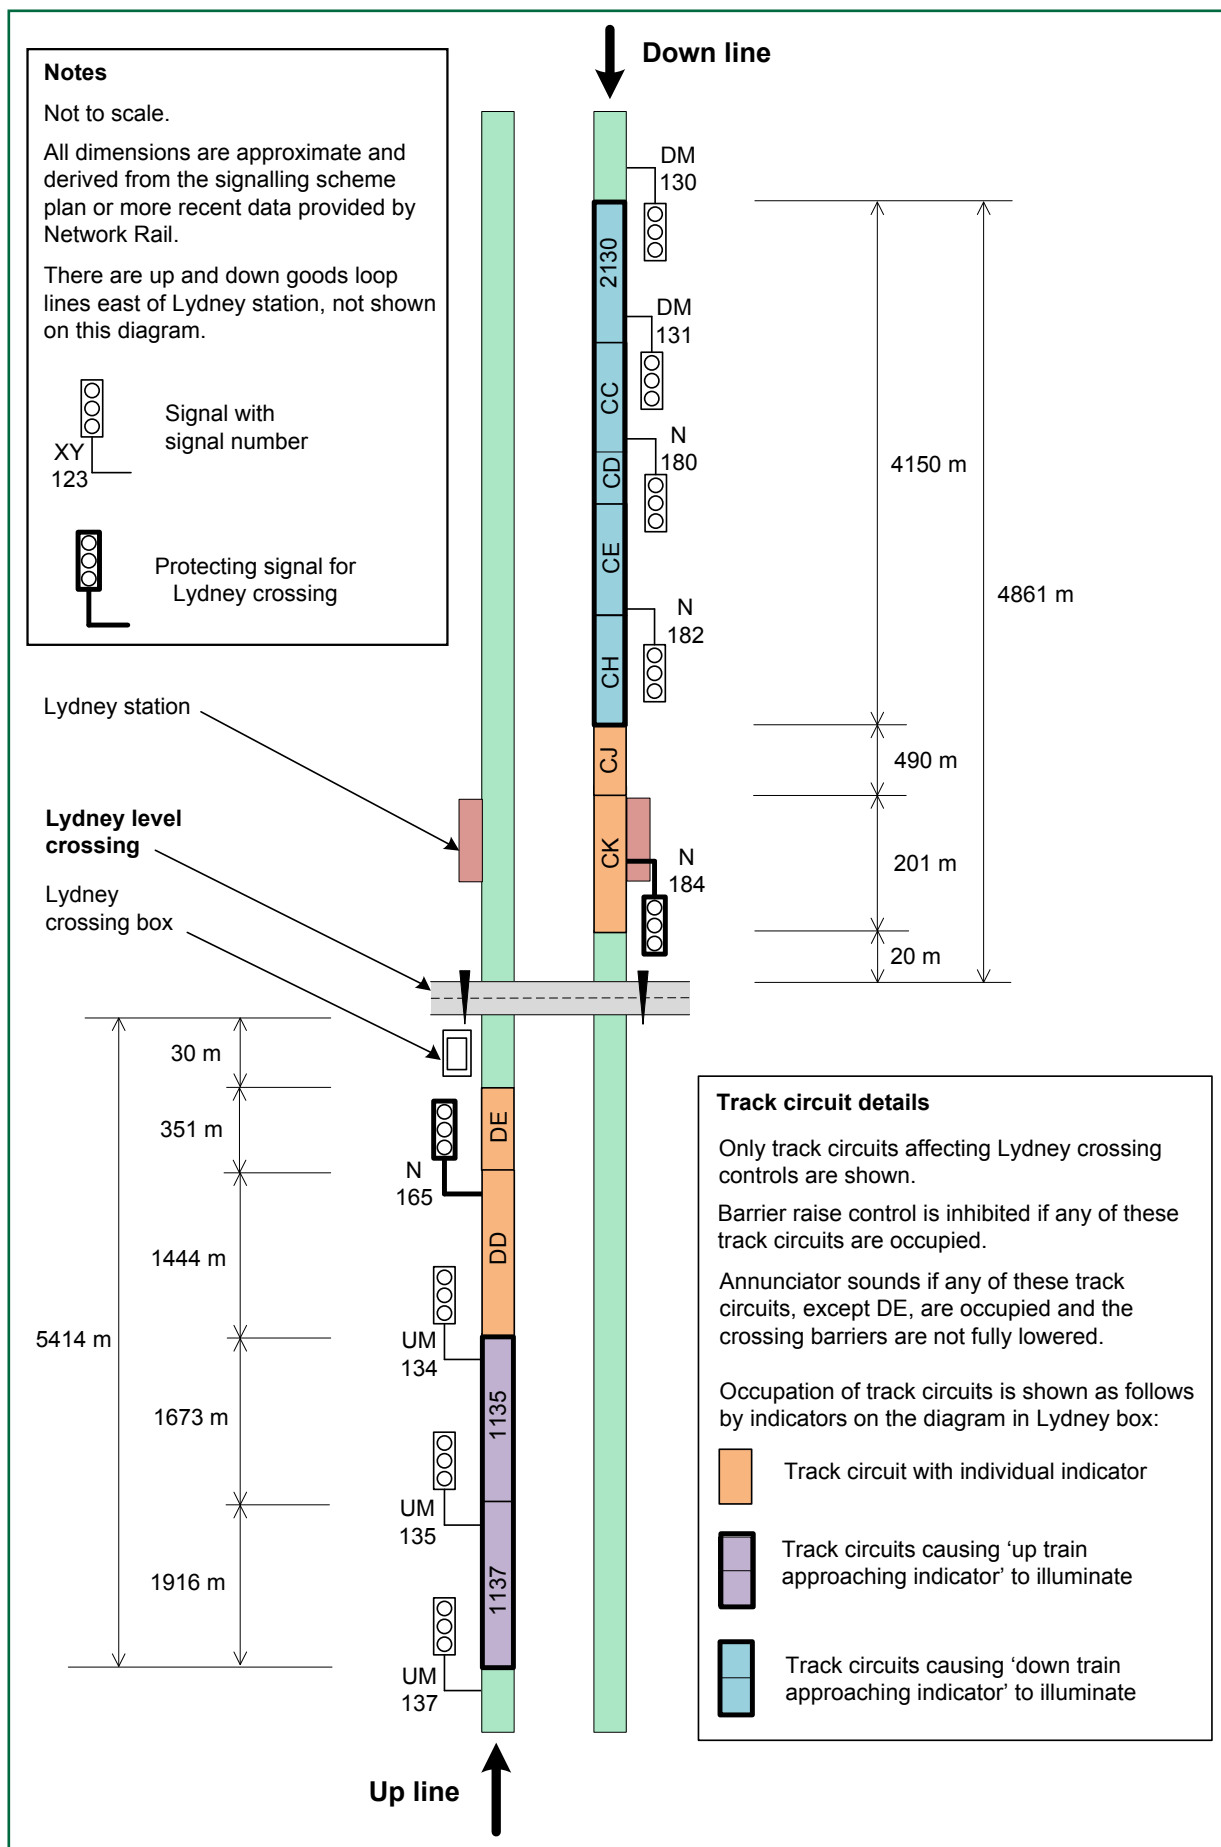
Figure 4: Lydney crossing signalling layout

- 22 The signals protecting Lydney crossing (signal number N165 on the up line and signal number N184 on the down line, figure 4) were operating automatically at the time of the incident. In this condition, they return to danger after the passage of each train. They *clear* (change from a red aspect to a proceed aspect) when another train approaches if the interlocking detects:

- the annunciator is triggered when an up train enters track circuit 1137 (or a down train enters track circuit 2130, figure 4);
  - the keeper presses the lower button on the control pedestal;

- 39 Before the raise button was pressed, train 1M68 had occupied track circuit 1137 on the up line at 14:21:46 hrs. As usual when the barriers were already lowered, this had caused the up line protecting signal (signal N165) to clear without the annunciator sounding.

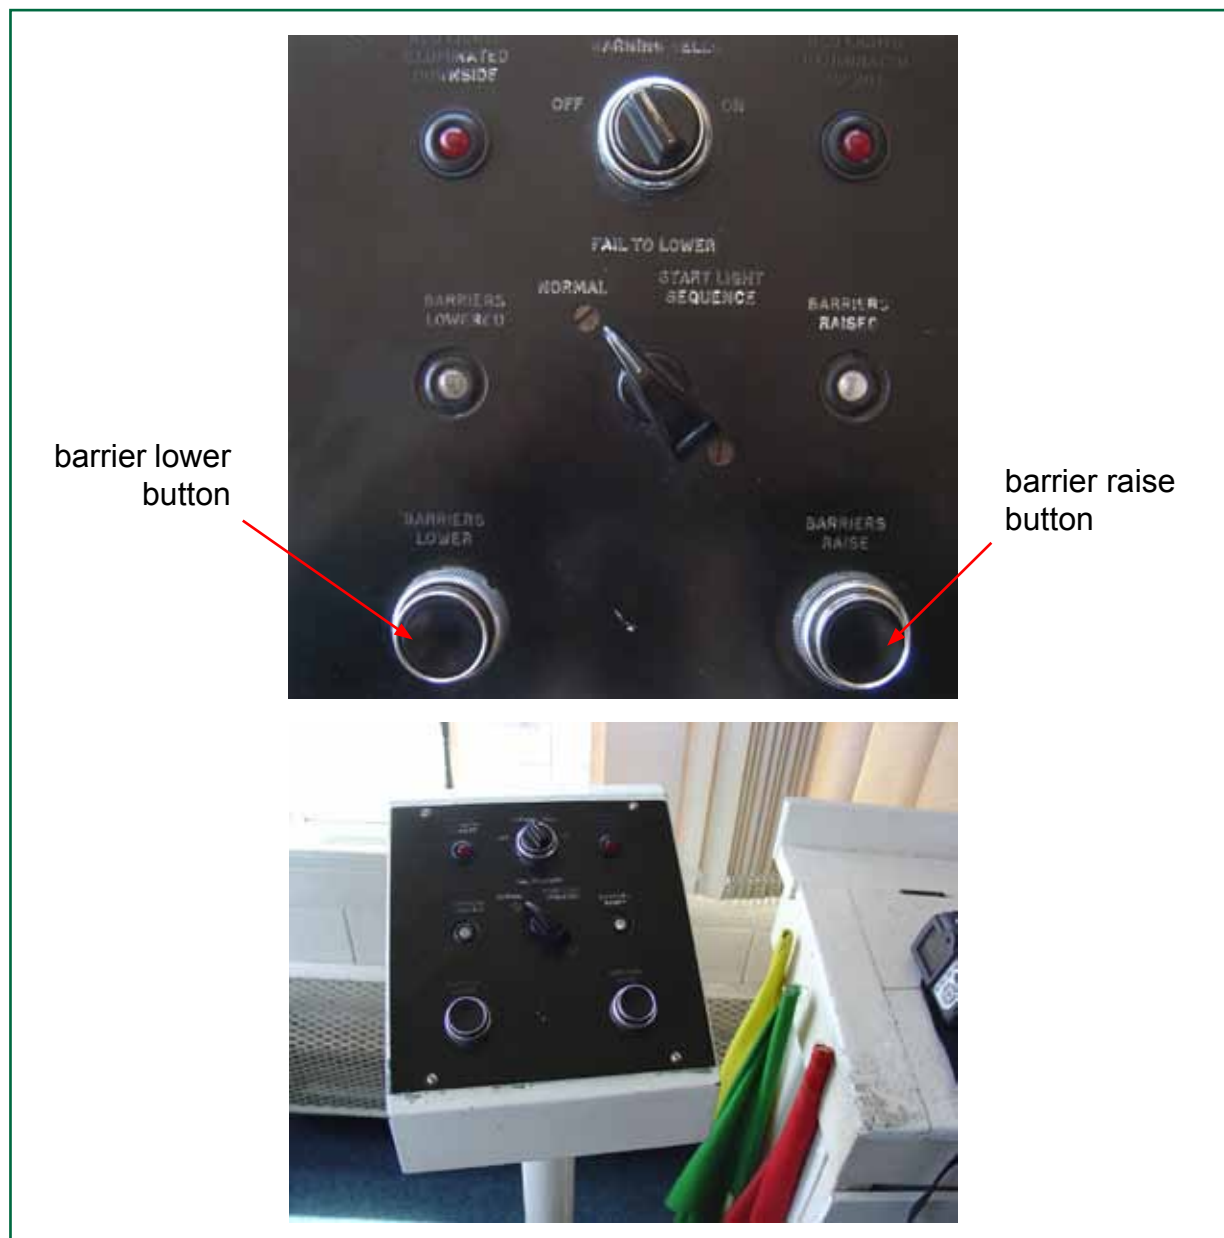
Figure 5: Lydney crossing control pedestal

- 23 The equipment in the crossing keeper's box for controlling Lydney crossing includes:
  - lower and raise buttons on a *control pedestal* adjacent to a window which allows the crossing keeper to observe the crossing when operating the controls (figures 5 and 6);

- 24 The crossing keeper at Lydney has no means of manually controlling the *protecting signals* for Lydney crossing, except an emergency release switch (ERS) not intended for use during manual operation of the barriers<sup>2</sup>. The aspects displayed by these protecting signals are not visible from the box; and there are no aspect repeaters in the box.

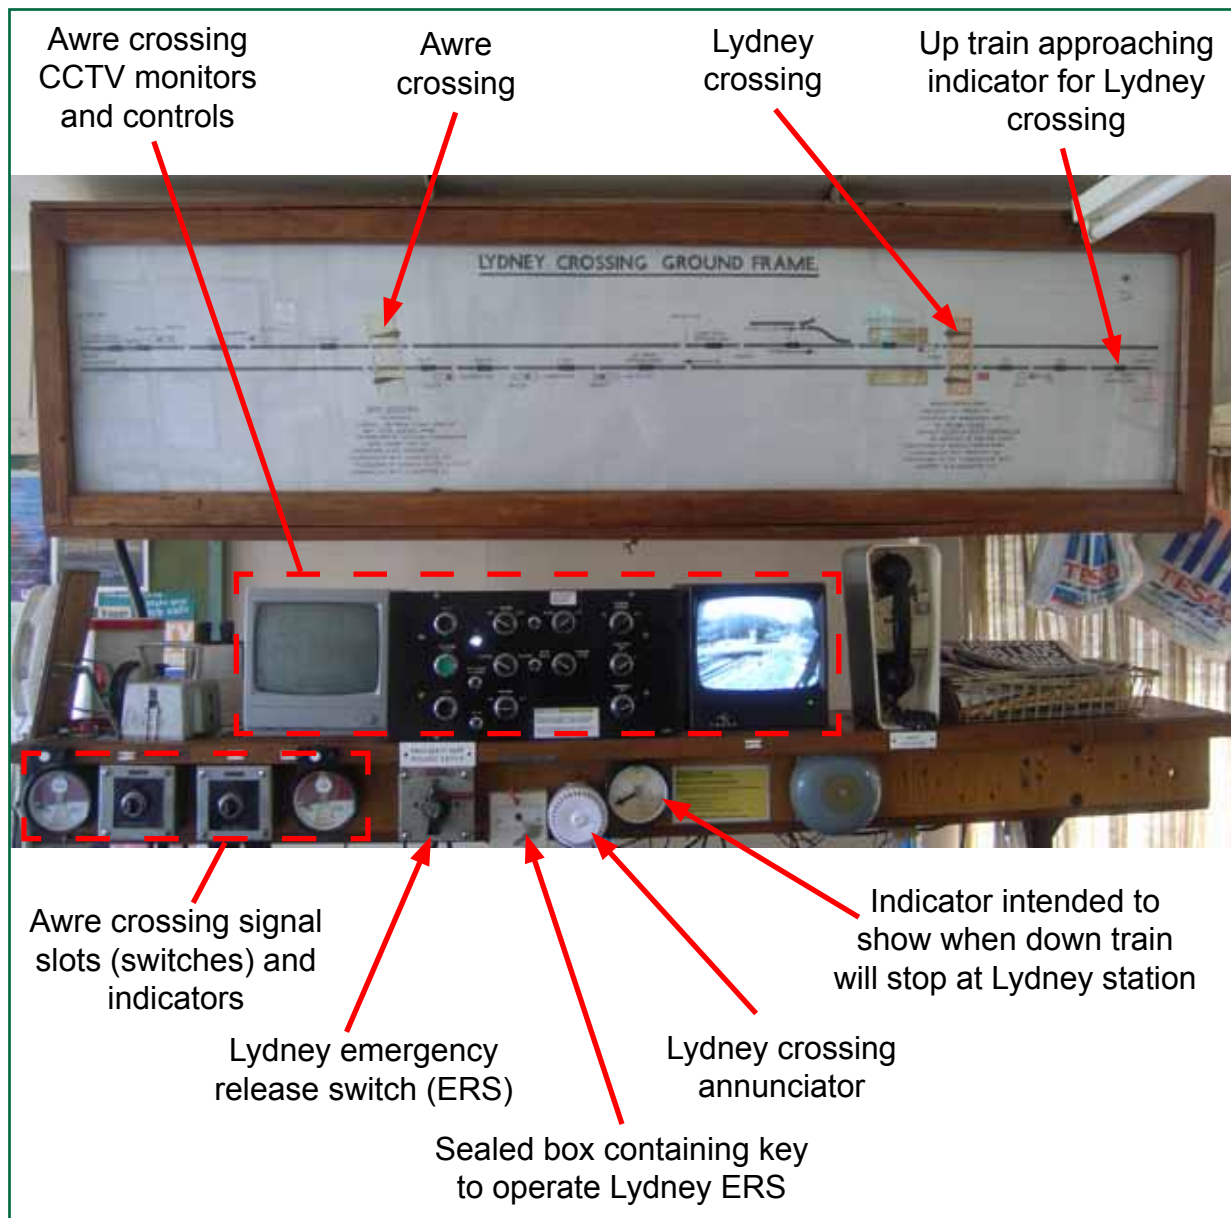
Figure 7: Diagram and instrument shelf

- a diagram showing the track layout, the location of signals and, by using indicator lamps, the position of trains near the crossing (figure 7); and

- 54 **When viewing the diagram, the crossing keeper did not see the illuminated indicator lamps which should have shown that a train was approaching. This is a causal factor.**
- 55 Before leaving the box to raise the barriers after train 2L59 passed, the crossing keeper could have looked at the diagram to determine whether any of the train approaching indicators were illuminated. If the indicators were operating correctly, train 1M68 should have illuminated two lamps in the “up train approaching” indicator (the indicator includes two lamps so that an indication is still provided if one lamp fails, figures 7 and 9). The crossing keeper stated that he looked at the diagram and did not observe any illuminated indicators.
