# **Rail Accident Report**

Passenger train derailment near East Langton, Leicestershire 20 February 2010

Report 01/2012 January 2012 This investigation was carried out in accordance with:

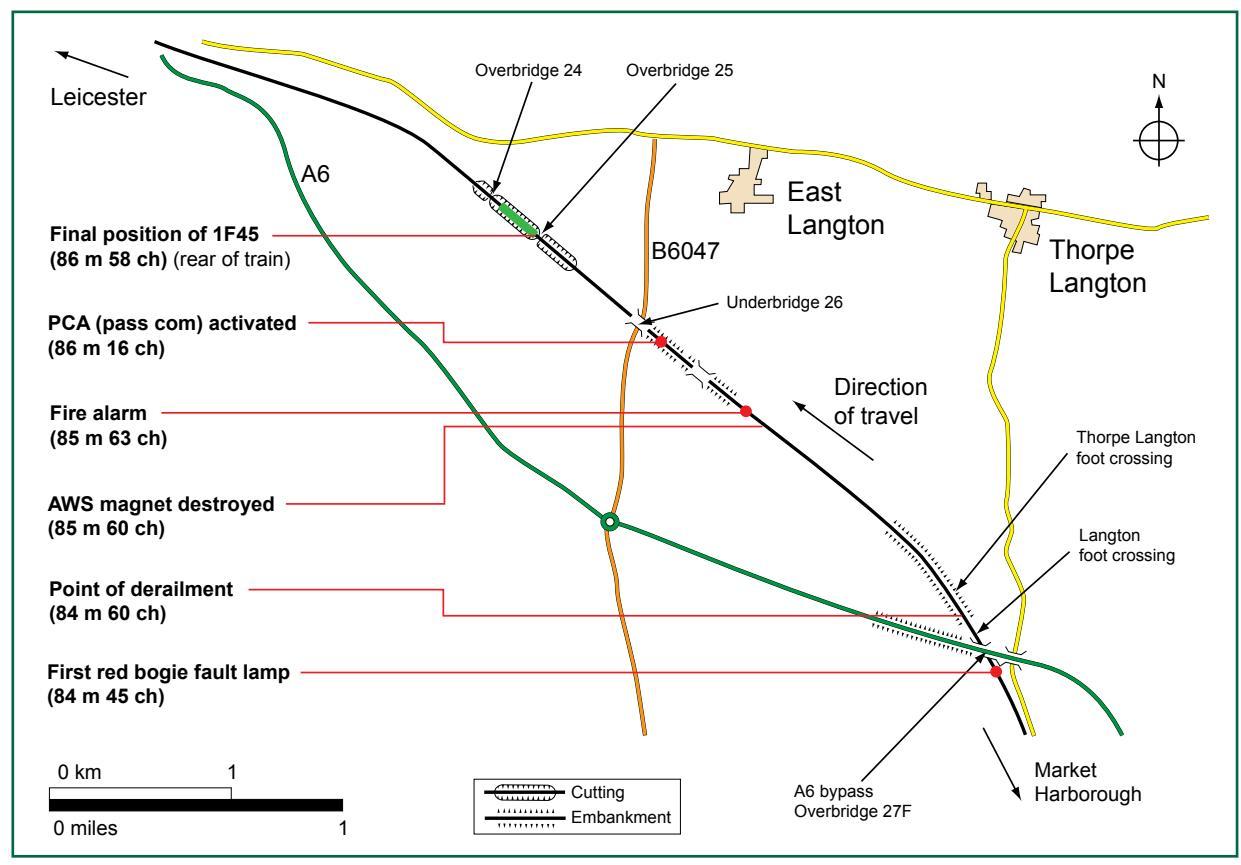
Figure 3: Location of the derailment

19 The derailment occurred on a rural section of the down main line between Market Harborough and Leicester, near East Langton, starting on the left-hand curve north of Market Harborough station and finishing on the subsequent straight section (figure 3).

- 20 The first signs of the axle breaking were irregular marks on the rail heads of the down line, approximately one wheel revolution apart, starting at 84 miles 30 chains. The left wheel derailed to the *cess* side at 84 miles 60 chains and the right wheel derailed into the *four-foot* at 84 miles 65 chains. The train came to rest in a cutting at 86 miles 58 chains.

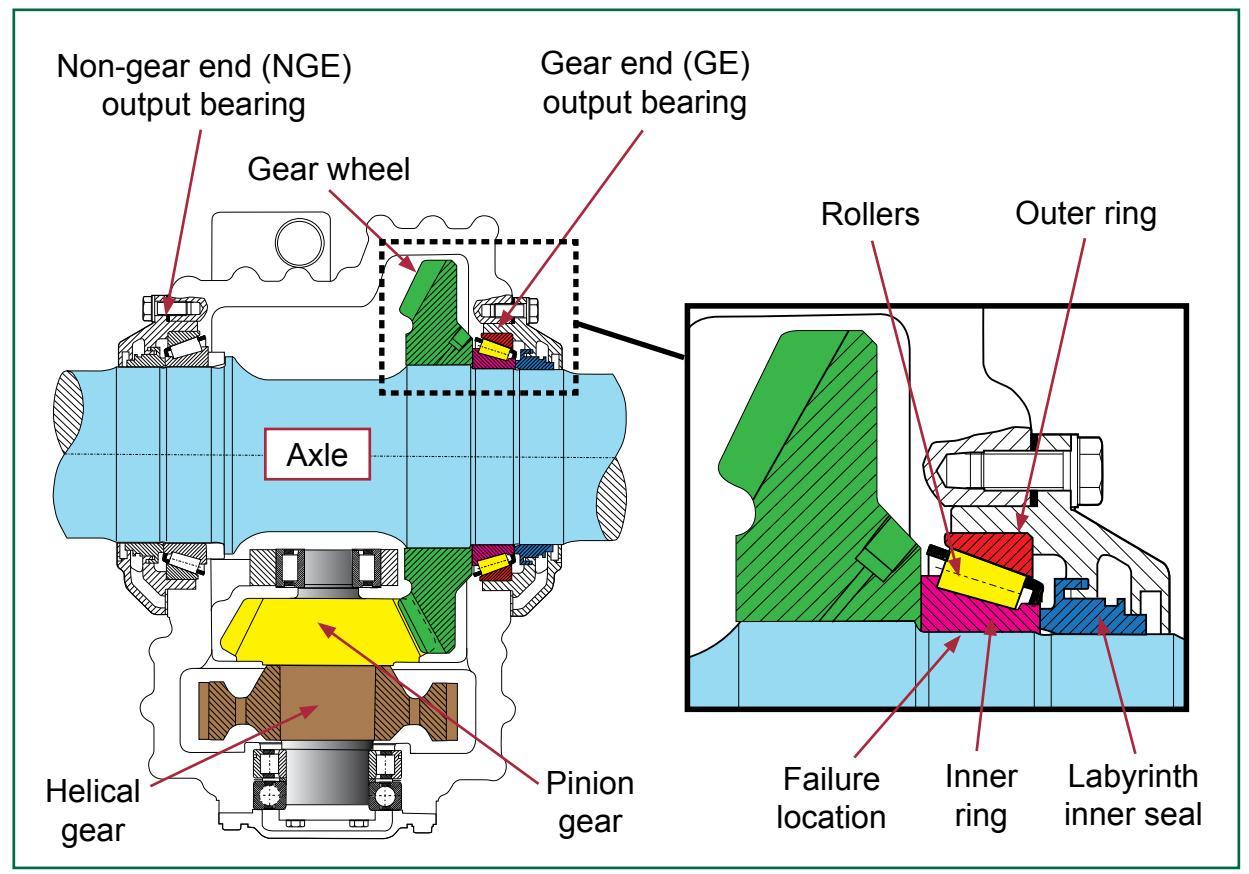
Figure 8b: Schematic of Meridian gearbox

64 Relevant parts of the final drive gearbox and axle are shown in figure 8a (photograph) and figure 8b (schematic). Throughout the following text and associated appendices, the abbreviations 'GE bearing' and 'NGE bearing' are used to denote the gear end and non-gear end tapered roller output bearings<sup>2</sup> respectively. A cutaway of this type of bearing is shown in figure 8c.

- 103 The design intent was that the inner rings of both the GE and NGE bearings would have an interference fit onto the axle of 75 -120  $\mu$ m.
- 104 However, the adjacent gear wheel (figure 8b), which is assembled onto the axle before the bearing, has a heavier interference fit onto the axle of 243 309 μm. The Meridian axle has a relatively thin wall compared to other hollow railway axles and the installation of the gear wheel caused the adjacent bearing seat on the axle to shrink below the minimum axle diameter necessary to achieve the correct (design) fit of the GE bearing.

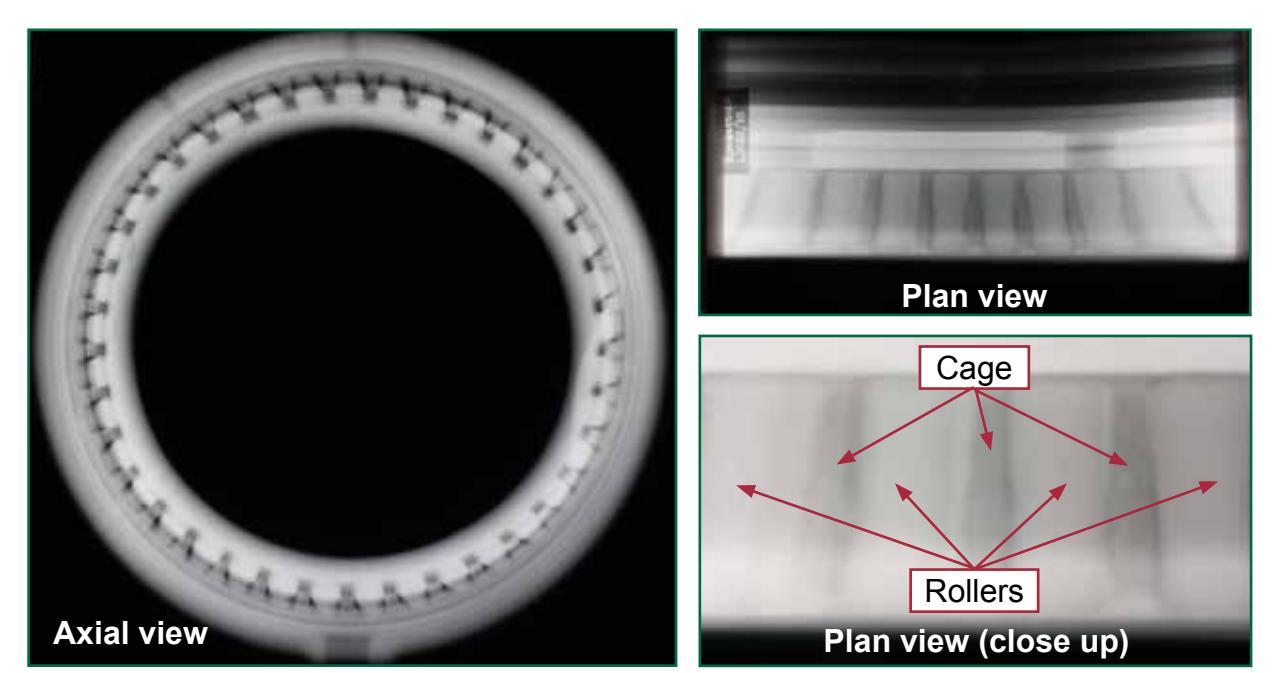
Figure D2: X-ray images of GE bearing (courtesy of Bombardier Transportation)

- D17 The rollers had become deformed during the last stages of the failure but this deformation was uniform indicating that the bearing had been rotating in the lead up to and after the derailment, until the train had stopped or nearly stopped.

- D18 The GE bearing had run for 922,000 miles (1.48 million km) without incident. Had there been some defect with the bearing or its installation, it is very likely the problem would have manifested itself earlier in its life.

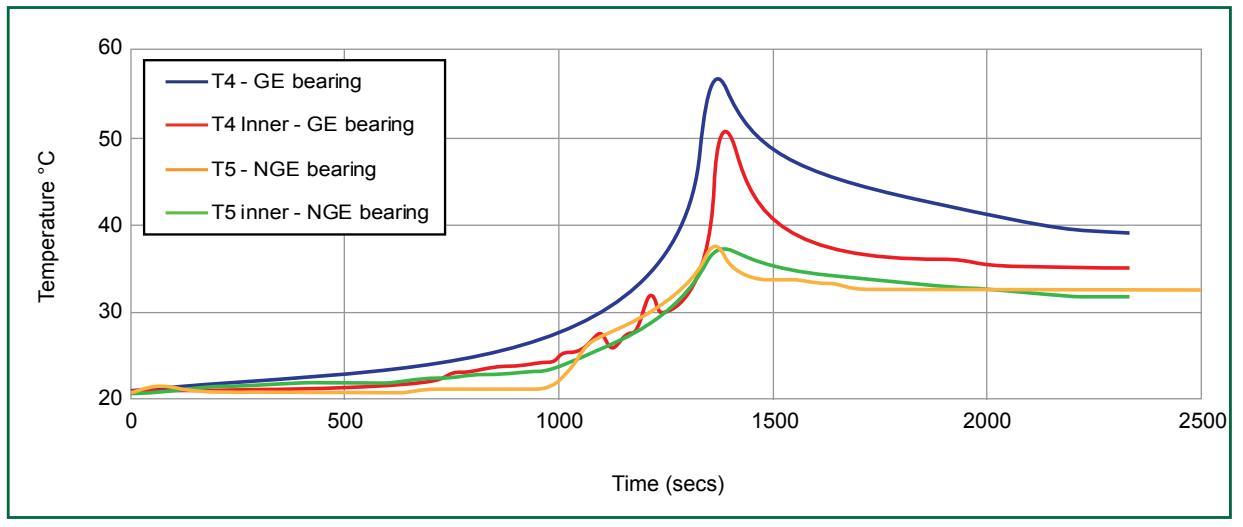
Figure E5: Output bearing temperature rise of gearbox 3 during splash test (normal oil level)

- E19 The splash test failure occurred 22 minutes into the run, shortly after increasing the speed from 600 to 1200 rpm. At this point, the gearbox ran with excessive vibration and there was a rapid rise of the GE bearing inner and outer ring temperatures up to 58°C (figure E5). There were also rapid rises of the NGE bearing temperatures. The gearbox was removed from the rig, stripped down and re-assembled with a new GE bearing and then re-installed in the rig.

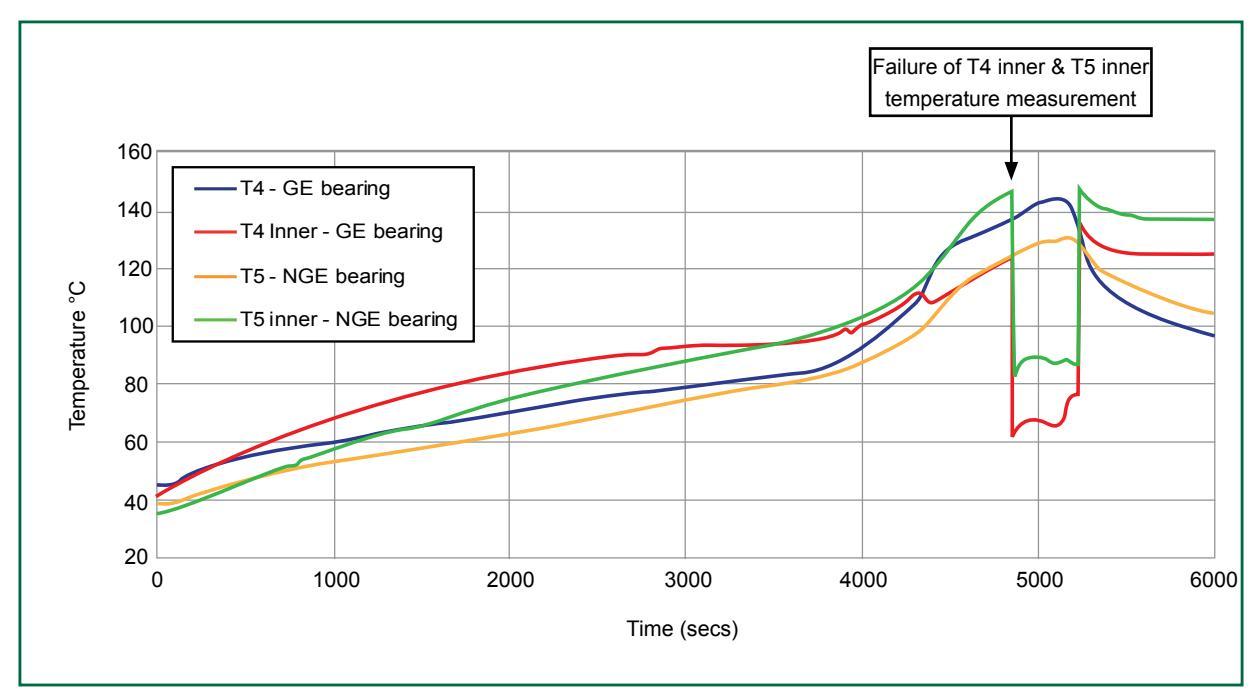
Figure E6: Output bearing temperature rise of gearbox 3 during '125' load cycle (normal oil level)

- E20 On restarting the testing, the splash test, running-in test and 1 hour of the 'HS-EMT' load cycle were completed without incident, with all temperatures remaining below 100°C. The loading was then changed to the '125' load cycle and the cooling fan was switched onto the GE bearing. A further incident of rapidly rising GE and NGE output bearing temperatures (to 143°C and 130°C respectively), occurred 20 minutes later (figure E6). The telemetry system failed at this point and the test was stopped to carry out repairs.

- E21 When testing was restarted (without a functioning telemetry system), the same sequence of loading was repeated to see if the high temperature incident could be repeated. However, the gearbox ran smoothly and the peak temperature only reached 95°C. The difference in maximum operating temperature from one day to the other under almost identical test conditions, was nearly 50°C.
