# Rail Accident Report

## Two incidents involving track workers between Clapham Junction and Earlsfield 8 March 2011

# Two incidents involving track workers between Clapham Junction and Earlsfield, 8 March 2011

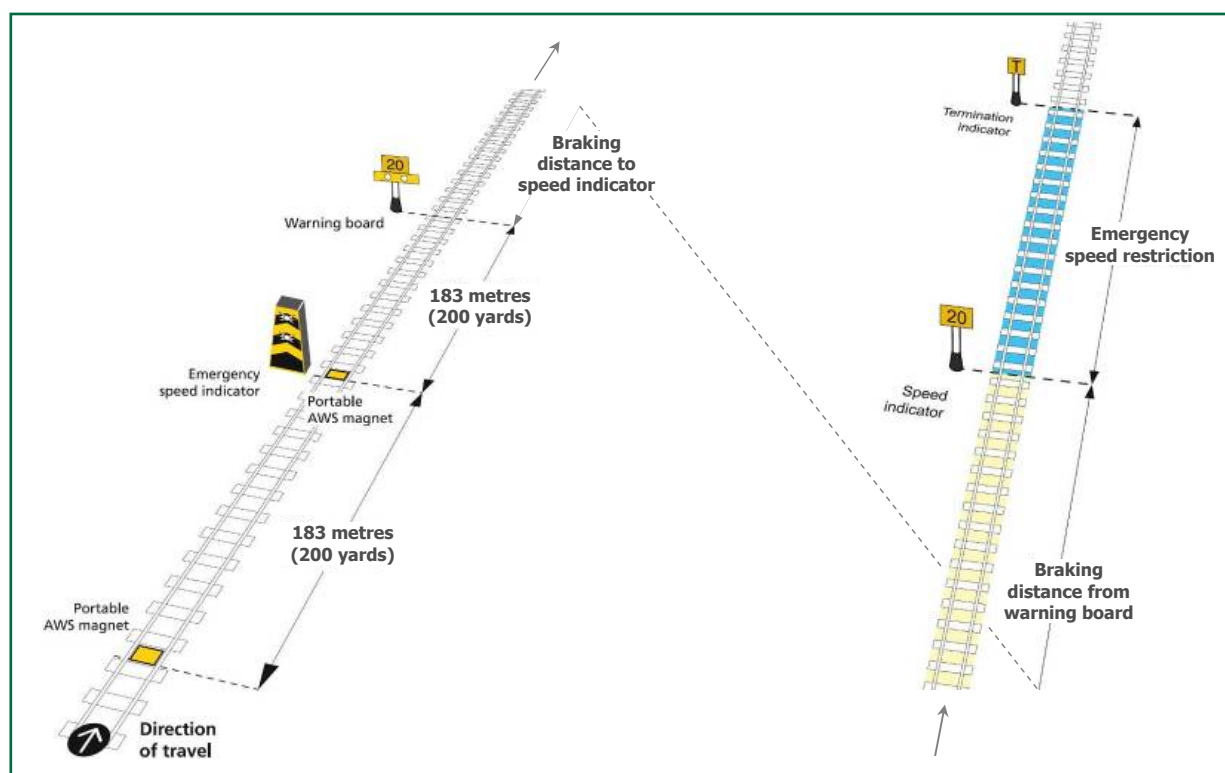
Figure 5a: Layout of the equipment required for an ESR (courtesy of RSSB)

Figure 5b: Layout of the ESR equipment installed on the Down Main Fast line on 8 March 2011

- 119 The driver of train 5D91 received the warnings triggered by the portable AWS magnets and observed the emergency indicator shown in figure 5b; the warning board was probably not visible as it had fallen over (paragraph 39). He did not immediately tell the signaller about the missing warning board as required by module SP of the Rule Book (if necessary stopping his train specially). He had been accelerating as he passed the ESR equipment, using step 2 of the traction controller<sup>14</sup>. About 350 metres further on, just before he passed signal number W165, he increased his traction demand to step 4, and continued until he observed COSS B's gang about 670 metres later (paragraph 44).
