Rail Accident Investigation Branch

Rail Accident Report

Boiler incident on the Kirklees Light Railway 3 July 2011

3 July 2011

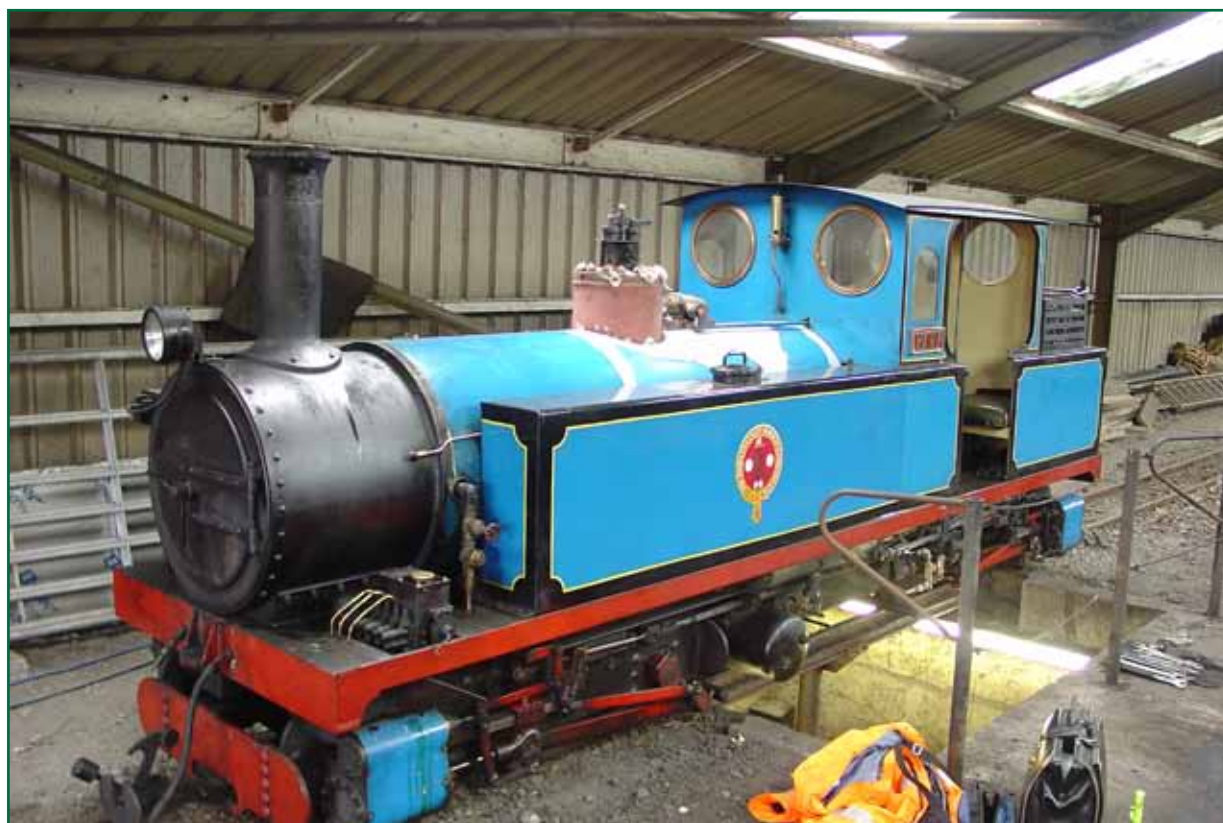
Figure 2: Locomotive 'Hawk' which was involved in the incident

- 14 The train involved was the 11:40 hrs departure from Clayton West to Shelley. This was the second passenger train of the day, but was the first to be hauled by the locomotive named 'Hawk' (figure 2). The train consisted of five passenger coaches and there were two train crew and between 25 and 30 passengers on board.
