Rail Accident Report

Partial failure of Bridge 94, near Bromsgrove, 6 April 2011

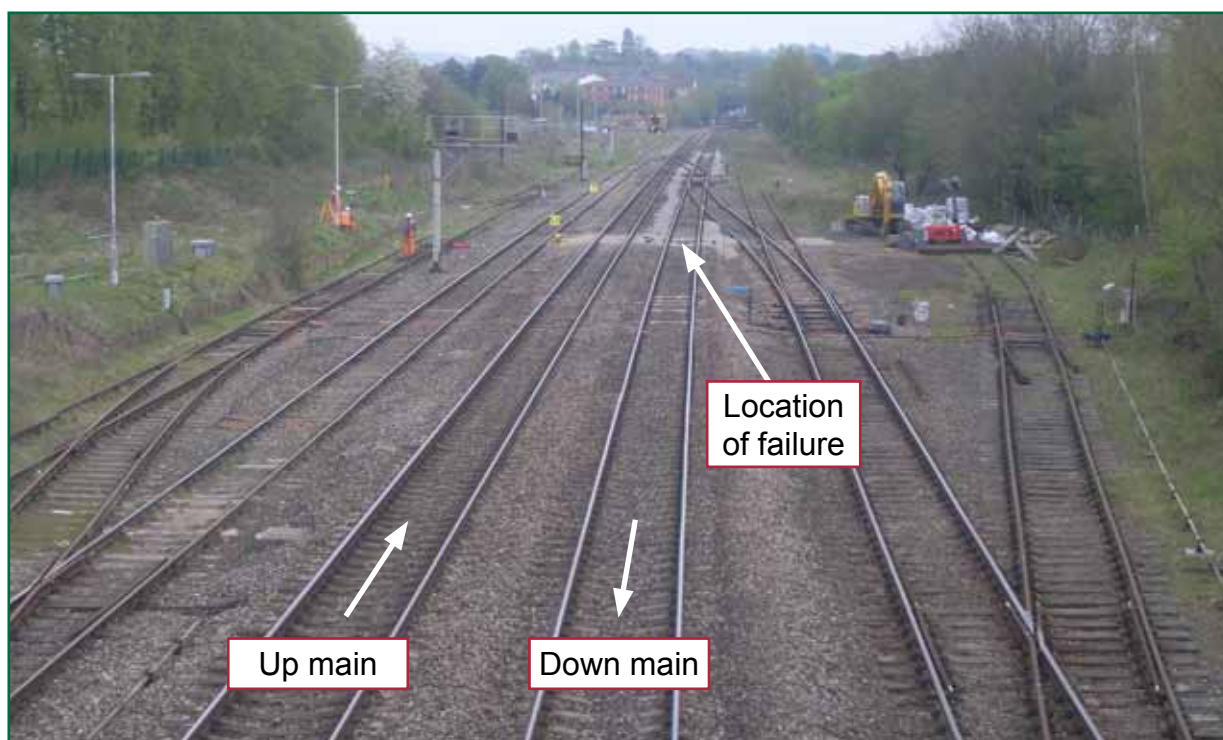
Figure 3: Site overview following the incident looking north-east towards Bromsgrove station

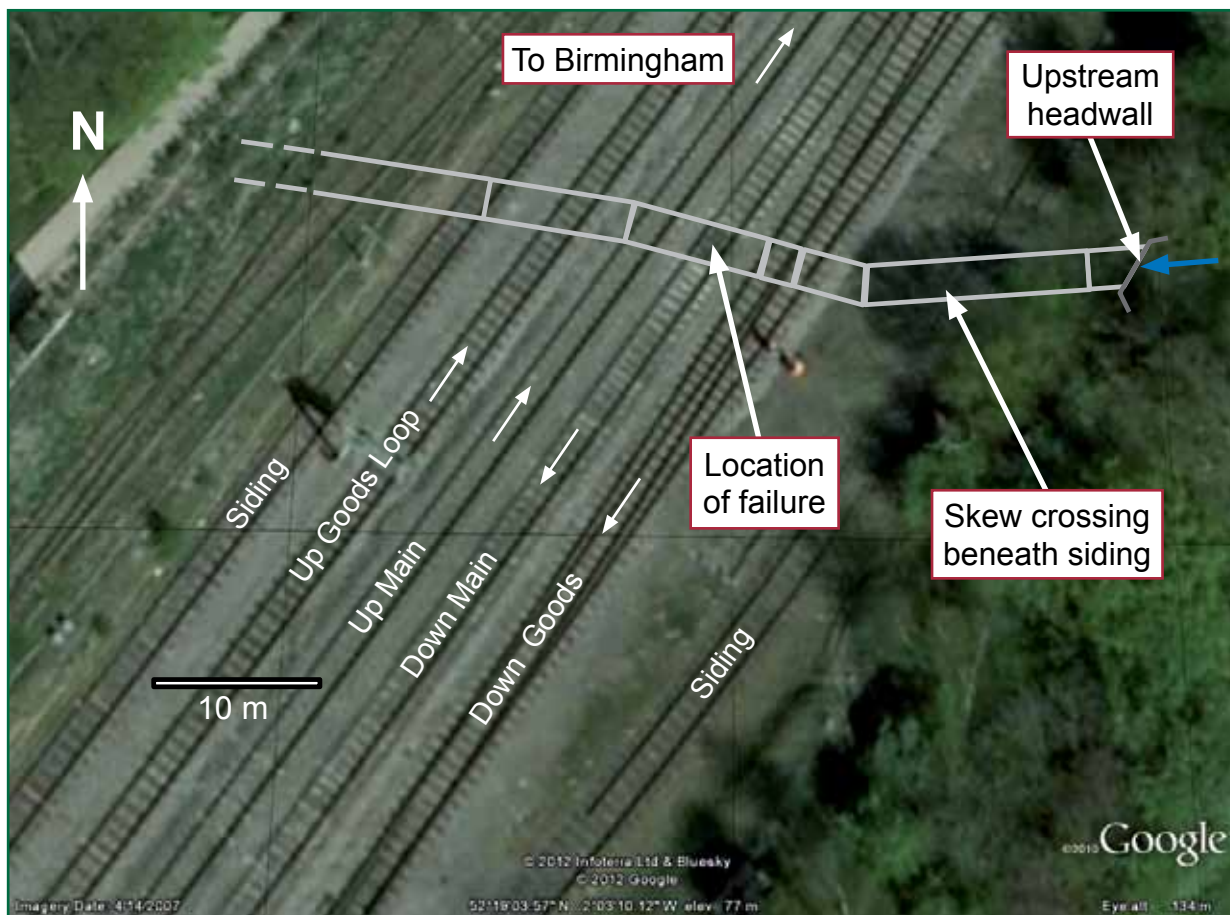
- 19 The structure changes direction at two locations. It is not possible to see through the structure from the upstream end, or to determine its course at track level. The downstream end is not visible from the surface.

Figure 4: Overhead view showing approximate alignment of Bridge 94 relative to tracks (courtesy of Google Earth)
