# Rail Accident Report

## **Safety incident between Dock Junction and Kentish Town 26 May 2011**

# Safety incident between Dock Junction and Kentish Town, 26 May 2011

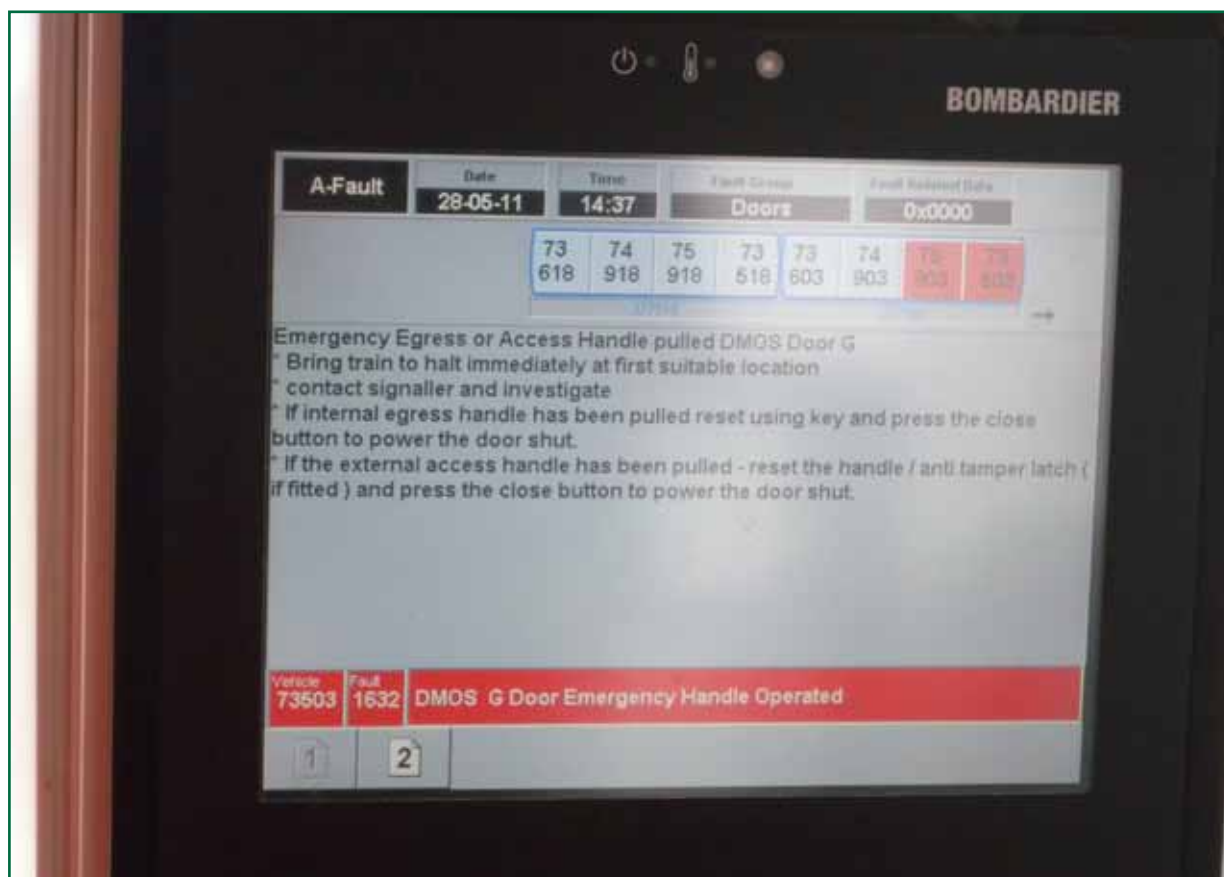
- 41 The driver of train 1W95 made his way to the front of the combined trains, which now consisted of 12 coaches. He started the combined train's computer controlled train management system at 20:29 hrs, but the public address system on the failed 8-cars still did not work. Operation of the emergency door release handles and passenger communication alarms continued, and this meant that the driver was still unable to move the train because there was a safety interlock which prevented him from taking traction power with the alarms operated. The fitter volunteered to walk through the train to reset all of the passenger communication alarms and to close any open doors. As he walked through the train he asked passengers (some of whom had been standing for over two hours) not to activate emergency door release handles and passenger communication alarms again as this would prevent the train from moving. However, some passengers ignored this request. The driver's computer display screen continued to show door faults on the failed portion of the train, which meant that he was unable to determine whether the doors were open or closed (figure 10). It was still not possible to obtain the door interlock necessary for movement of the train.

Figure 10: Door activation and instructions given to the train driver on the in-cab display

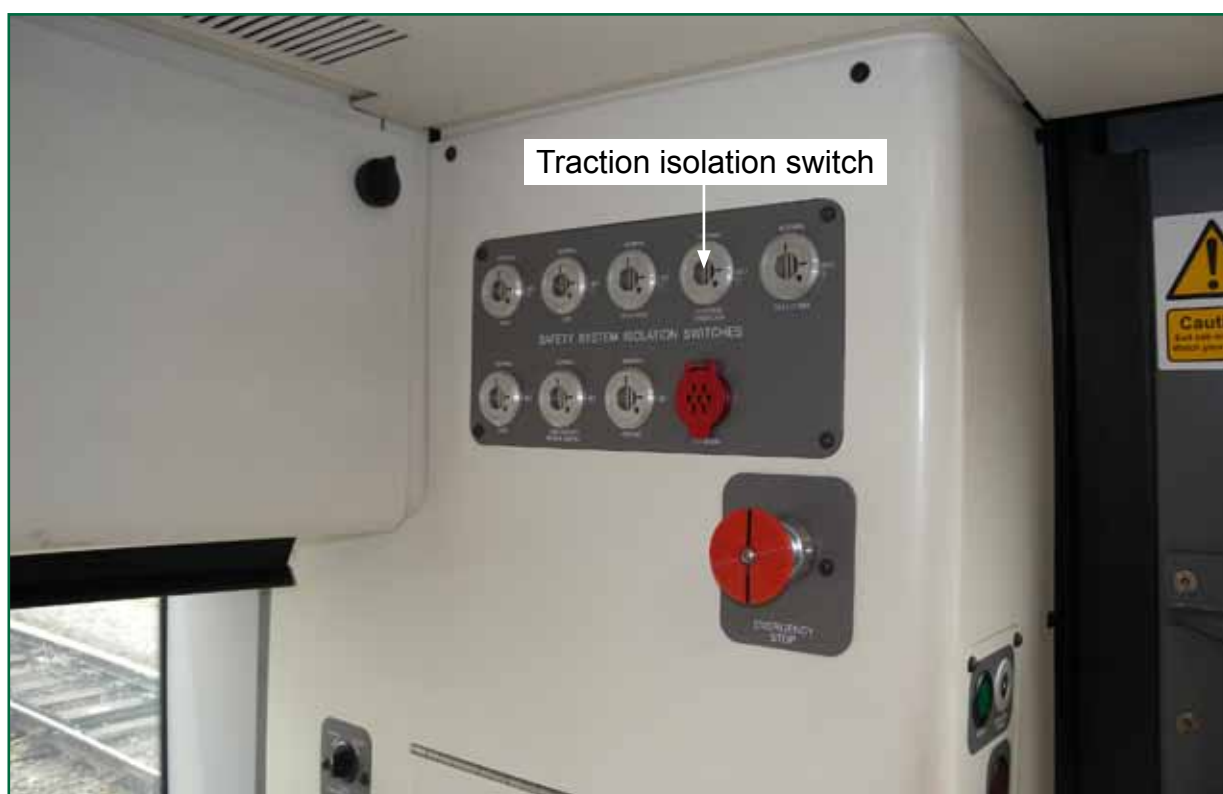
- 42 At 20:58 hrs the signaller (in consultation with FCC control) advised the fitter and the driver that if no solution could be found, and the driver could not obtain the door interlock, then the driver was authorised to operate the traction interlock switch. Operation of this switch would override the safety interlock and enable the driver to move the train. At approximately 21:00 hrs, the driver duly operated the traction interlock switch, and almost immediately afterwards applied traction to carry out a short 'pull test' which involved moving the train a distance of less than one metre to ensure that it was securely coupled. The train driver, who was focused on the task in hand, did not make any announcement to passengers that the pull test was to be undertaken. Had he done so, it would not have been heard in the rear eight coaches because the PA system was still not working. The driver was unaware that around 30 to 40 passengers from the two rear carriages had now decided to leave the train with some passengers getting off the train as it moved forward a short distance during the pull test. Other passengers were walking between the train and tunnel / cutting wall in the cress towards Kentish Town station.

Figure 11: Traction Isolation Switch (TIS)

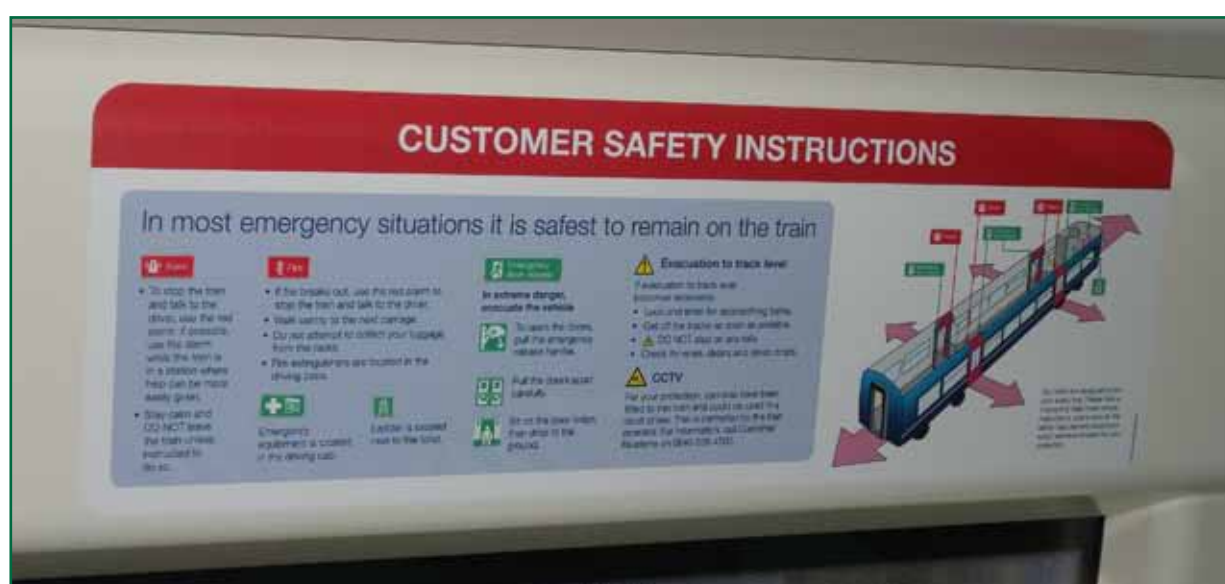
- 99 Such was the mood among passengers that doors were being re-opened as soon as the staff had returned to the front of the train. In turn, this resulted in further warning messages on the train management system display screen in the driving cab. This further delayed the movement of the train and increased the frustration of passengers, resulting in some of them leaving the train. Notices above the doors advise passengers to stay calm and not to leave the train unless instructed to do so, but there is also text and pictograms showing them how to evacuate themselves to track level (figure 15).

Figure 15: Guidance and passenger evacuation notices and pictograms above the train door

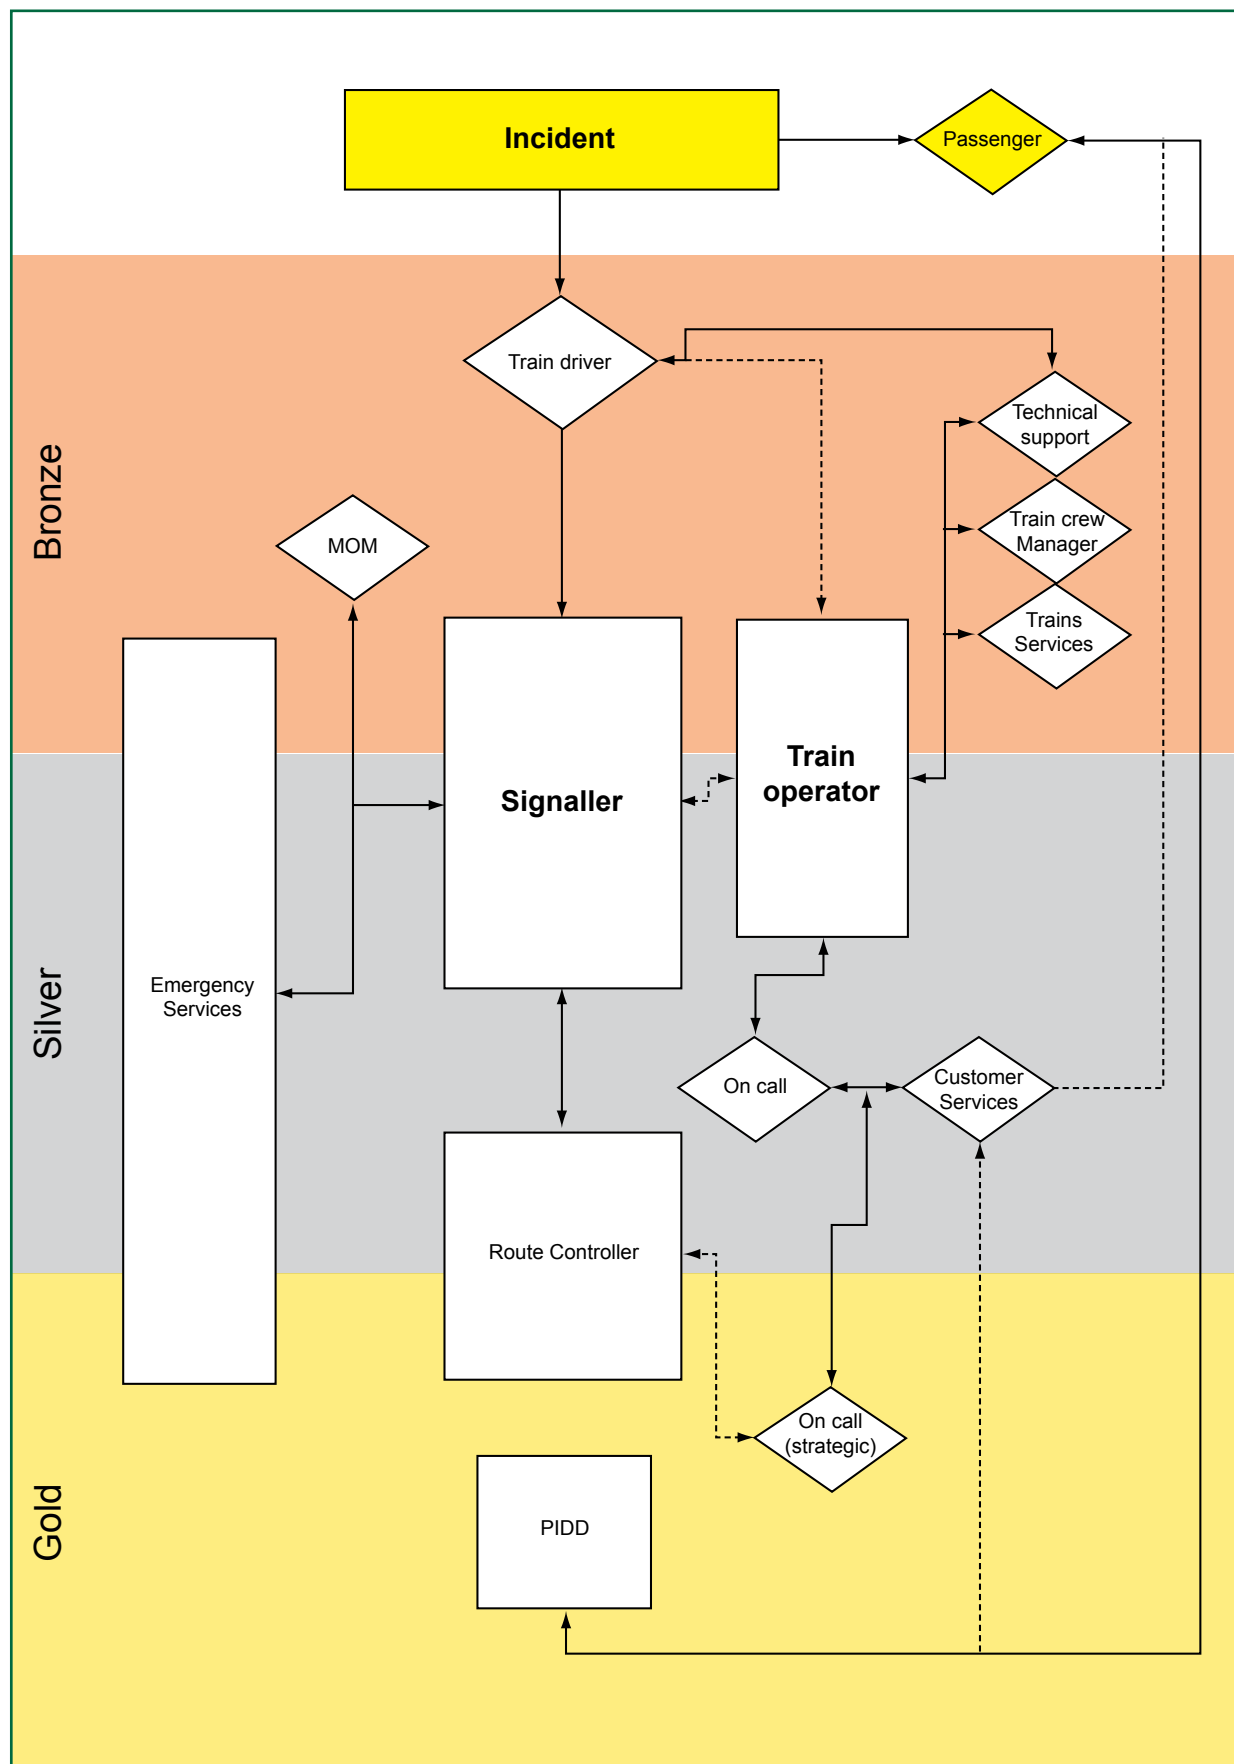
- fleet technicians at Cauldwell depot, for technical matters in relation to the train.
- 120 Although the FCC controllers wanted to contact the driver at various times during the incident, they had no means of doing so as they did not have the driver's mobile telephone details. Even if the controllers had wanted to assume strategic control of the incident, they would have had difficulty doing so because of their inability to talk directly to the driver of the train (figure 17).

Figure 17: Stakeholders involved in the incident and operational (Bronze), tactical (Silver) and strategic (Gold) roles

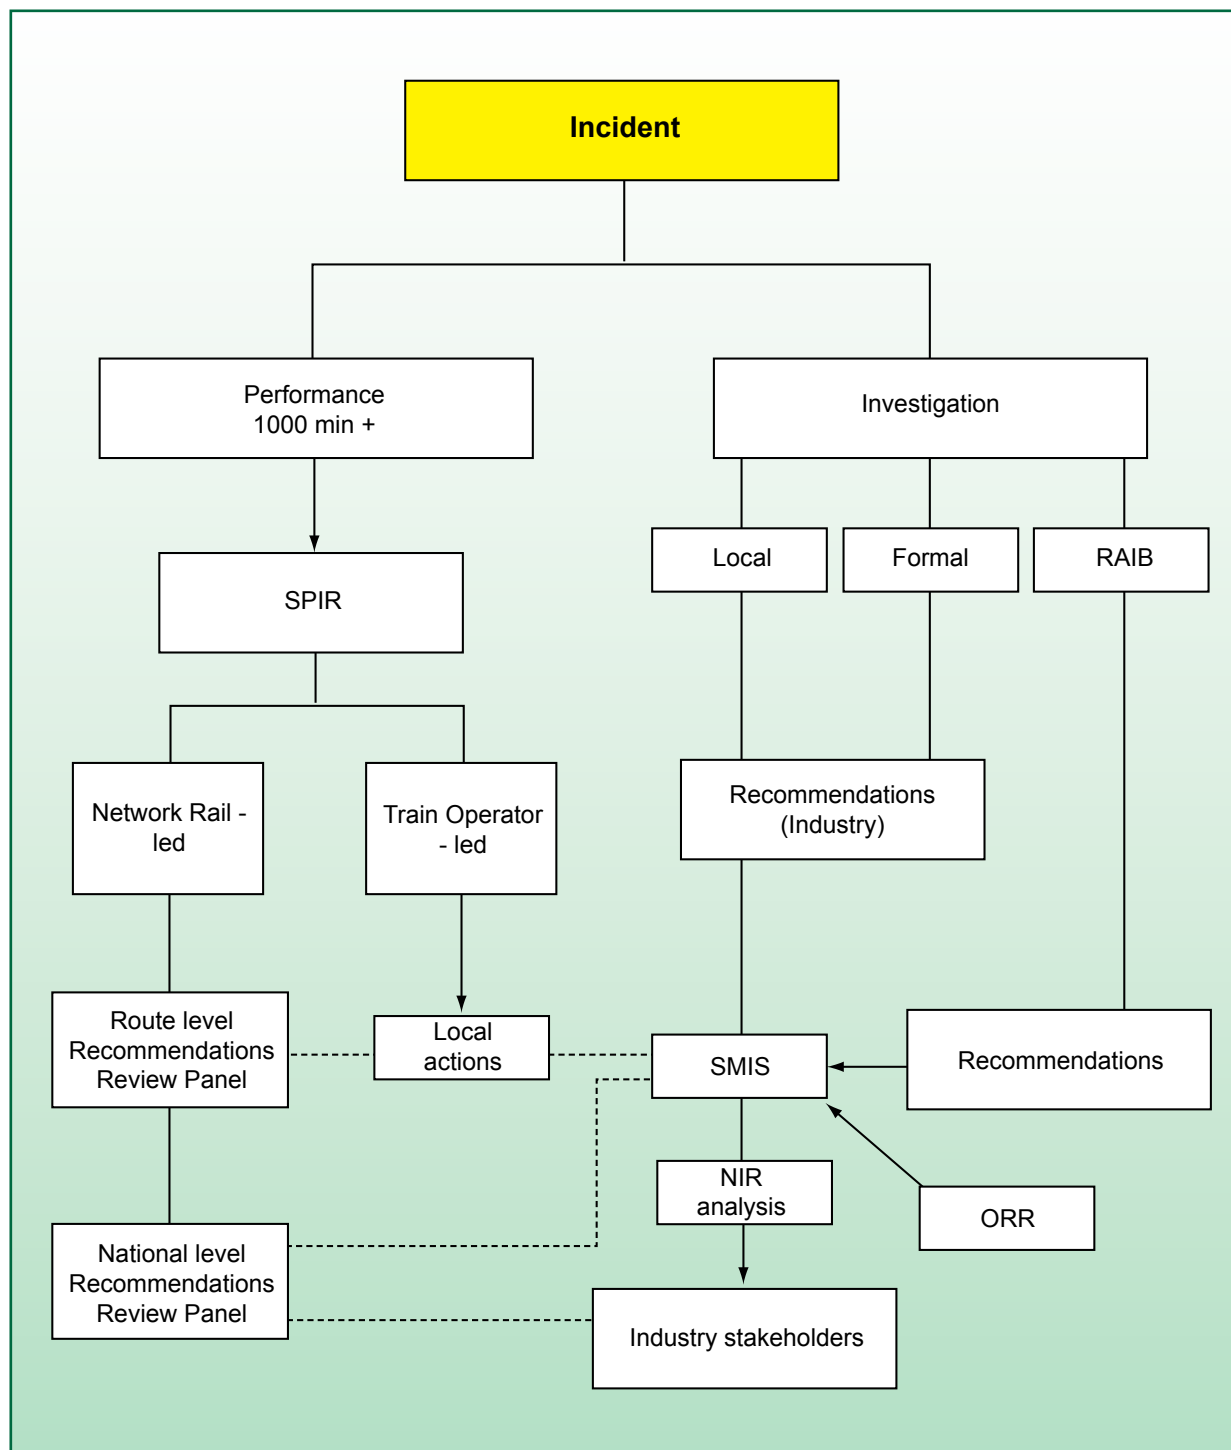
- 168 In addition to formal and local investigations, Network Rail and / or train operators conduct Significant Performance Incident Reviews (SPIR) for incidents where the total consequential delay to trains passes a threshold of 1000 minutes or where performance lessons can be learnt. Although SPIR reviews are intended to focus on performance issues and possible financial implications arising from incidents, they also seek to identify root causes and all factors contributing to incidents and consider measures to prevent a recurrence (figure 18).

Figure 18: SPIR and SMIS process diagram

- 171 Although it is not prohibited, there is currently no requirement for SPIR reports to be input to SMIS. It is up to the individual route where the SPIR report was produced to decide whether a safety lesson has been identified and how to share the safety lesson with the railway industry or if the safety lesson is to be changed into a safety recommendation. The RAIB reviewed the SMIS and SPIR data relating to the incidents at Foxton, Leagrave, and Elstree where train evacuations had taken place and safety lessons had been identified. SMIS contained a summary of each incident, but no details of lessons learnt or recommendations made from such lessons. The Farringdon incident (2010) was not recorded on SMIS. There was no local investigation into the incidents and therefore no visible safety learning.
