Rail Accident Report

**Fatal accident at Mexico footpath crossing (near
Penzance)
3 October 2011**

Fatal accident at Mexico footpath crossing (near Penzance), 3 October 2011

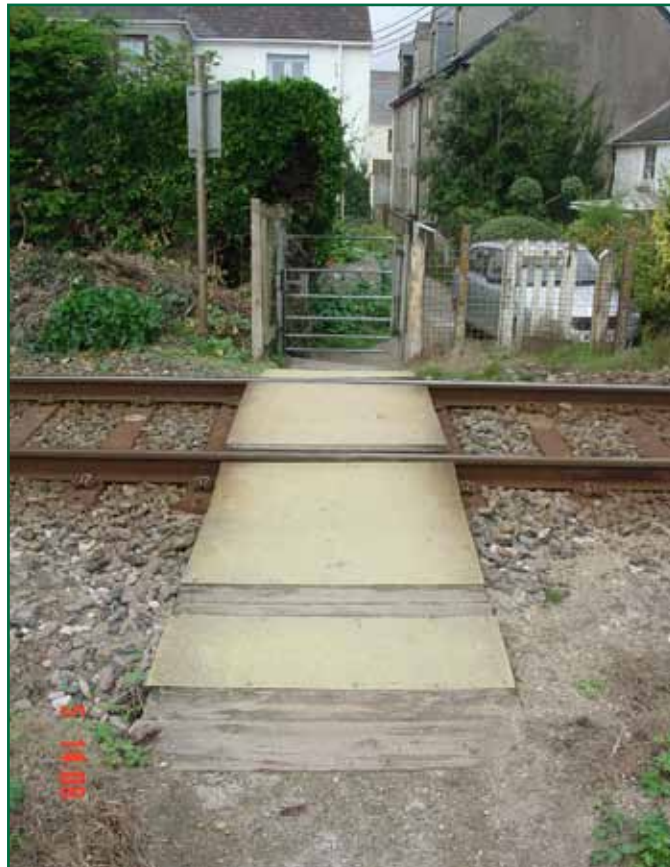
Figure 4: Mexico footpath crossing from the south (beach) side

- 15 The crossing is made of timber decking with a non-slip surface. There were no deficiencies in the condition of the crossing deck. There is a difference in height between the access lane on the north side of the crossing and the railway, which necessitates a slope between the gate and the crossing on the north side. There is a shallower slope on the south side of the crossing.
- 16 Trains are limited to a maximum speed of 50 mph (80 km/h) over Mexico footpath crossing when running towards Penzance and 70 mph (113 km/h) when running towards St Erth.
