# Rail Accident Report

## Incident at Llanbadarn Automatic Barrier Crossing (Locally Monitored), near Aberystwyth, 19 June 2011

# **Incident at Llanbadarn Automatic Barrier Crossing (Locally Monitored), near Aberystwyth, 19 June 2011**

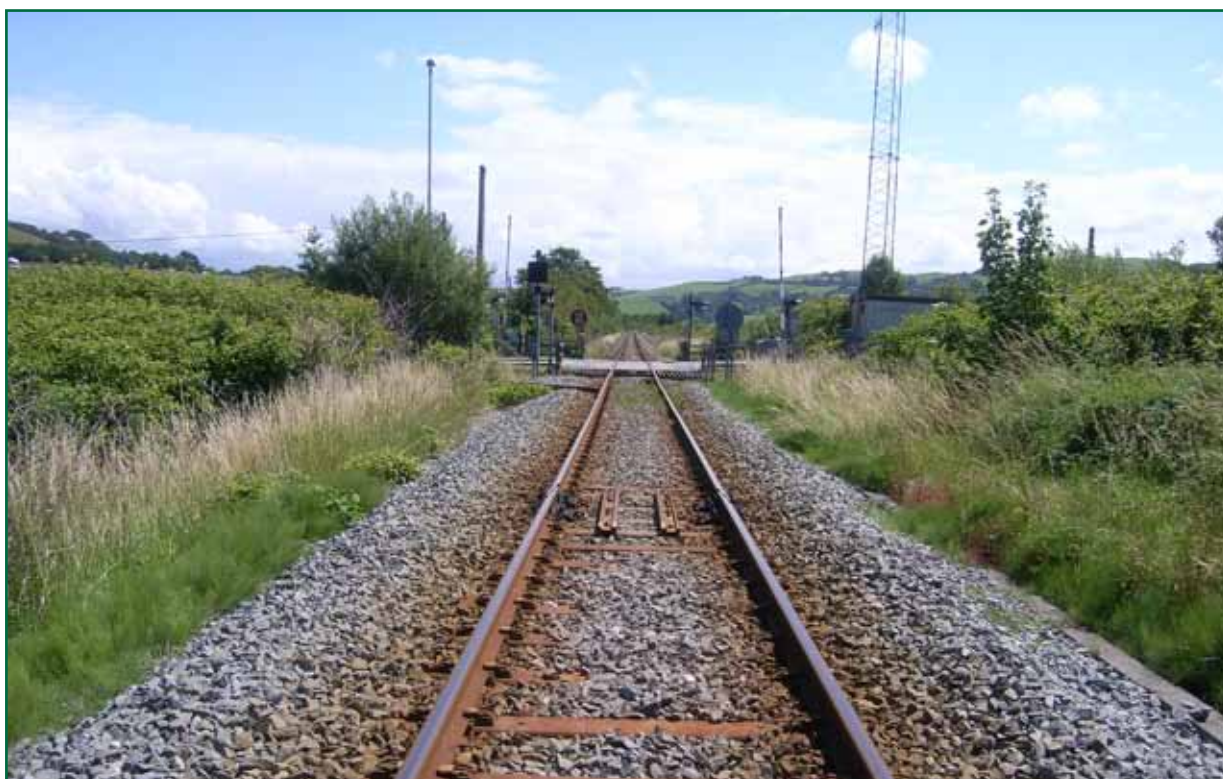
- 15 The Network Rail line rises as it approaches Llanbadarn *Automatic Barrier Crossing, Locally Monitored* (ABCL) from Aberystwyth, and continues to rise until approximately 325 metres east of the crossing (figure 4).

Figure 4: Llanbadarn ABCL crossing approach in the up direction

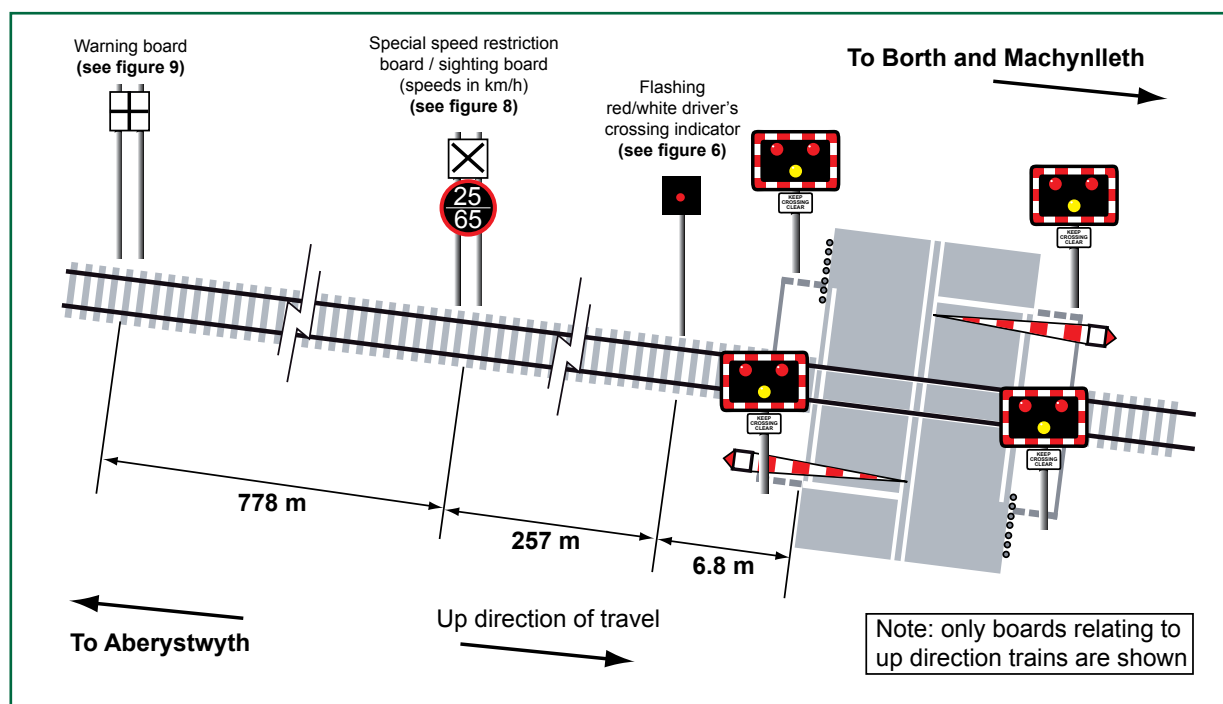
- 29 Until the arrival of a train initiates its operation, the crossing is in its 'normal state'. In this state an indicator, known as the *driver's crossing indicator* (DCI), shows a flashing red light to rail traffic (figures 5 and 6), and there are no lights shown to road traffic. If, when a train approaches, the crossing sequence has initiated correctly, and the highway flashing red lights have begun to show to road traffic, and the barriers have started to lower, then the flashing red light at the DCI will be replaced by a flashing white light. This flashing white light informs the driver that the crossing is functioning correctly. The maximum permitted speed of trains as they pass over the crossing (known as the crossing 'permitted' speed) is limited by the ETCS<sup>1</sup>, and a 'sighting board' is placed a set distance before the crossing. This board should be positioned so that a train travelling at the permitted speed<sup>2</sup> can be stopped before reaching the crossing if the DCI has not displayed a flashing white light by the time the front of the train passes the board. This board is referred to in the Office of Rail Regulation Guidance<sup>3</sup> as the special speed restriction board (SSRB). This board is known in the Rule Book as a 'sighting board'. Another board, known as the 'warning board' (paragraph 37) warns the driver that the train is approaching the sighting board.

Figure 5: Schematic diagram of Llanbadarn ABCL

- 36 The sighting board for up direction trains at Llanbadarn ABCL is located 257 metres before the DCI (figures 5 and 8), which, in turn, is located 6.8 metres before the crossing. Thus the board is approximately 264 metres before the crossing. The DCI can be seen by a driver approximately 950 metres before the train reaches it. The warning board is located 778 metres on the approach to the sighting board.

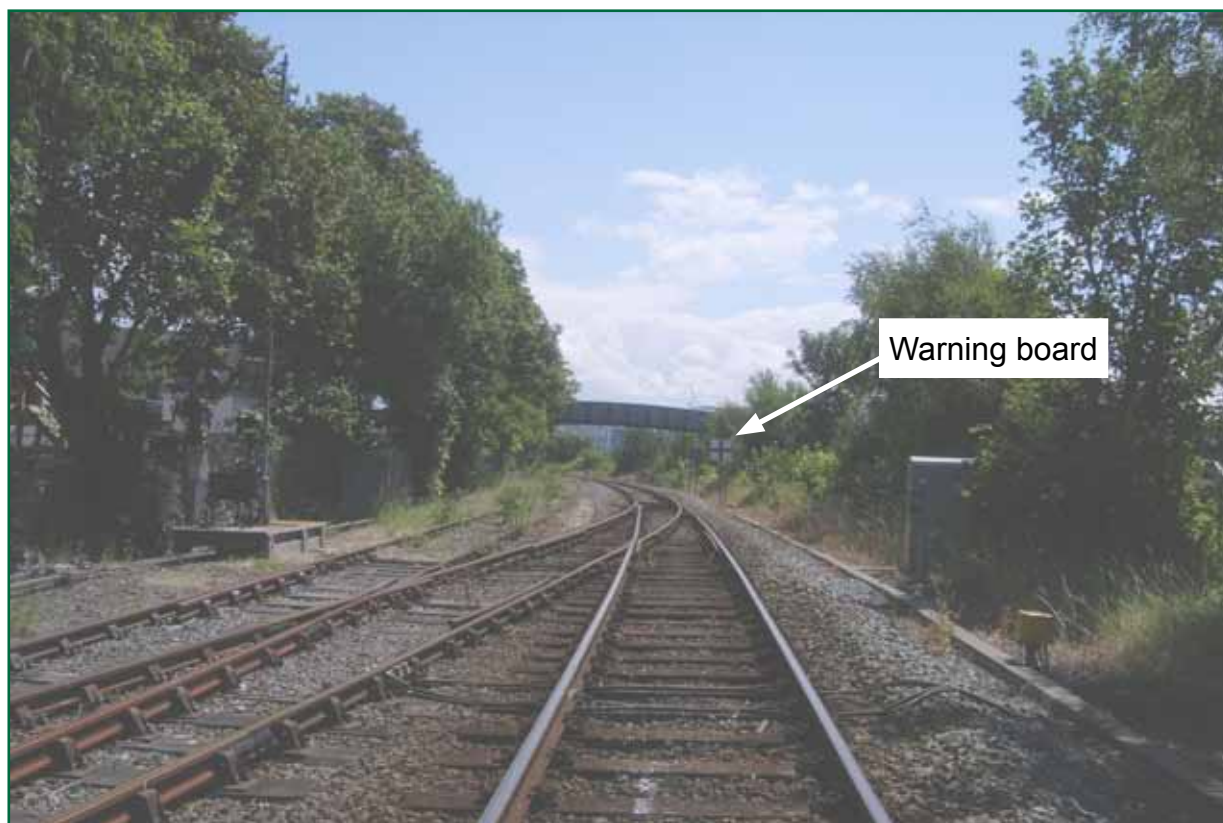
Figure 9: Warning board - as seen by an approaching train driver after leaving Aberystwyth station

- 37 A warning board (figure 9) warns the driver that the train is approaching the sighting board<sup>5</sup>. Under ERTMS operation, on the approach to the warning board, an audible alarm is sounded in the driver's cab and a text message, 'ABCL ahead' appears on the driver's DMI screen. This text message disappears from the DMI when it is acknowledged by the driver by pressing a button on the DMI. If the message is not acknowledged within 3 seconds, then the brakes on the train will automatically apply.

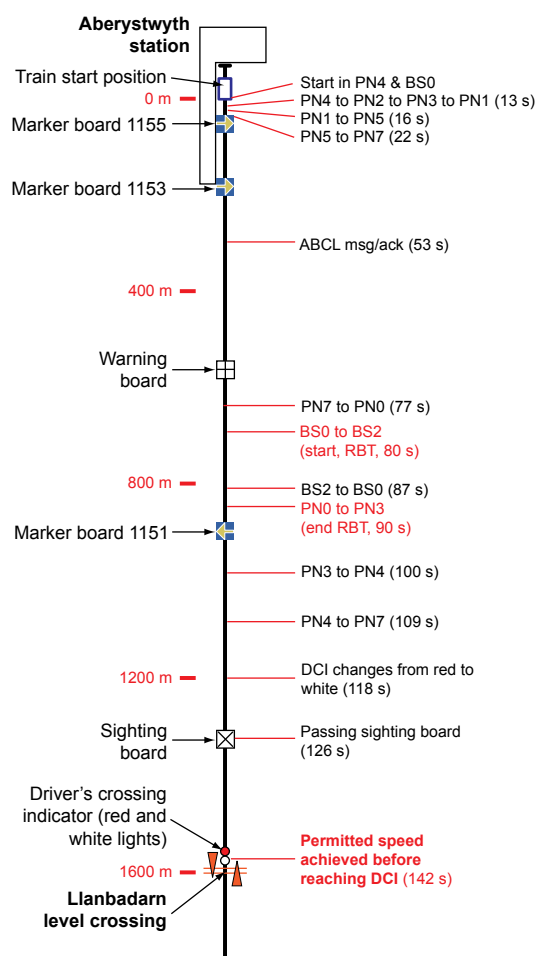
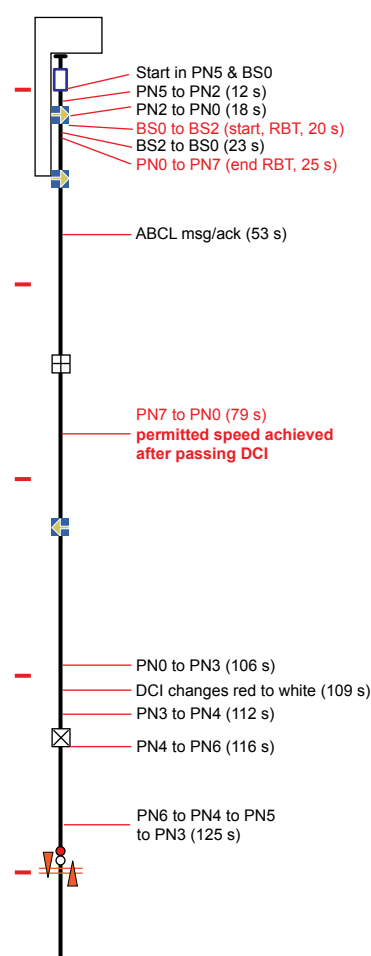
## Typical train starting in on sight (OS) mode with standard running brake test (RBT)

## Typical train starting in OS mode with reduced speed RBT

- Instructed drivers that they should operate the plunger at Aberystwyth station when their cab is set up correctly and they are ready to depart.
- Issued all drivers with an instruction concerning lower speed running brake tests. At Aberystwyth, a small speed reduction (2-3 km/h) is required and can be completed in time for the train to accelerate to the permitted speed before the driver is required to concentrate on the DCI (figure 13). The instruction to reach 65 km/h (the standard running brake test which applied at the time of the incident) is no longer required for Arriva Trains Wales trains departing from Aberystwyth.
