Rail Accident Report

Detachment of a cardan shaft at Durham station 10 April 2011

Detachment of a cardan shaft at Durham station

10 April 2011

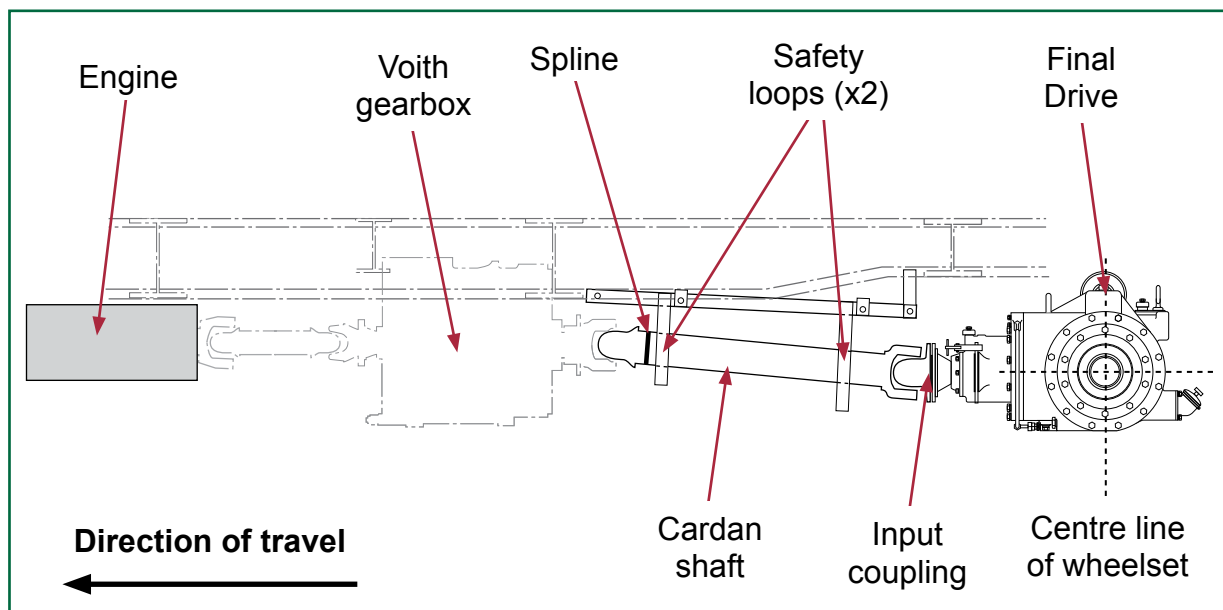
Figure 3: Drive arrangement on Class 14x

- 9 The train involved was formed of two 2-car class 142 units (figure 1). The shaft detached at the trailing end of the third vehicle and was not held up by its *retention devices* (in this case two *safety loops* – figure 3). The detached cardan shaft came to rest between the rails of an adjacent line after damaging the underside of the third and fourth vehicles, piercing the fuel tank on the fourth vehicle and releasing around 500 litres of diesel fuel onto the railway.
- 10 Unaware of what had occurred, but alerted by an un-commanded brake application and the engine warning light illuminating on his cab console, the driver stopped his train on the approach to signal T291, 2 miles (3.2 km) outside Durham station (figure 2).

- 76 The cardan shaft is by design supported between the gearbox and final drive by two *universal joints*, one at each end of the shaft. In order to minimise the effects of axial loads transferred by the cardan shaft, the shaft itself is made of two parts connected by a *spline* (figure 3). The spline is located towards the Voith gearbox end which means that the part of the cardan shaft attached to the Voith gearbox is short (approximately 0.4 m) and the part attached to the final drive is long (approximately 1.4 m).

- 118 An effective retention system for a cardan shaft would need to contain the energy stored in a large mass rotating at high speed. The two safety loops fitted to unit 142045 were to the original design for class 142/0 dating back to the mid-1980s. There was no specific load case in any of the standards applicable in the mid-1980s to cover the design of the cardan shaft safety loops. This situation remained the same in 2011. In order to accommodate the cardan shaft movement and its inclination, the loops are at different heights (figure 3). The loops are made of 10 mm steel plate, 50 mm wide welded to the underside of the vehicle body.

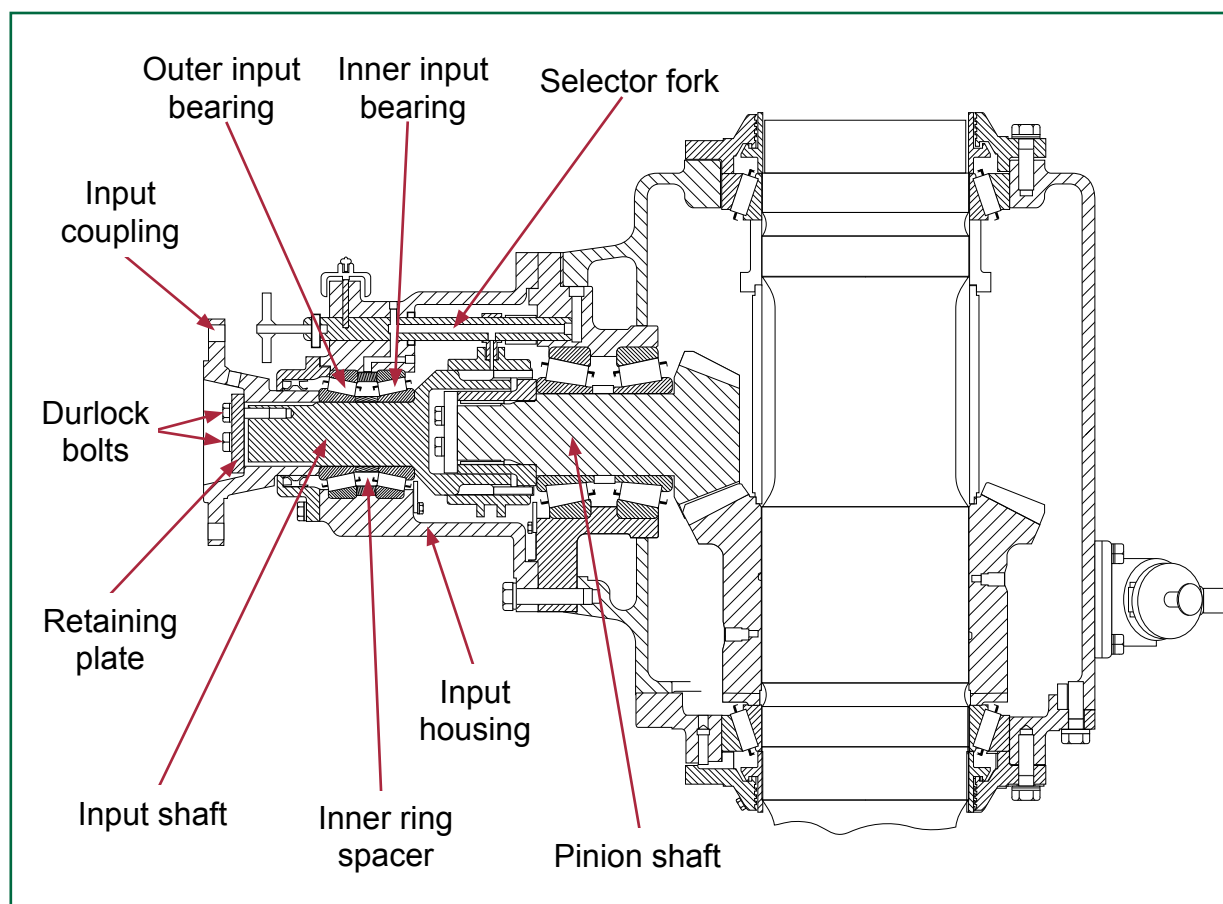
Figure 4: Final drive cross-section

- 29 The SCG final drive, model RF420i, is a *single reduction bevel gearbox*. It is connected to the cardan shaft through an input coupling which drives the input shaft within the final drive (figure 4). Power is transmitted by the input shaft to the pinion shaft which in turn drives the wheelset through a set of bevel gears (figure 4). The final drive is oil lubricated and oil cooled with the oil pump being mechanically driven directly off the axle.

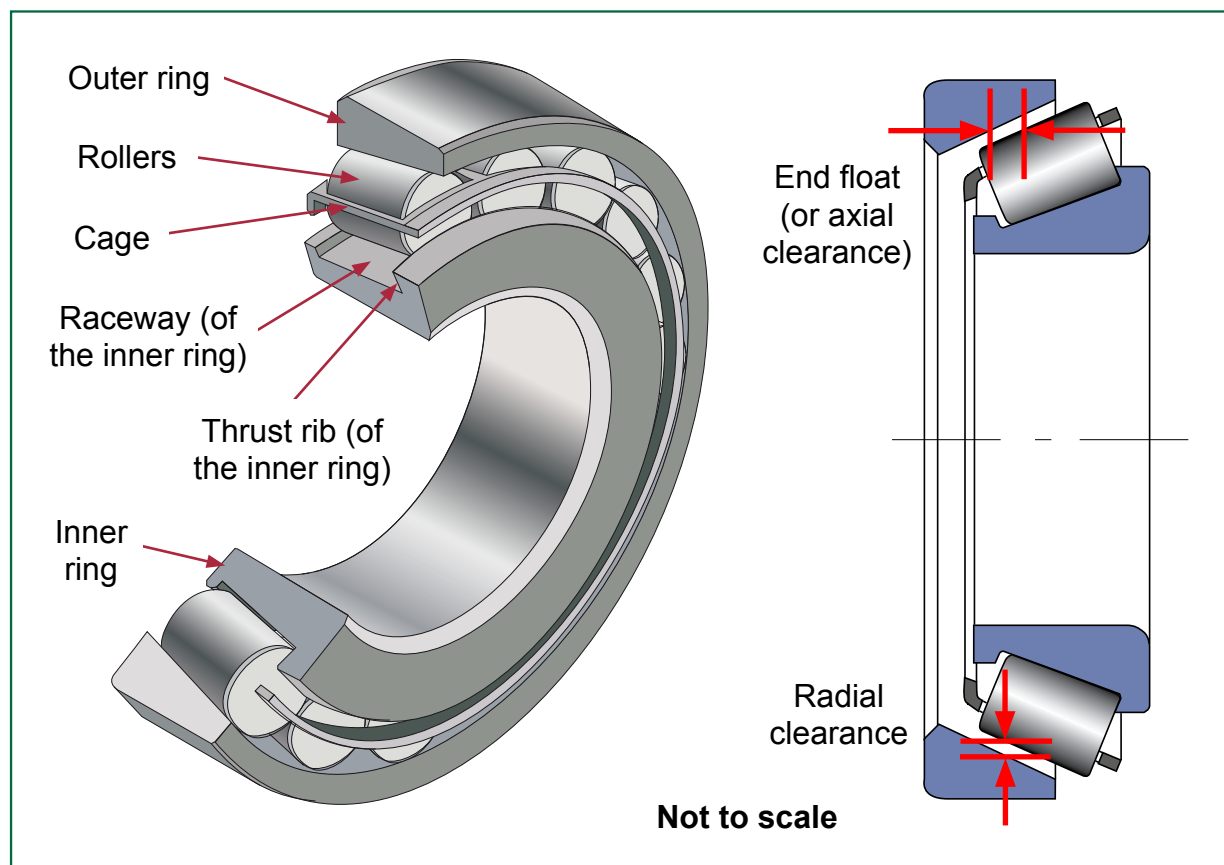
Figure 5: Tapered roller bearing

- 31 Although not relevant to this accident, a further modification programme is now underway to eliminate the selector fork (paragraph 69).
- 32 The input shaft is mounted within the final drive input housing through a pair of *tapered roller bearings* (figure 5 shows the various bearing components). These bearings, referred to in this report as the input bearings, are mounted *back-to-back*. The inner rings of the bearings together with the inner spacer ring are clamped in between the input coupling and input shaft by the retaining plate and *Durlock* bolts.

- 33 Bearings produce heat when in normal operation and the inner ring of a bearing usually runs hotter than the outer ring. This is because the outer ring is usually in direct contact with the air cooled housing whereas the inner ring is in contact with a shaft that is less able to dissipate the heat transferred to it. This temperature difference between inner and outer rings causes the inner ring to expand more than the outer ring when running. To accommodate this differential expansion the bearing is set up at installation with a radial clearance. The radial clearance is defined as the radial gap between the rollers and the outer ring once installed (figure 5). On tapered roller bearings, the radial clearance is directly related to the axial clearance also known as 'end float'.
