Rail Accident Investigation Branch

Rail Accident Report

Track worker struck by a train at Stoats Nest Junction 12 June 2011

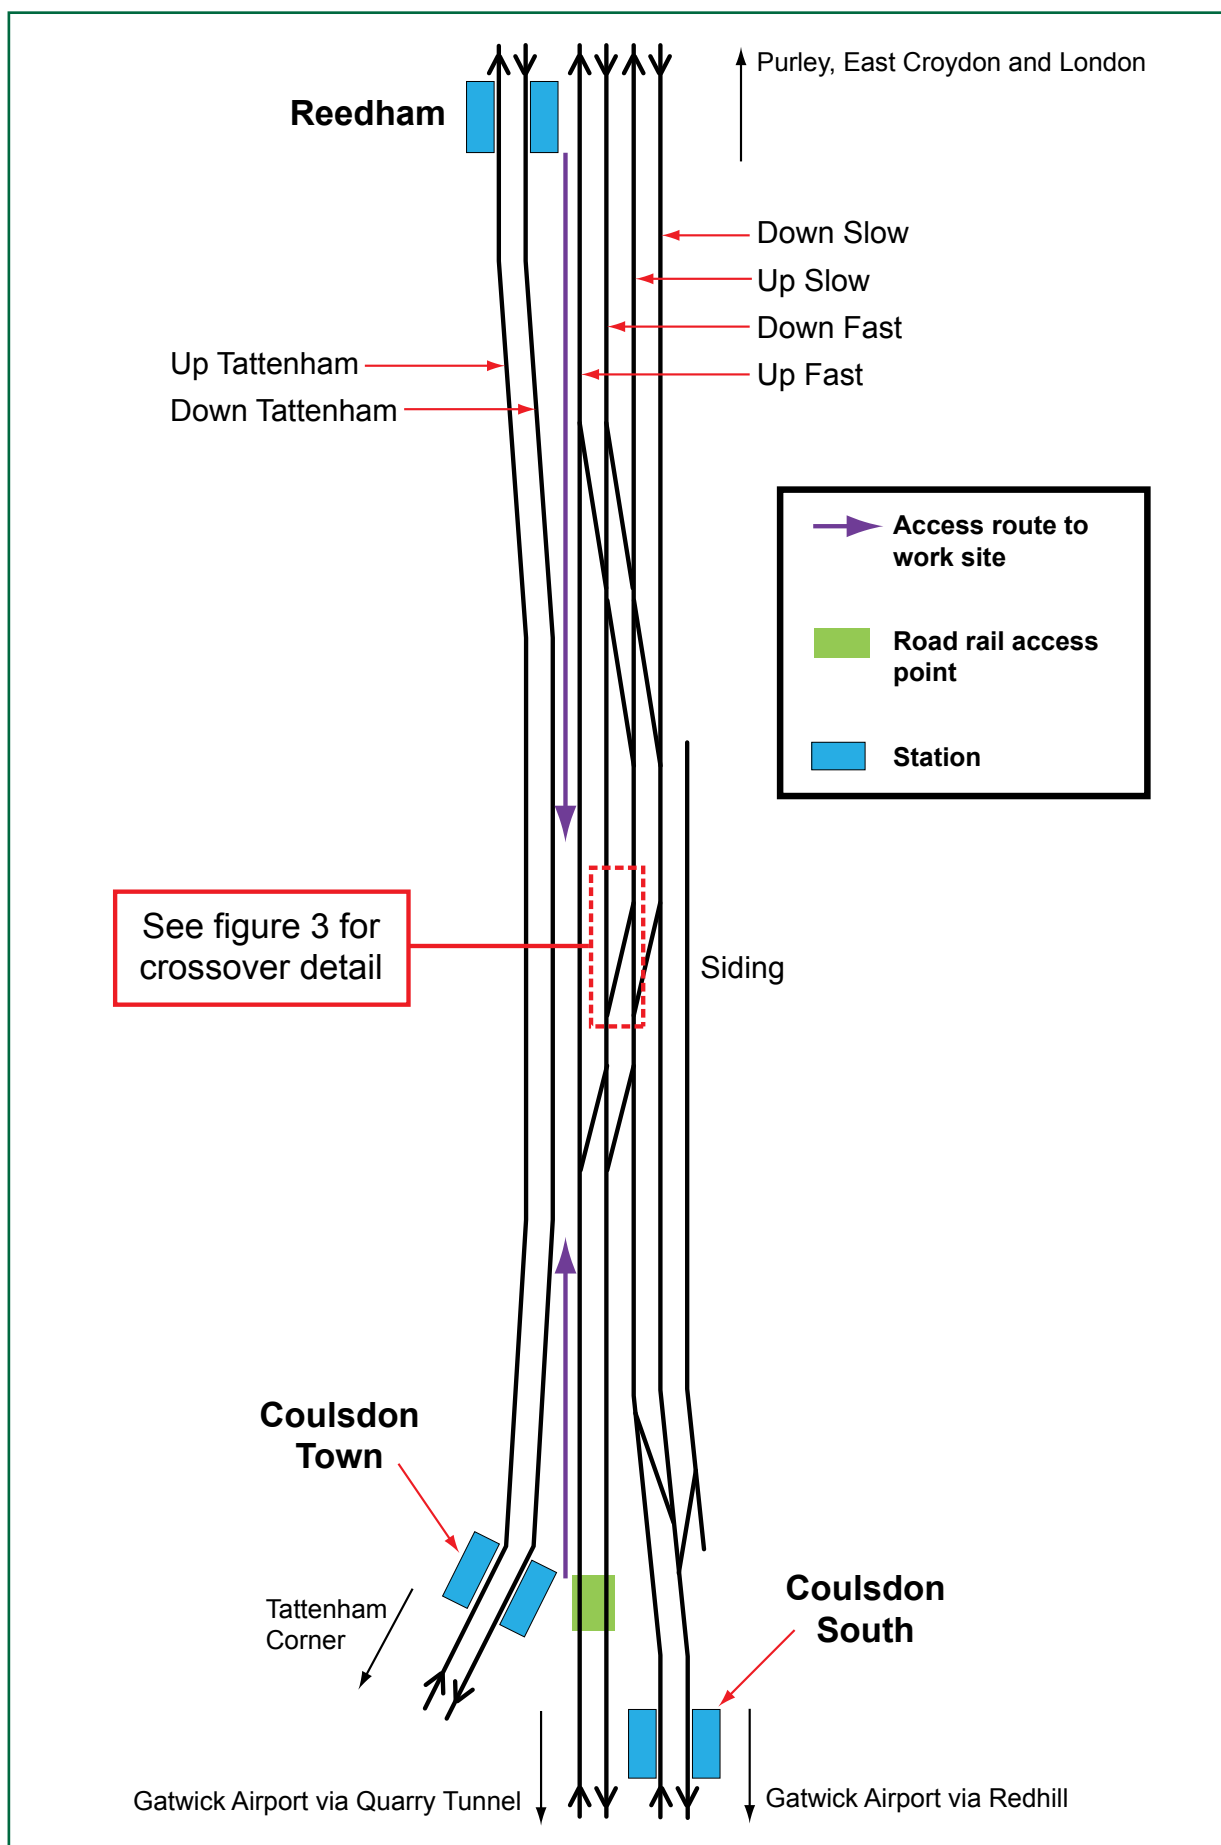
Figure 2: Track layout at Stoats Nest Junction

- 17 The route through Stoats Nest Junction is *quadruple track*, consisting of a pair of fast lines and a pair of slow lines. A series of *crossovers* connect the fast and the slow lines. There are also an additional two adjacent tracks, on the route to Tattenham Corner (figure 2).

- 36 The maintenance organisation at East Croydon depot had planned to replace the crossing of 1666A points, which was cracked, on the night of 11 June 2011. These points form part of a crossover between the down fast and up slow lines at Stoats Nest Junction (figures 2 and 3). This work was to be done during an engineering possession. Details of the possession arrangements are given in paragraphs 69 to 74.

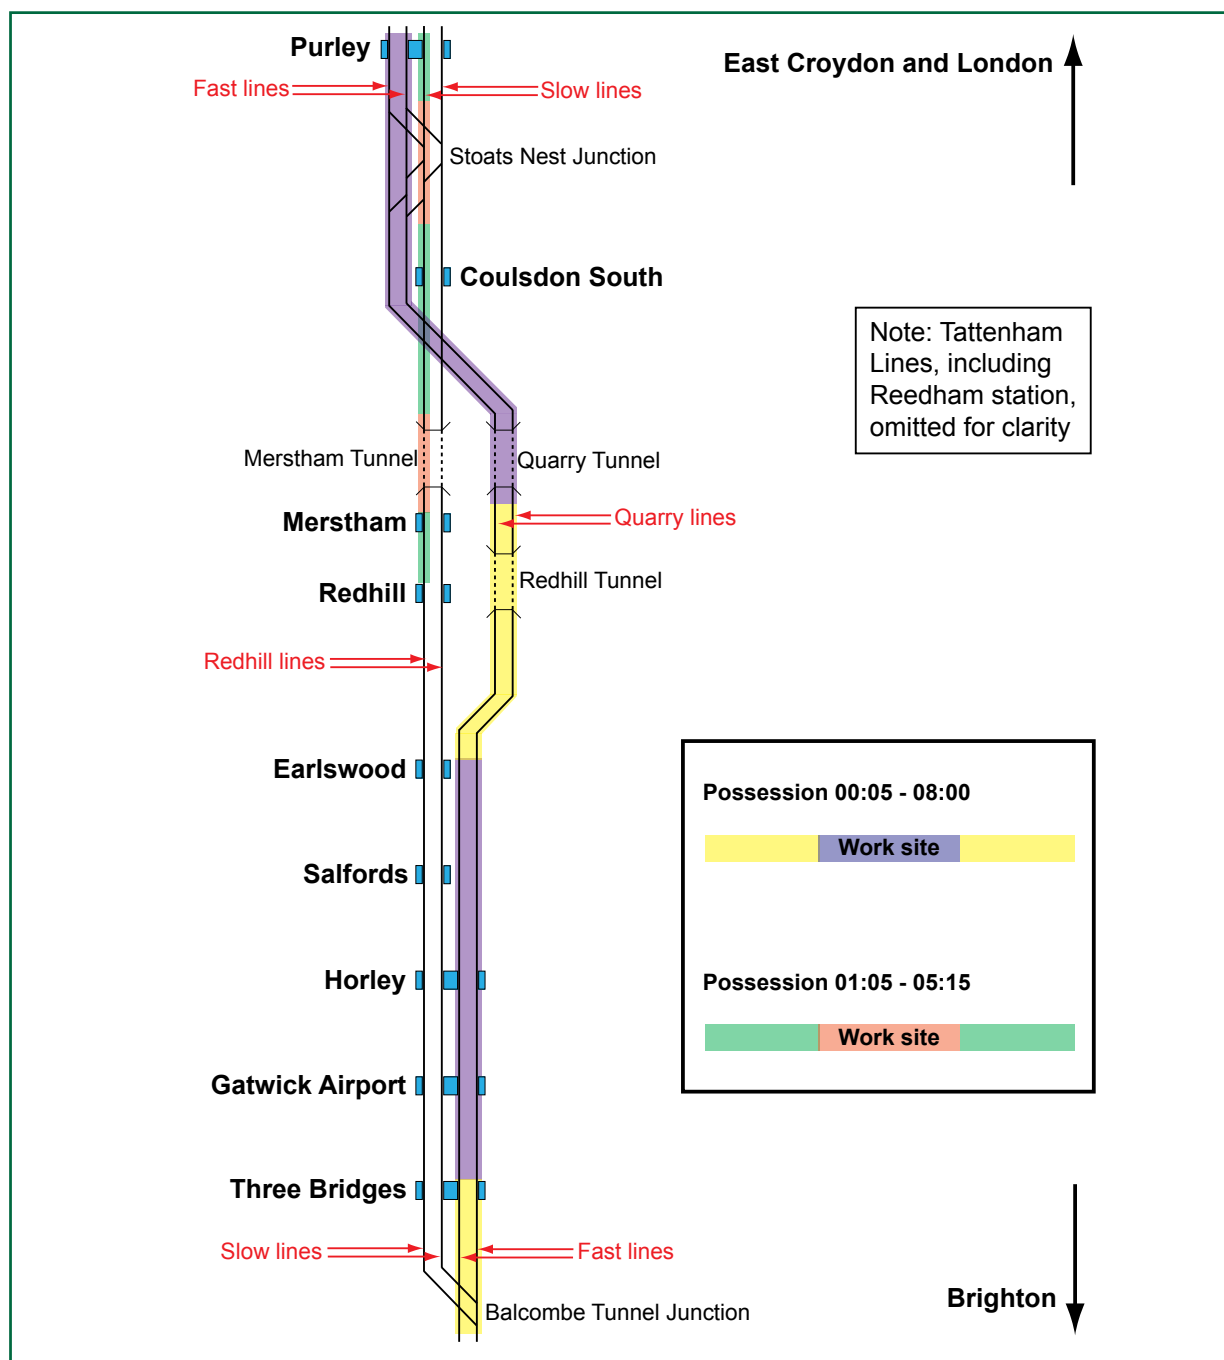
Figure 6: Simplified layout of the possessions

- 69 The work at Stoats Nest Junction on the night of 11-12 June 2011 was being carried out under a three part² possession of the lines between Purley and Balcombe Tunnel Junction (figure 6).

- 74 The work site associated with the crossing work extended from Purley (13 miles 21 chains) to Quarry Tunnel (18 miles 71 chains) on the up and down fast lines, and between 14 miles 0 chains and 14 miles 40 chains (in the vicinity of Stoats Nest Junction) on the up slow line (figure 6).
