# Rail Accident Report

## Container train accident near Althorpe Park, Northamptonshire 18 July 2011

# Container train accident near Althorpe Park, Northamptonshire, 18 July 2011

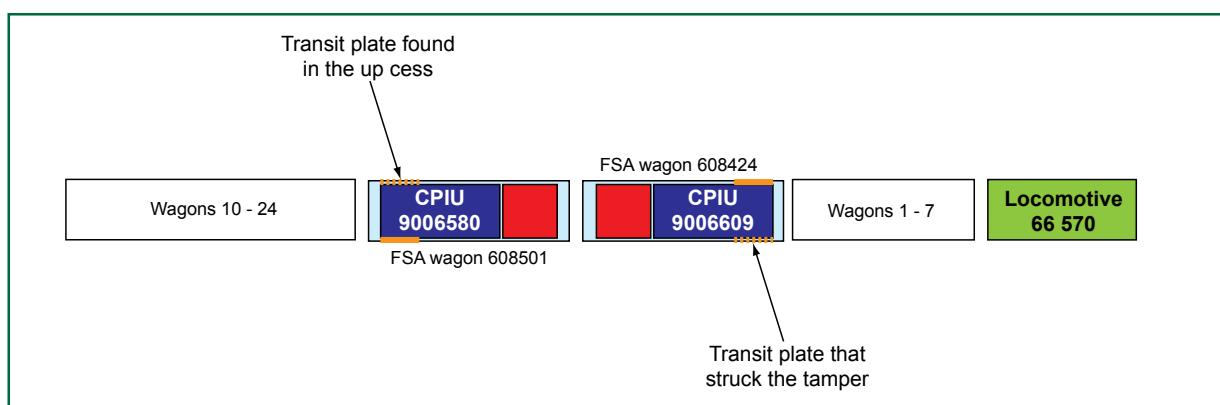
- 16 Train 4L68 comprised a class 66 diesel electric locomotive and 24 container flat wagons. One of the power-generation unit containers was loaded on the leading end of wagon 8; the other, on the trailing end of wagon 9. Both wagons were FSA-type wagons. The containers had ISO identification marks<sup>1</sup>, CPIU 9006609 and CPIU 9006580.
- 17 Figure 3 shows key aspects of the train configuration and position of the containers.

Figure 3: Configuration of train 4L68

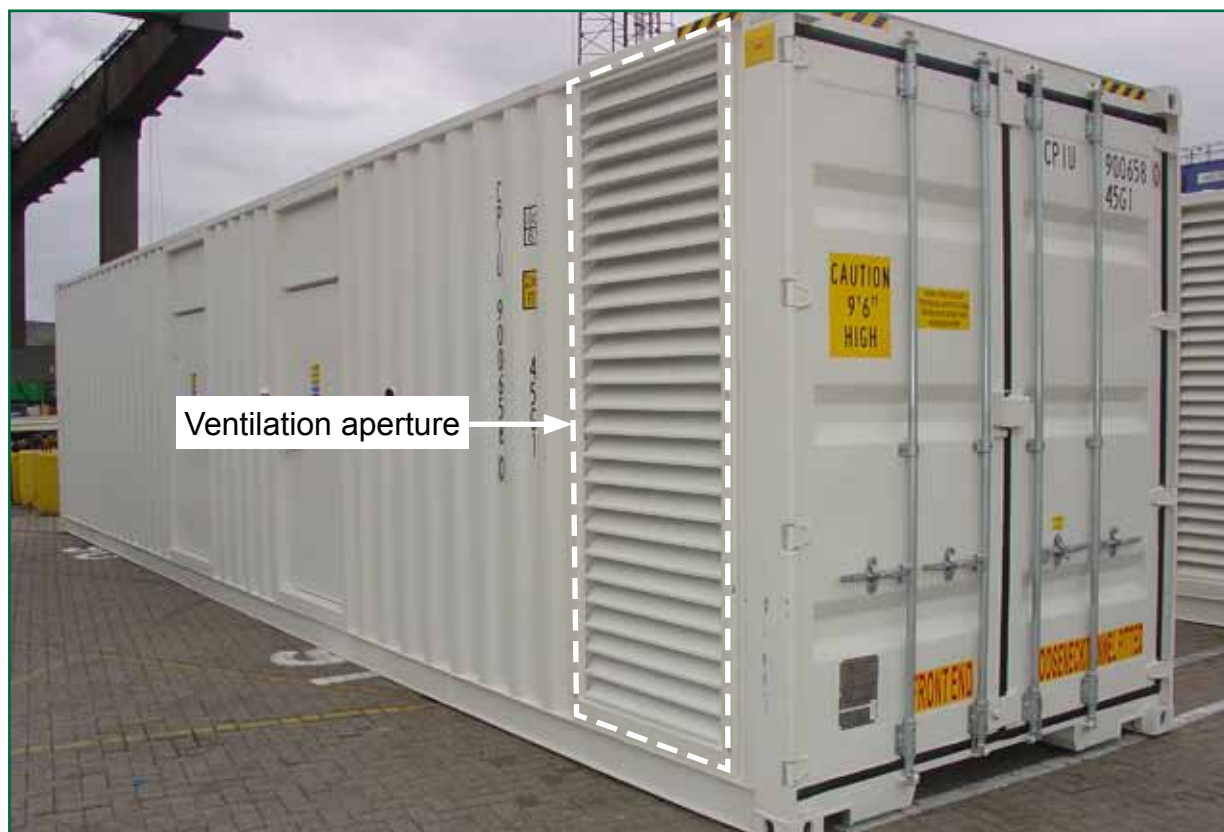
- 21 Two of the apertures, one in each container side, were to allow the necessary airflow into the enclosure when the power-generation equipment was running. These side ventilation apertures were fitted with open horizontal louvres (figure 4).

Figure 4: Container CPIU 9006580 showing the location of the side ventilation aperture

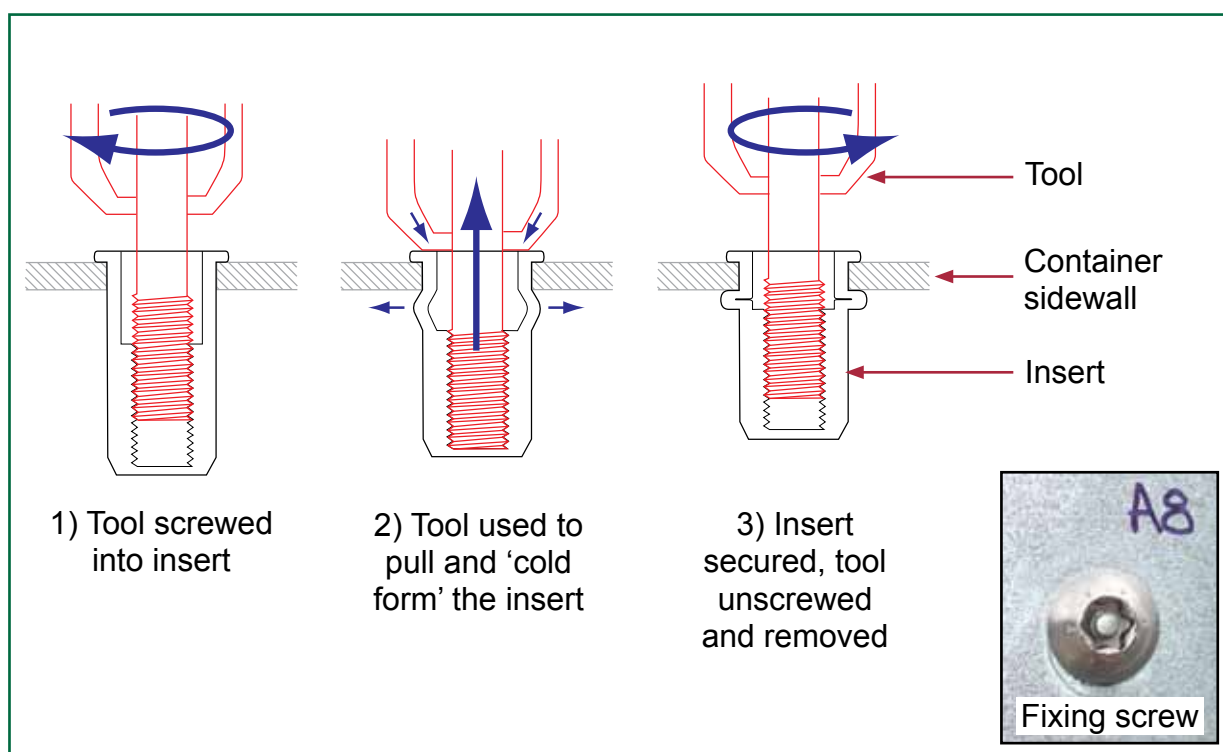
Figure 6: Threaded insert and fixing screw used to secure the transit plate

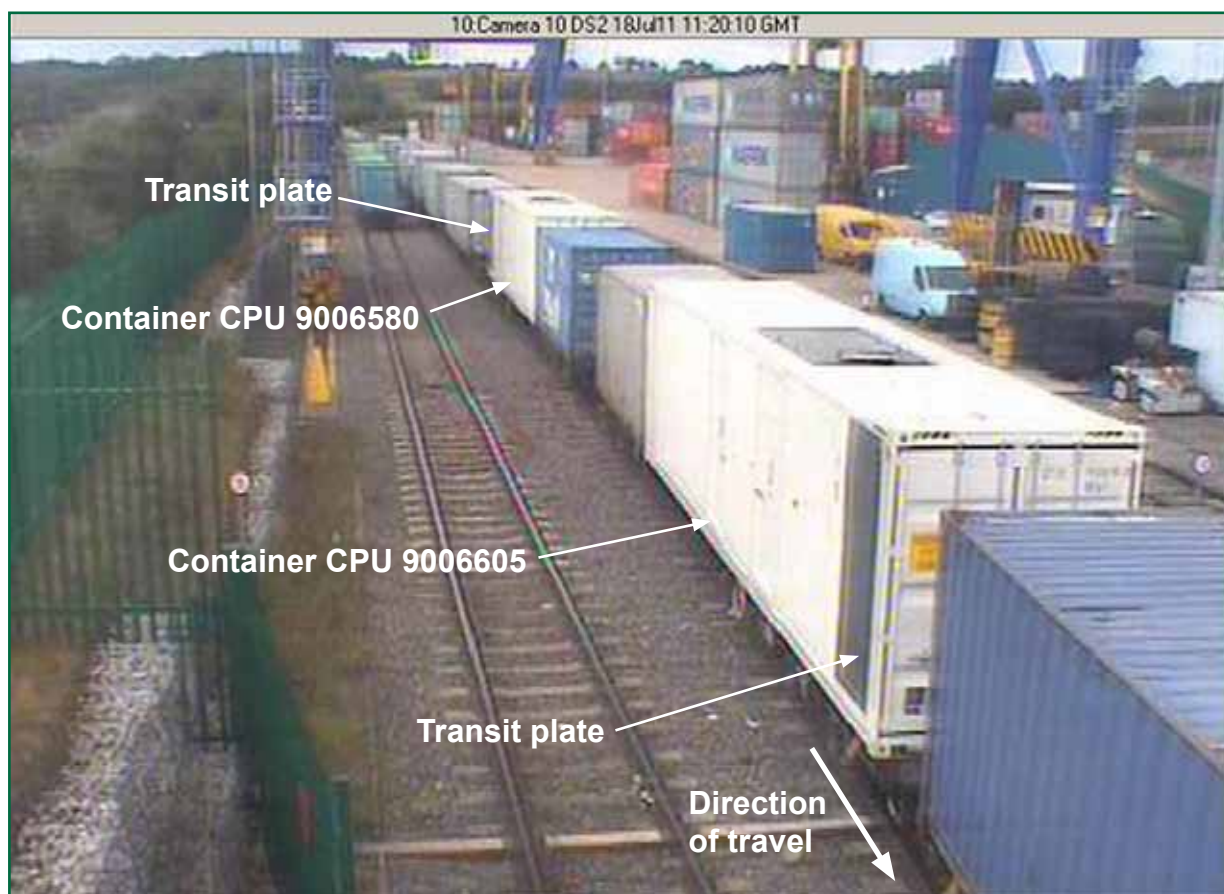
- 29 Train 4L68 departed from BIFT at 12:20 hrs. Footage from a closed circuit television (CCTV) camera at BIFT showed that the transit plates were in place as it left (figure 7).

Figure 7: CCTV image of the right-hand (six-foot) side of train 4L68 departing BIFT (image courtesy of Roadways)
