Rail Accident Report

**Derailment at Princes Street Gardens,
Edinburgh
27 July 2011**

Derailment at Princes Street Gardens, Edinburgh, 27 July 2011

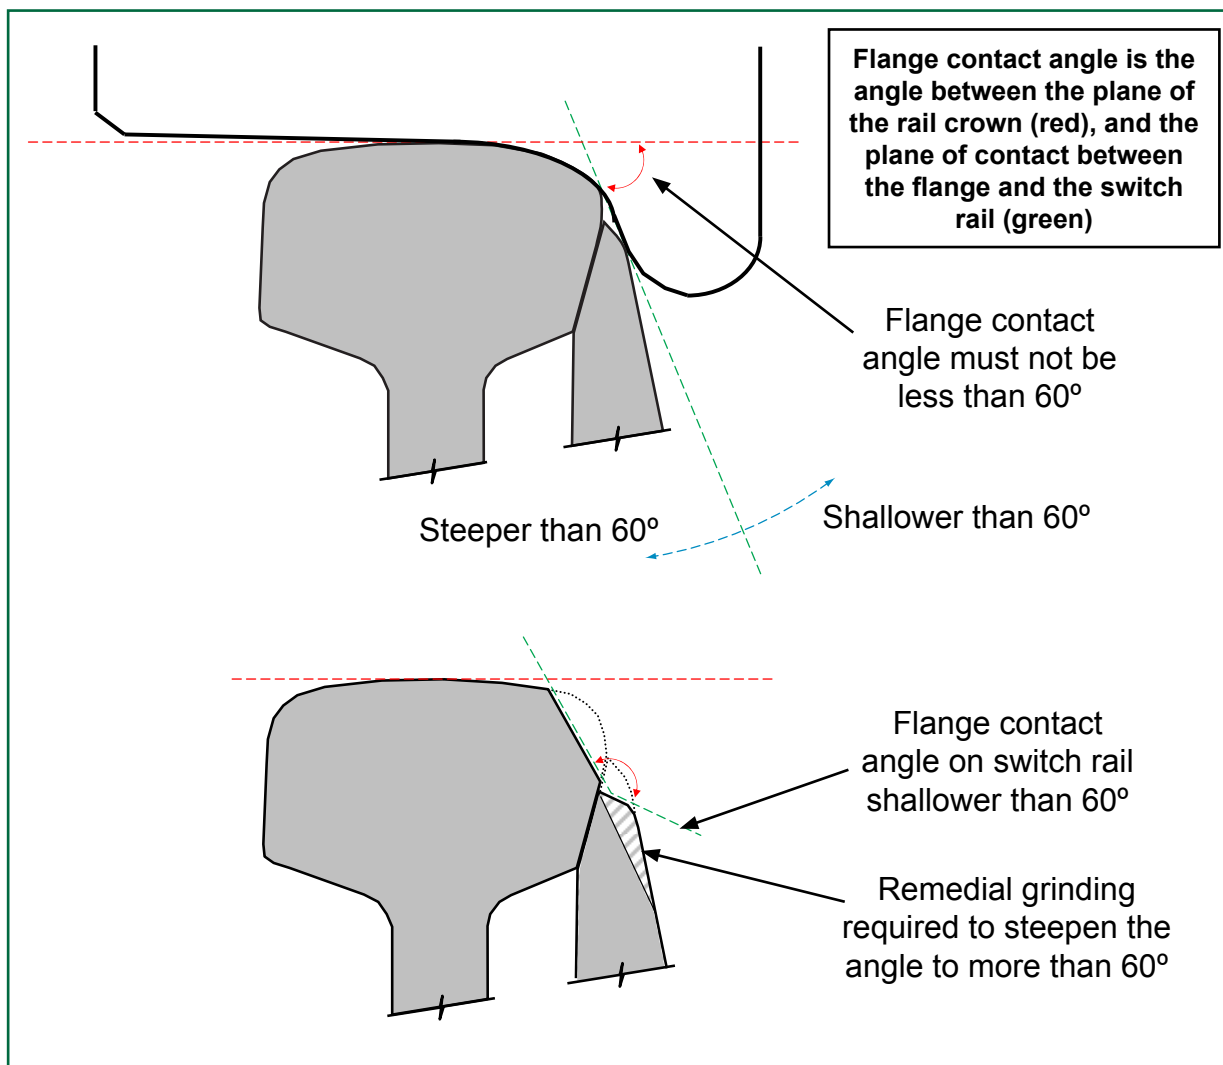
Figure 5: Illustration of derailment hazard 2 as defined by standard NR/SP/TRK/053 (issue 5)

- 36 The technical officer found the left-hand switch rail of points 167B was not compliant with the 053 standard because it failed to meet certain safety limits (paragraphs 79 to 80). The main concern was that the *flange contact angle* that the switch rail presented to the wheel flange was too shallow (figure 5) and therefore had the potential for causing a derailment. Consequently, an urgent grinding repair was organised for the following night shift on 24/25 July 2011 to restore a steeper angle on the switch rail that would meet the standard (paragraphs 82 to 83). In the interim, the switch rail remained in use for traffic.

- 55 A change in the flange contact angle to present a shallower angle to the train wheel (figure 5) in the early part of a sideworn switch (where the switch rail is steering the wheel to the turnout route) can increase the risk of derailment. Wheels that encounter such a change of contact angle may, depending on such factors as the amount of friction between the switch rail and wheel, vehicle suspension characteristics, and the speed of the train, climb up the *gauge face* of the switch rail. This is known as 'flange climb'. From there wheels can either drop back down or continue on to the top of the switch rail and take the other route. Wheel flanges usually leave visible marks on the switch rail to indicate where this is happening.

⁷ A flange contact angle of at least 60° or steeper (ie more than 60°) minimises the risk of a derailment occurring should a high coefficient of friction develop between the wheel and the rail (figure 5).

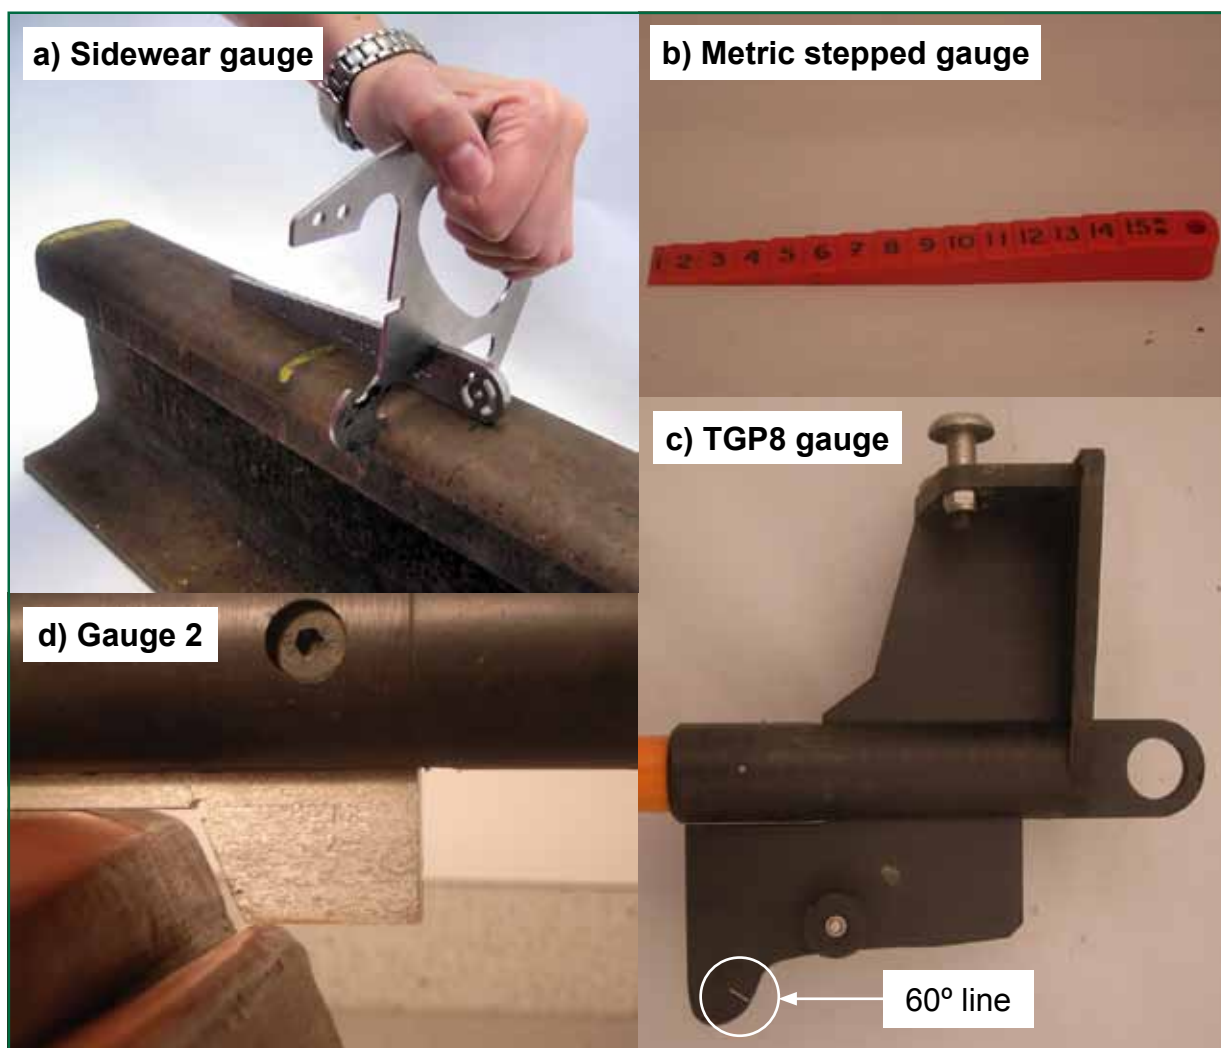
Figure 14: Gauges used in the inspection of switches

- 56 The Network Rail TGP8 gauge has the profile of a P8 wheel and is used to show where the wheel flange can contact the switch rail (appendix D and figure 14c). There is a line marked on the gauge representing a flange contact angle of 60° which is the intervention limit for derailment hazard 2⁷. A switch will fail a detailed inspection to the 053 standard if there is contact below the 60° line on the TGP8 gauge for more than 200 mm on the rail. The limit changes, however, after a grinding repair, where any single contact on or below the 60° line causes the switch to fail the inspection.

- 57 The TGP8 gauge is normally applied in the first metre of the switch rail where the wheel flange makes first contact with the switch rail. However, switch rails that are reduced in height because they have previously been ground or worn near the toe may not make first contact with the wheel flange until further into the switch and it will then be necessary to check the flange contact angle beyond the first metre. The need to extend the length of switch rail inspected is determined by gauge 2. If gauge 2 passes over the switch rail (appendix D and figure 14d) in the first metre, then the distance over which the TGP8 gauge is applied increases from one metre to three metres.
