Rail Accident Report

Derailment at Bordesley Junction, Birmingham **26 August 2011**

This report is published by the Rail Accident Investigation Branch, Department for Transport.

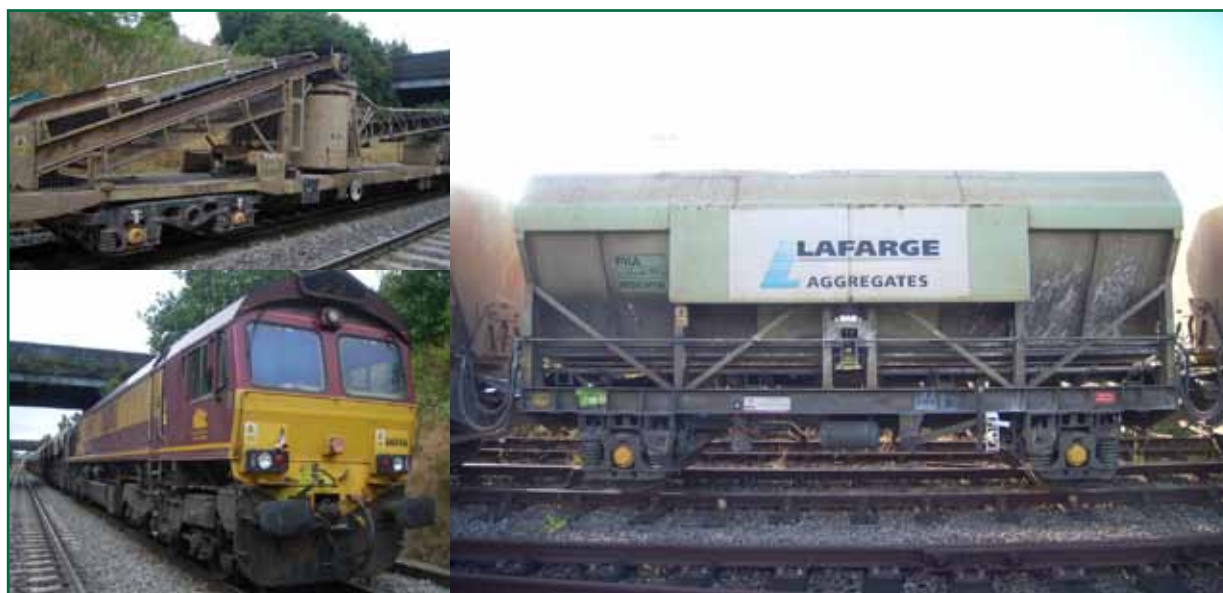
Figure 5: Train 6Z31 showing a PHA wagon (right), a KJA wagon (top left) and the locomotive (bottom left)

- 16 The freight train that derailed was 6Z31, the 23:45 hrs service from Banbury Redland Stone sidings to Barrow-on-Soar. It consisted of a class 66 diesel electric locomotive hauling 30 two axle *hopper wagons*, type PHA, and an unloading wagon, type KJA (figure 5). The train was 290 metres long. All of the wagons were empty giving a trailing weight of 472 tonnes.

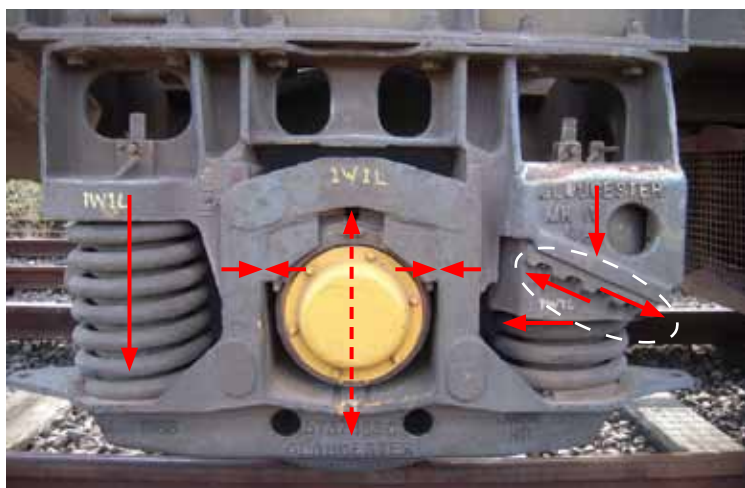
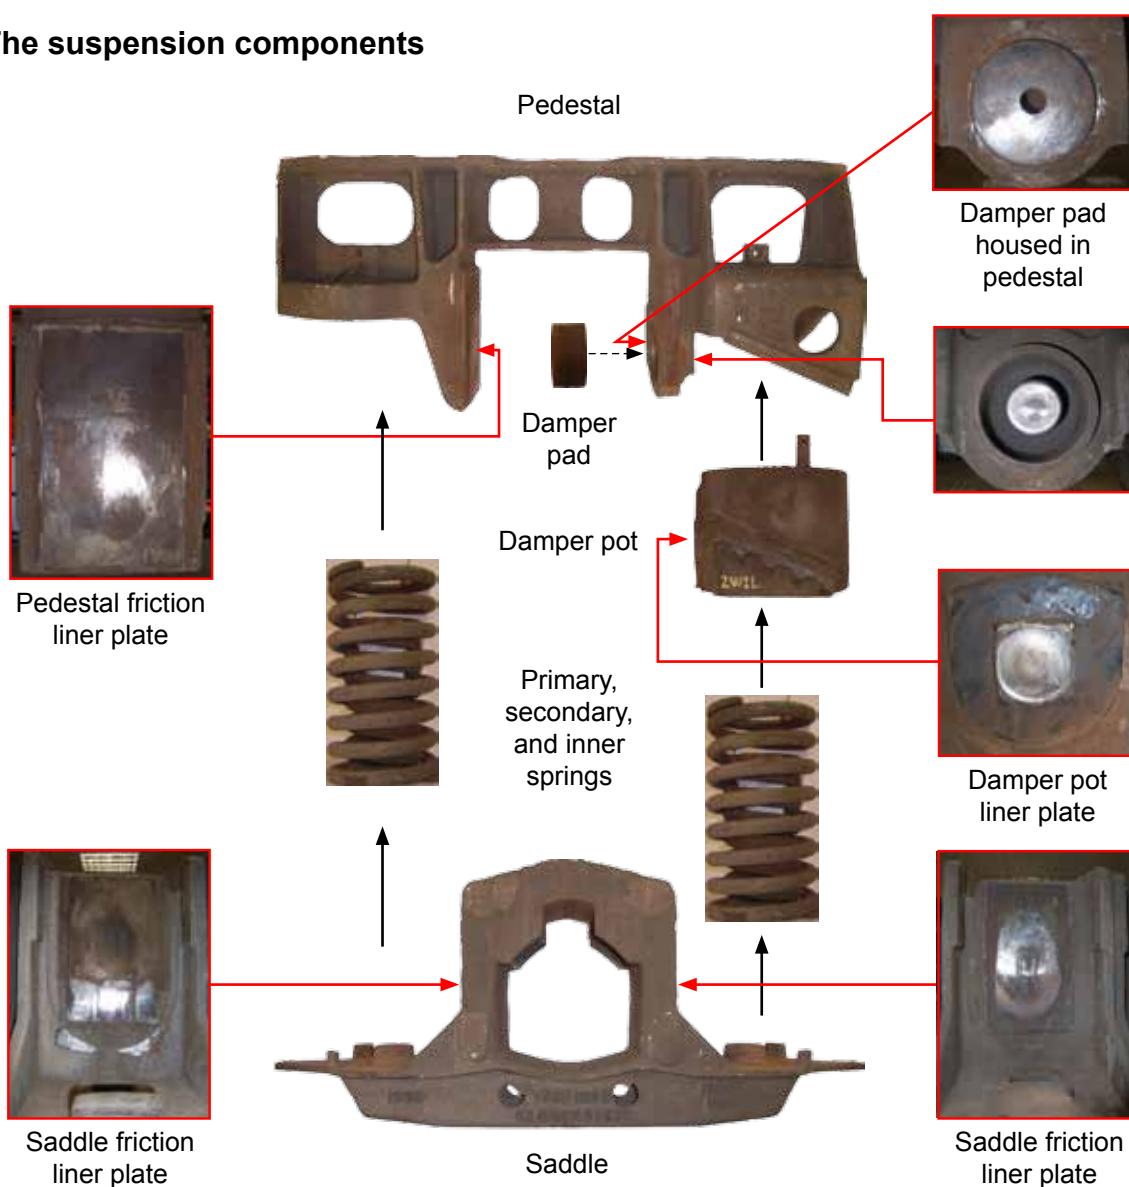
Figure 7: The Mark 4 Floating Axle Suspension

- 44 The suspension used by the PHA wagon was manufactured by the Gloucester Railway Carriage and Wagon Company in 1987 and is known as a Mark 4 Floating Axle Suspension (figure 7). This suspension unit has a *pedestal* (also known as an axle horn guide) bolted to the underside of the frame. A *saddle* sits on the axle bearing and slots into the pedestal.

Wedge between pedestal and damper pot to convert vertical force into a horizontal force which damps movement of the saddle

- 45 The saddle supports primary, secondary and inner top hat or 'cup' springs. The spring arrangement is fixed with a retaining pin known as an 'anti-separation pin' running through the centre. The springs are located between the pedestal and the saddle and are compressed by the weight of the wagon.
- 46 On the inner side of the saddle, a *dampener pot* is located between the top of the springs and the pedestal. The weight of the wagon and its payload acts upon a pair of wedges between the pedestal and the damper pot. The damper pot converts the downwards force into a horizontal force which pushes a *dampener pad*, housed inside a hole in the pedestal, against a friction liner plate on the saddle, to damp the vertical movement of the saddle. The damping force thus changes according to the load.

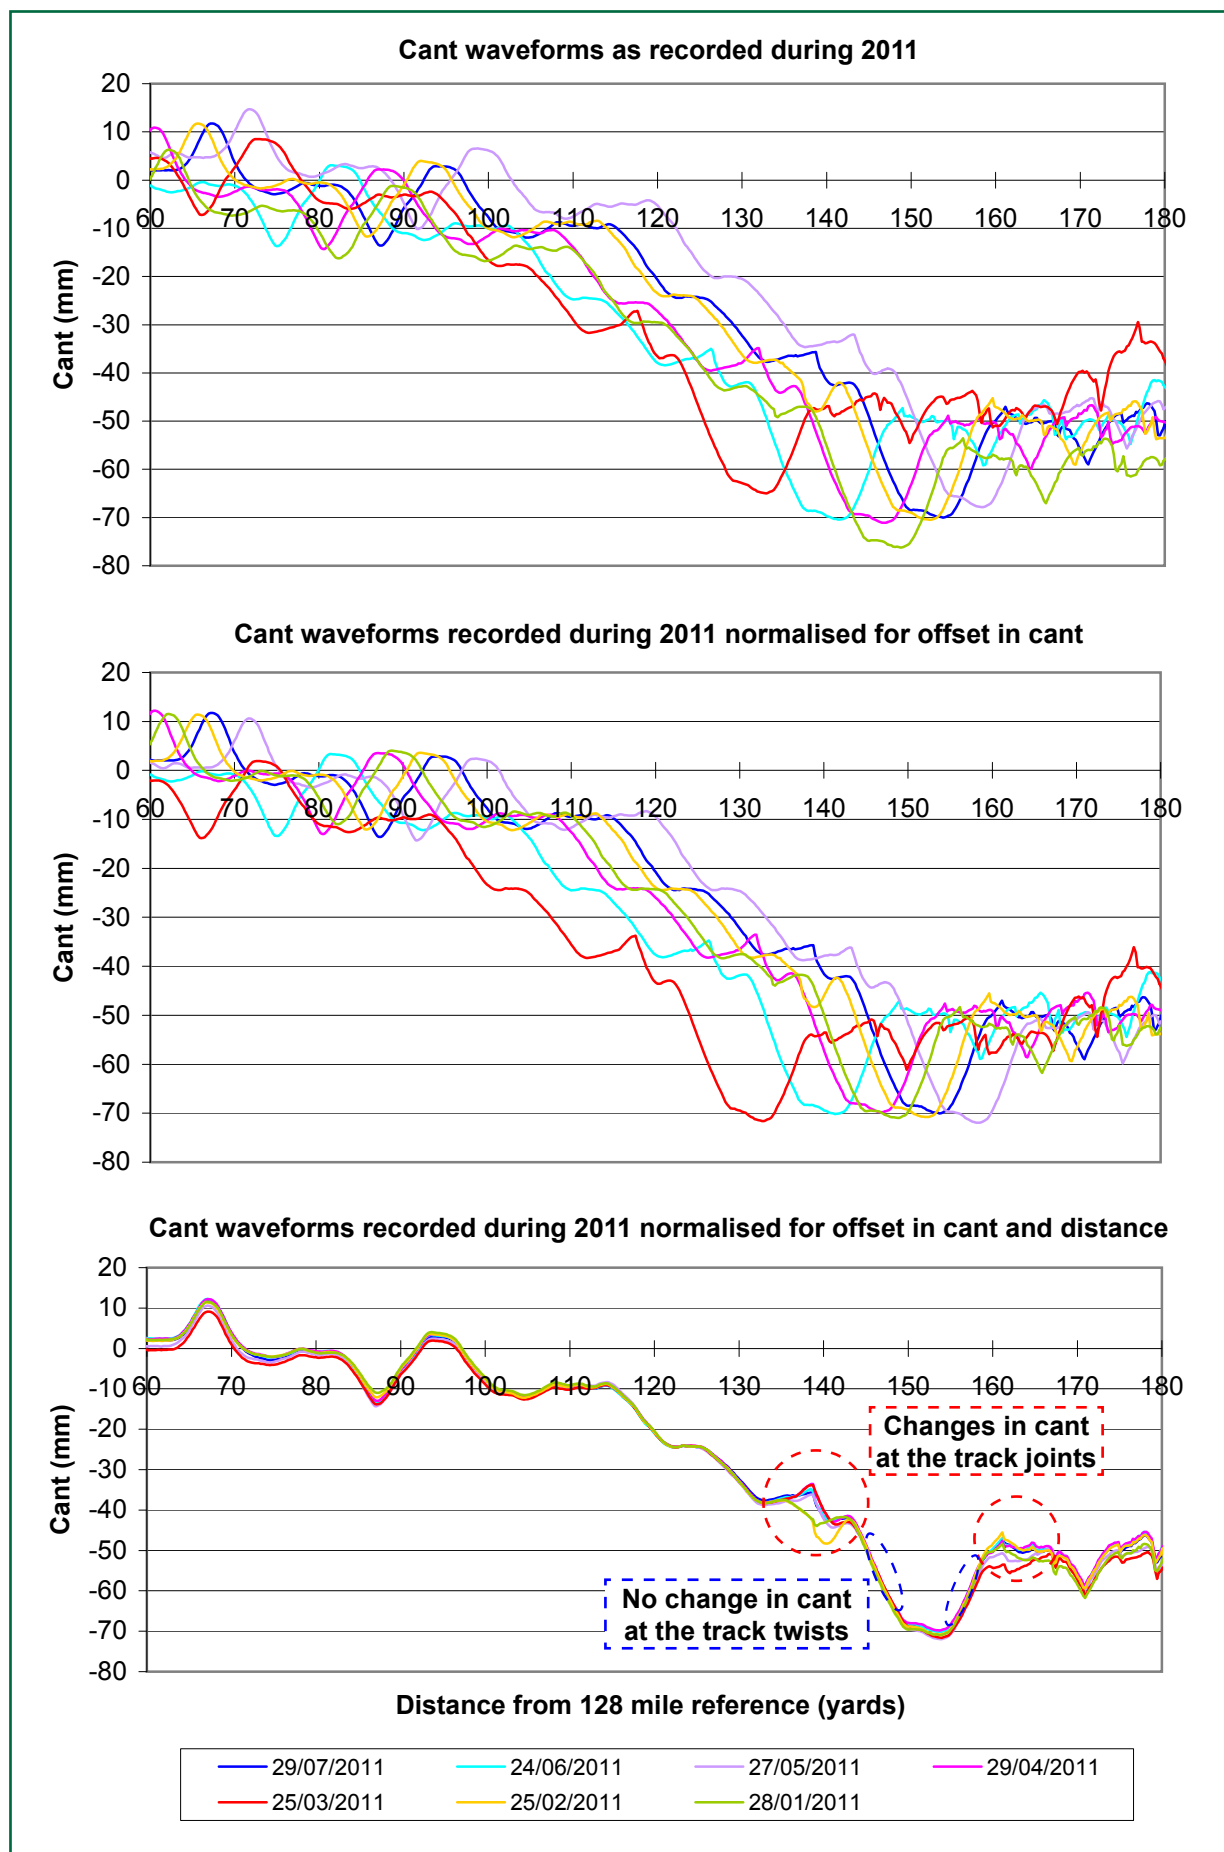
Figure 17: Graphs showing how cant changed during 2011

- 113 Each time the track geometry recording train finds a fault that requires intervention, the type of fault together with a mileage for its location, is included on an action sheet issued to the local maintenance team. Network Rail's records show that a maintenance team was going out to fix these faults and they were being signed off as repaired within 14 days. The RAIB analysed the track geometry data from 2011 and aligned the waveforms for cant (figure 17) to take account of offsets in both the cant and mileage. This showed that the location information for the same track twist varied from one track recording run to the next. The mileages recorded for the same track twists differed over a range of 25.6 yards (23.4 metres).

- 115 From witness evidence and analysis of the track geometry data, the RAIB concluded that the repair work was being carried out in the wrong place, either side of the track twists. The maintenance team were carrying out measured shovel packing repairs at a track joint before the first track twist and at the joints within the switches and crossing for the junction after the second track twist (figure 18). Figure 17 shows the cant waveforms measured by the track geometry recording trains in 2011. The cant reaches a peak of about 70 mm, with it changing at a rate of about 1 in 200 either side of this peak, which is just on the threshold for a reportable track twist (paragraph 112). The aligned cant waveforms for the section of track with the track twists did not change throughout 2011, but it did change over time in the vicinity of the joints which was as a result of the work done by the maintenance team.

- 116 The maintenance team had carried out similar repairs at these joints several times in the past. When the team had gone out to do the repairs, they had measured and found changes in the cant at these joints, so that was where they did the work to lift and pack the track. They did not measure the cant in the section of plain line between the joints, so they did not find the reported track twists. Therefore the track twists went unrepaired.
