Rail Accident Report

Collapse of the overhead line near to Jewellery Quarter Tram Stop, Midland Metro 20 April 2011

This report is published by the Rail Accident Investigation Branch, Department for Transport.

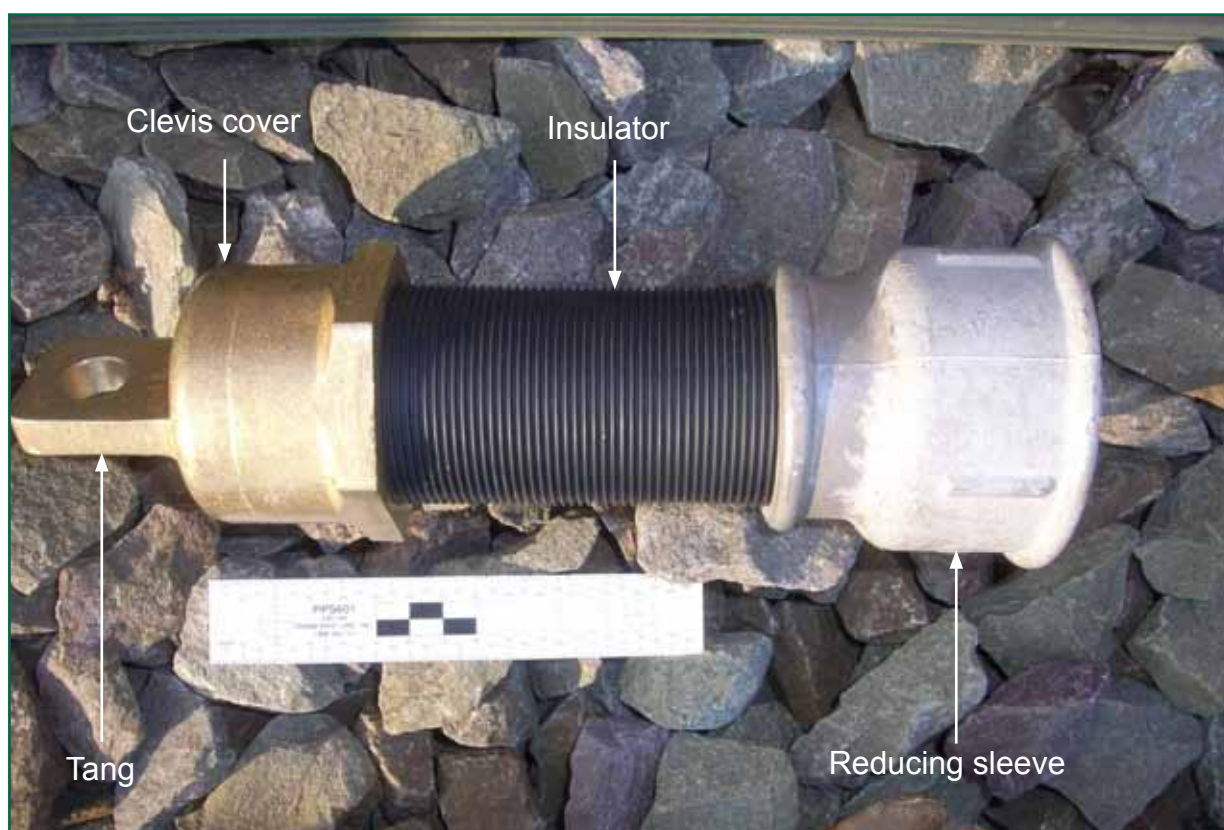
Figure 6: Bracket foot assembly

- 61 **The partial detachment of the cantilever at 18512 pole was due to the fracturing of the reducing sleeve.**
- 62 Examination of the bracket arm showed that the bracket foot assembly (figure 14) had parted at the point where the nylon insulator threads into the reducing sleeve, leaving both items damaged. The clevis cover and insulator remained attached to the pole bracket by the clevis pin, with the main body of the reducing sleeve remaining with the cantilever. The examination also found that the delta suspension connecting to the contact wire on the Wolverhampton line had been ripped from the clamp connecting it to the cantilever (figure 15) and that the register arm on this line was also disconnected. The Wolverhampton out-of-running pulleys had become separated from the cantilever at 18512 pole, although the out-of-running ropes and contact wires remained intact.

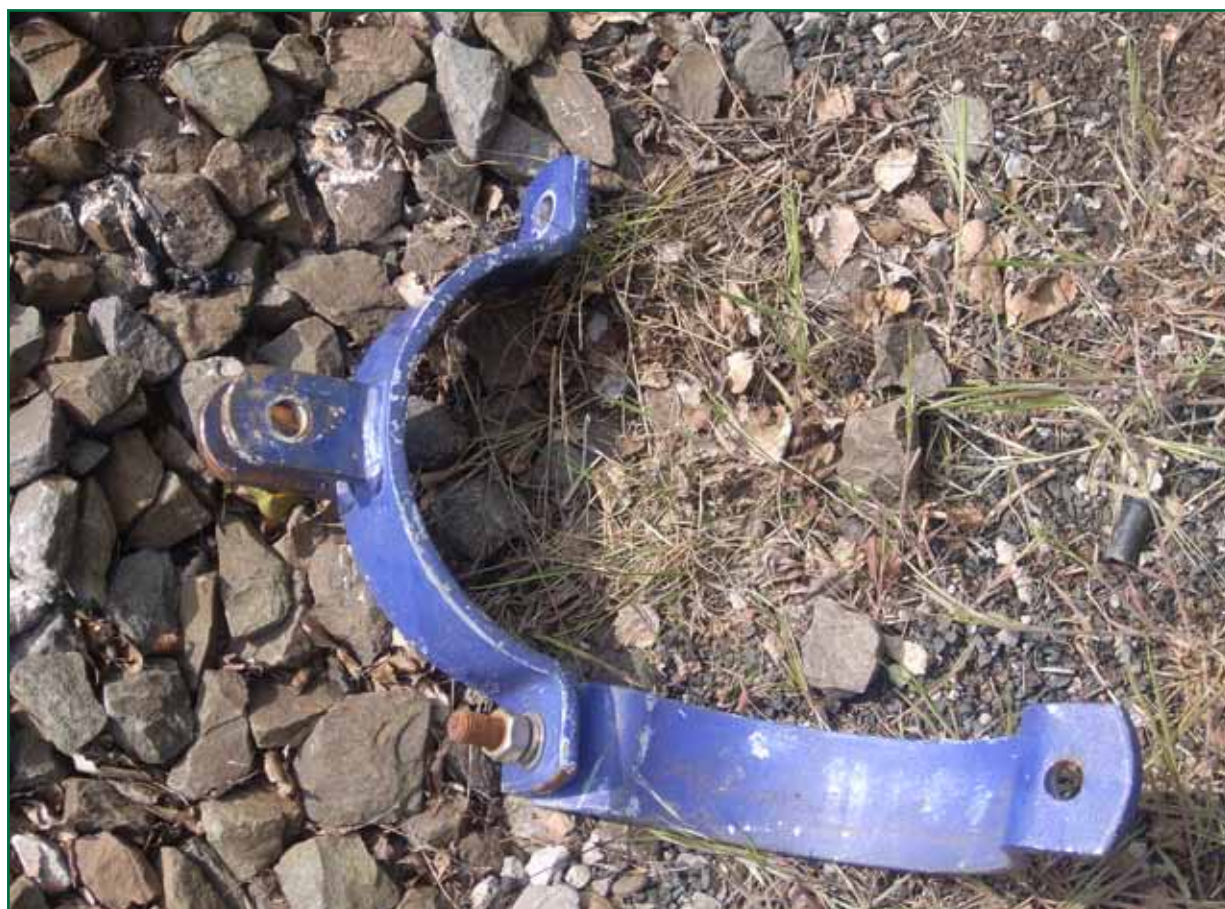
Figure 19: An example of a modified design of pole bracket

- 89 The pole bracket fitted to 18512 pole at the time of the accident was of the modified design (paragraph 35), made of steel and with a rounded clevis (figure 19). This design had a longer clevis than the original design (figure 20) and so could contact the clevis cover of the bracket foot assembly when the two items were pressed together under the action of the operating loads.

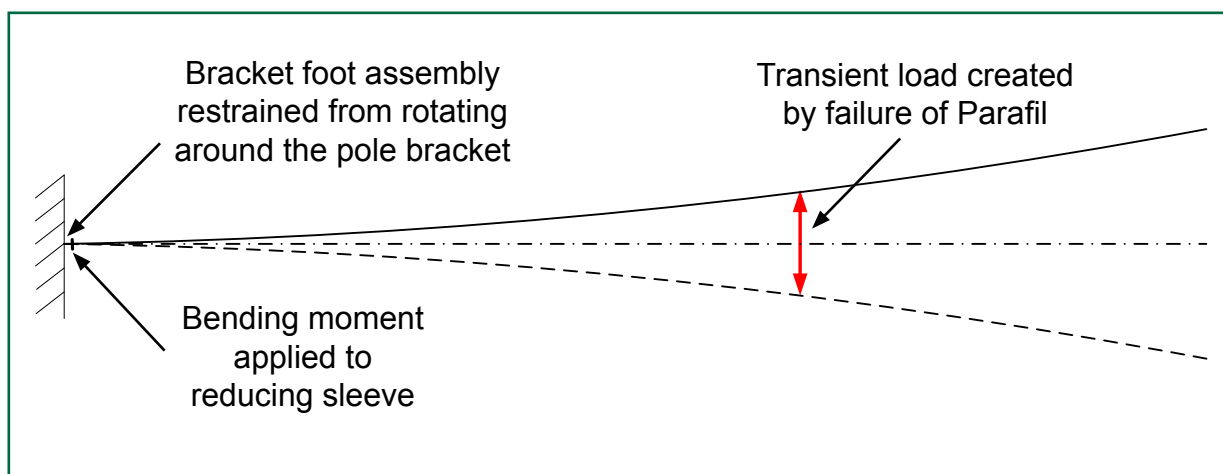
- 118 The RAIB undertook Finite Element Analysis of the transient abnormal loads which could be created by the failure of the outer Wolverhampton in-running Parafil rope. This demonstrated that a load of this nature could cause the reducing sleeve to fail if:

- the bracket foot was restrained from rotating around the pole bracket pin; and/or
 - the cantilever became fixed at some point along its length, creating a pivot.

Figure 26: Diagrammatic representation of the bracket foot being restrained from rotating around the pole bracket pin and a transient load was created by the failure of the Parafil

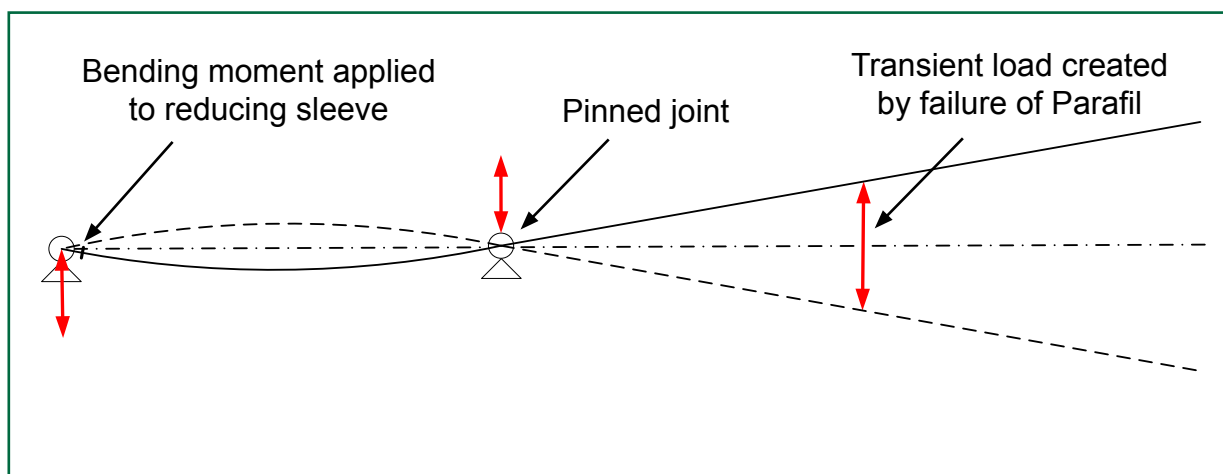
Figure 27: Diagrammatic representation of the cantilever becoming fixed at some point along its length and a transient load being created by the failure of the Parafil
