# Rail Accident Report

**Fatal accident at Grosmont, North Yorkshire  
Moors Railway  
21 May 2012**

Report 23/2012  
October 2012

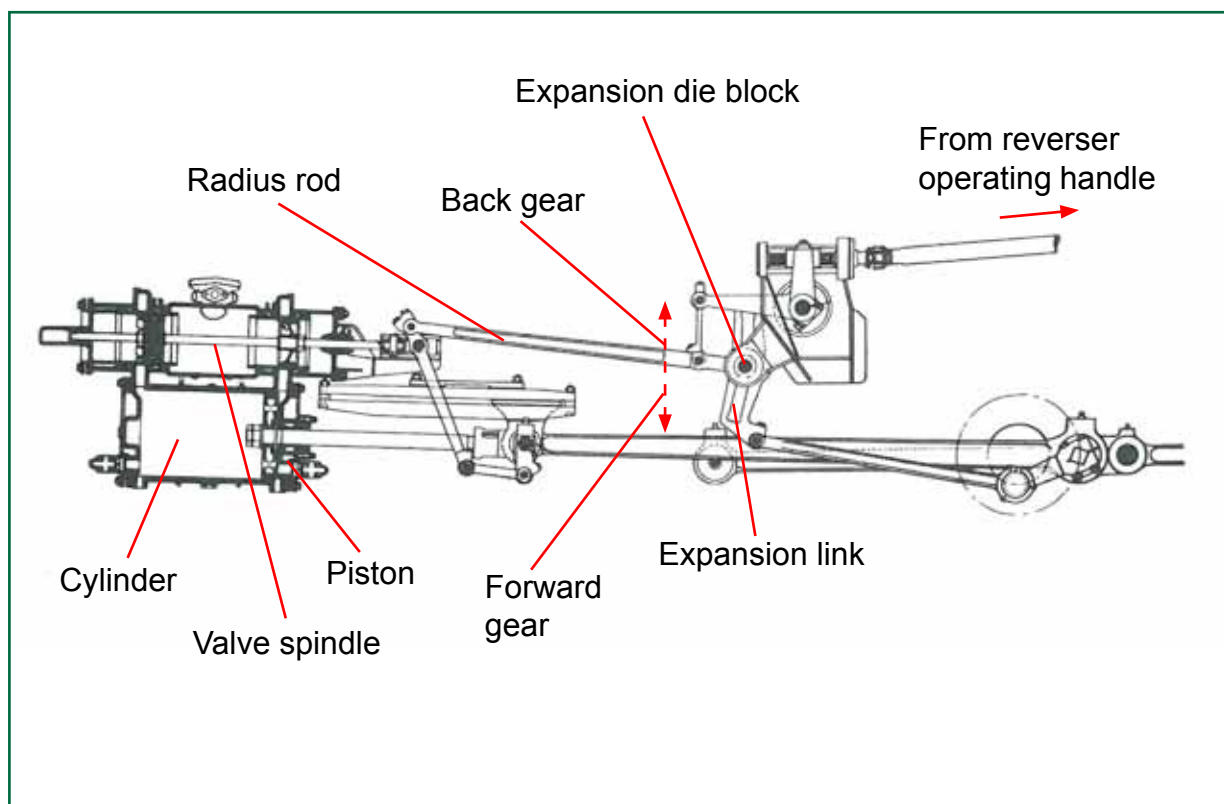
Figure 6: Diagram of typical valve gear (as fitted to S15 class locomotive no.825) shown in the mid-gear position

- 12 When the reverser is operated to alter the position of the valve gear from full forward gear towards mid-gear and then (if the locomotive is required to go backwards) into reverse (back) gear, its mechanism lifts one end of both radius rods, each of which is able to slide in its associated expansion link (figure 6). If the reverser is not restrained, the weight of the radius rods then acts to try and pull the valve gear to full forward gear, altering the position of the reverser. To prevent this movement, screw reversers are fitted with locking devices.
