## **Rail Accident Report**

Derailment at Bletchley Junction, Bletchley 3 February 2012

Report 24/2012 November 2012 This investigation was carried out in accordance with:

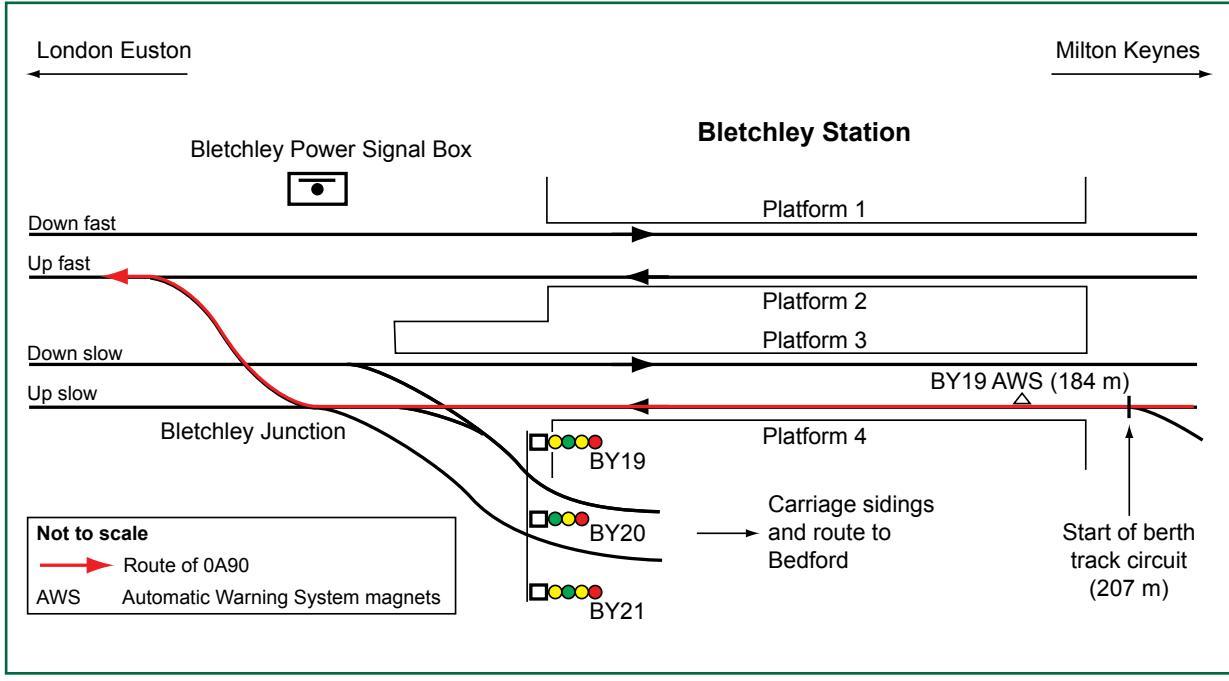
Figure 4: Track layout of Bletchley Junction (distances shown are from BY19 signal)

- 9 Bletchley Junction is on the West Coast Main Line which is electrified with 25 kV overhead equipment. There are four tracks designated from east to west; up slow, *down* slow, up fast and down fast. It is located immediately south of the platforms of Bletchley station and is 46 miles 43 chains, measured from a datum of zero miles, north of London Euston. The junction enables trains to be switched from the up slow line to the up fast line (figure 4).

- 47 For crossing moves to the up fast line, signal BY19 clears from red to a proceed aspect (providing the route ahead is clear) once the approaching train occupies the track circuit (known as the berth track circuit) that extends from a point 207 m on the approach to signal BY19 (figure 4). The signal changes to a proceed aspect and the alphanumeric route indicator displays the letter 'F' (figure 2) to advise the driver that he is taking the diverging route at the junction.

- 48 The automatic warning system magnets associated with signal BY19 are located between the running rails 184 metres on the approach to it (figure 4). The indication given to the driver by the automatic warning system will depend on the aspect displayed by signal BY19 (paragraph 40).

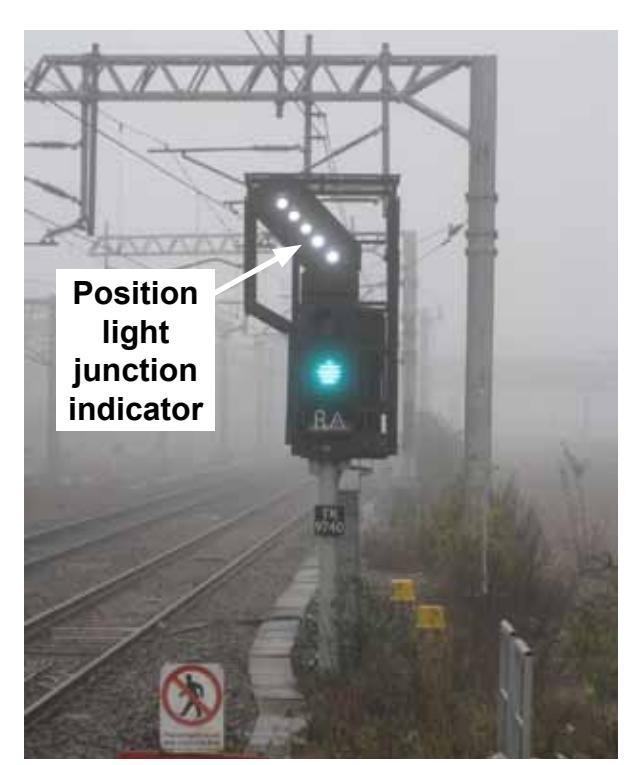
Figure 6: Signal fitted with a position light junction indicator (showing the junction ahead of the signal is set for a diverging movement to the left)

- A position light junction indicator (often referred to as a 'feather') which indicates the route to be taken by the angle at which a row of white lights is displayed (figure 6). It is designed to be able to be read<sup>5</sup> from a maximum distance of 800 m and is usually the preferred choice for simple junctions at any speed.

87 Position light junction indicators (paragraph 46) are significantly brighter than the alphanumeric type fitted to signal BY19, and their physical form (figure 6) gives a clearer indication that a diverging route is to be taken. Had one been fitted to signal BY19 rather than the alphanumeric indicator, it would probably have appeared to be more prominent in the driver's view. Therefore, it is possible that had a position light junction indicator been fitted, the driver of train 0A90 would have perceived it and been alerted to the fact that he was taking the diverging route.
