Rail Accident Report

Fatal accident at James Street station, Liverpool 22 October 2011

Report 22/2012
October 2012

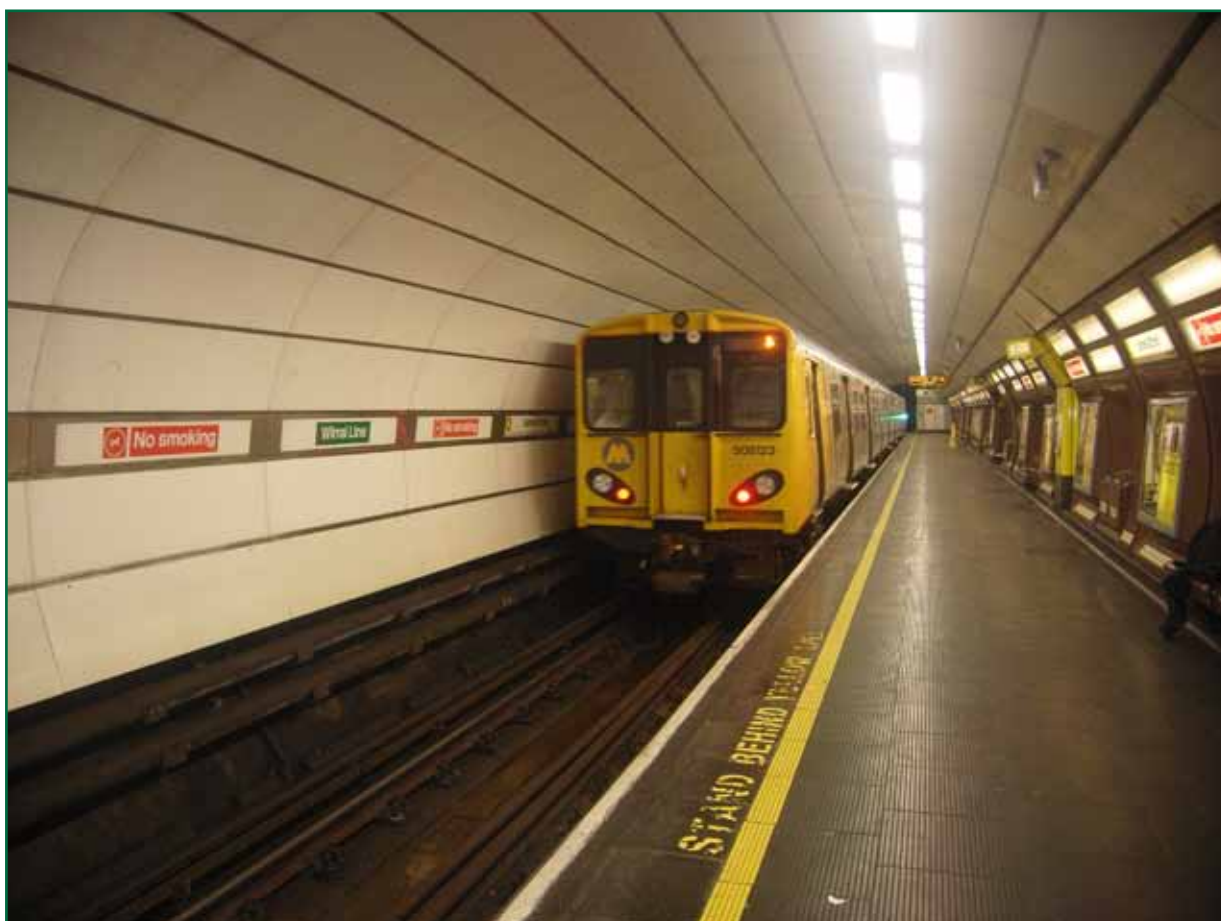
Figure 2: James Street station platform 1

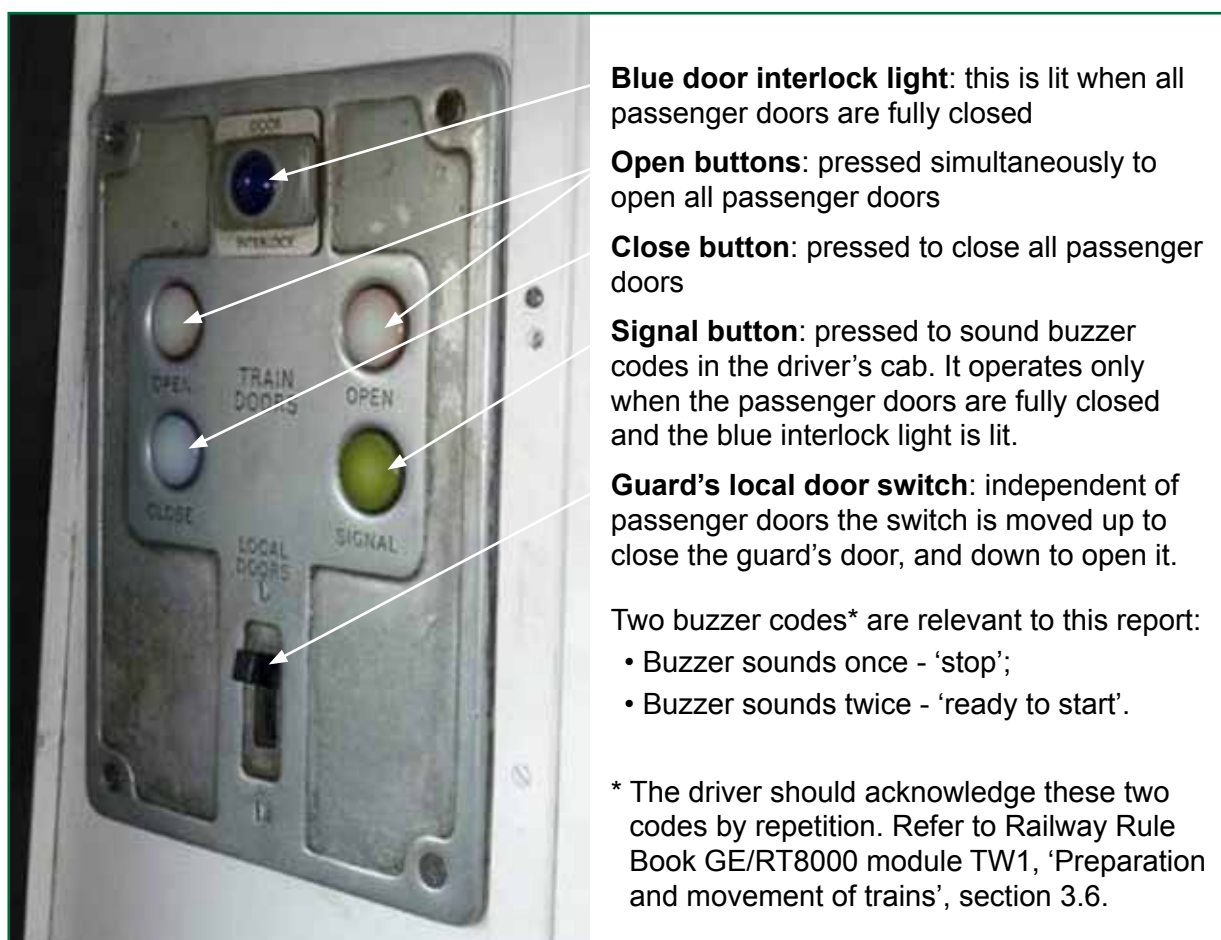
- 8 The young person first left the train at Meols, the first stop after Manor Road. When the guard pressed the door close button on his control panel (figure 3), the young person's friends held the passenger doors open and called for her to rejoin the train. The guard walked down the platform from his position at the rear of the train to investigate why the passenger doors had not closed. However, the young person had boarded the train and the doors had closed before he reached them, so he returned to his control panel and dispatched the train. The guard recalled seeing the young person on the platform before she got back on board and recalled that she appeared to be under the influence of alcohol. Figure 4 shows the train's layout and the guard's position at the rear of the train in an area separate from the passenger saloon.

Figure 3: The guards' control panel

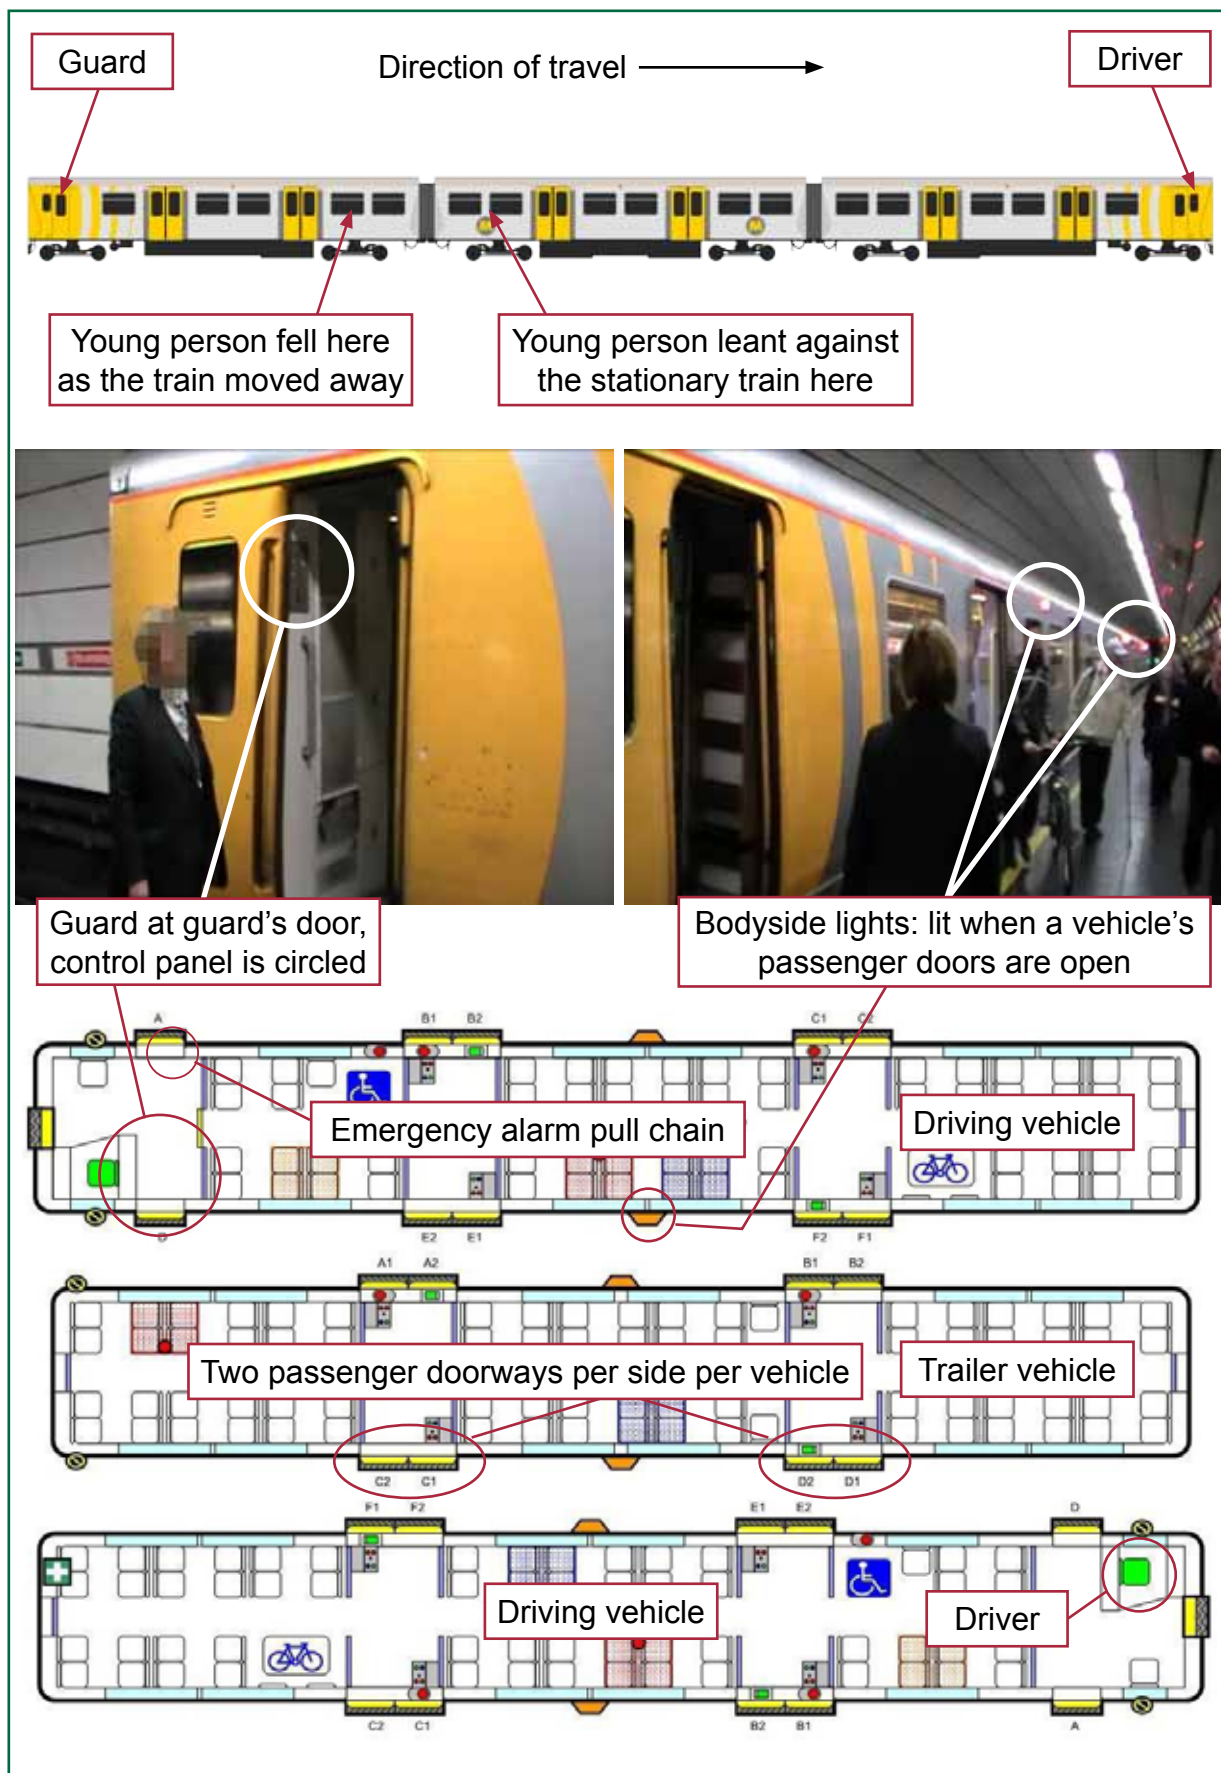
Figure 4: The Merseyrail unit and the locations of those involved in the accident (reader note – the people in the photographs were not involved in the accident)

- 13 From his position at the rear of the train the guard can only communicate with the driver by using the control panel to send and receive codes. The train's design ensures that the guard cannot send codes until the passenger doors are closed, the bodyside lights have gone out (see figure 4) and the blue interlock light is lit (see figure 3). Platform video camera footage shows that the young person placed her hands on the train before the doors had fully closed because the bodyside lights had not gone out. Therefore, the guard must have sent the 'ready to start' code after the young person had placed her hands on the train. The driver repeated the 'ready to start' code, released the train's brakes and prepared to set off.

- 45 The guard could have pulled the emergency alarm chain (see figure 4) instead of warning the young person to stand back. When the trains were first built this device interrupted the brake control wire and fully applied the train's brake. However the trains were modified for the device to sound an alarm in the cab warning the driver that an automatic brake application will take place within 3 - 4 seconds. Within this time the driver may brake immediately or override the automatic brake application and continue to a better place to stop. Crossing to the other side of the vehicle to pull the emergency alarm chain would not have affected the outcome of the accident because it would have resulted in the driver receiving the alarm later than she received the 'stop' code.

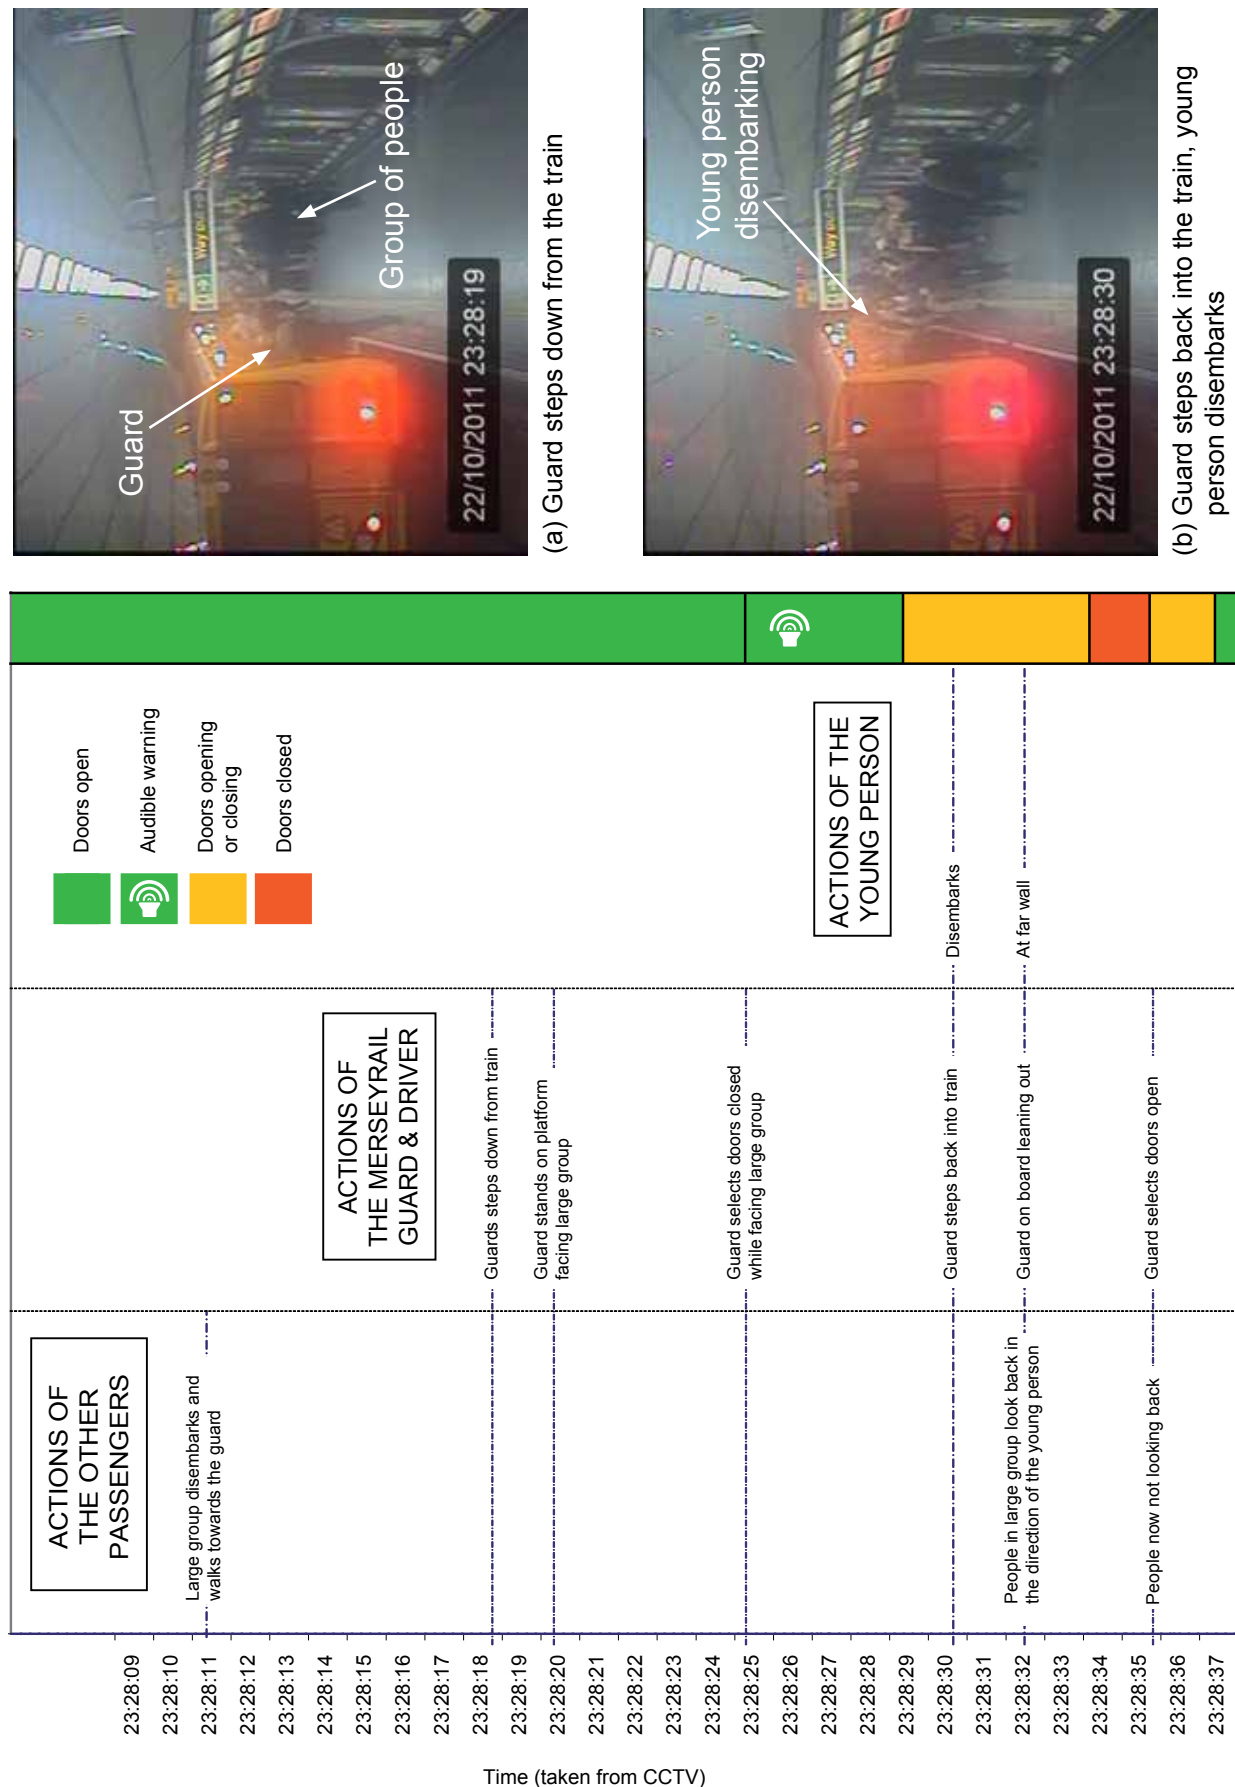
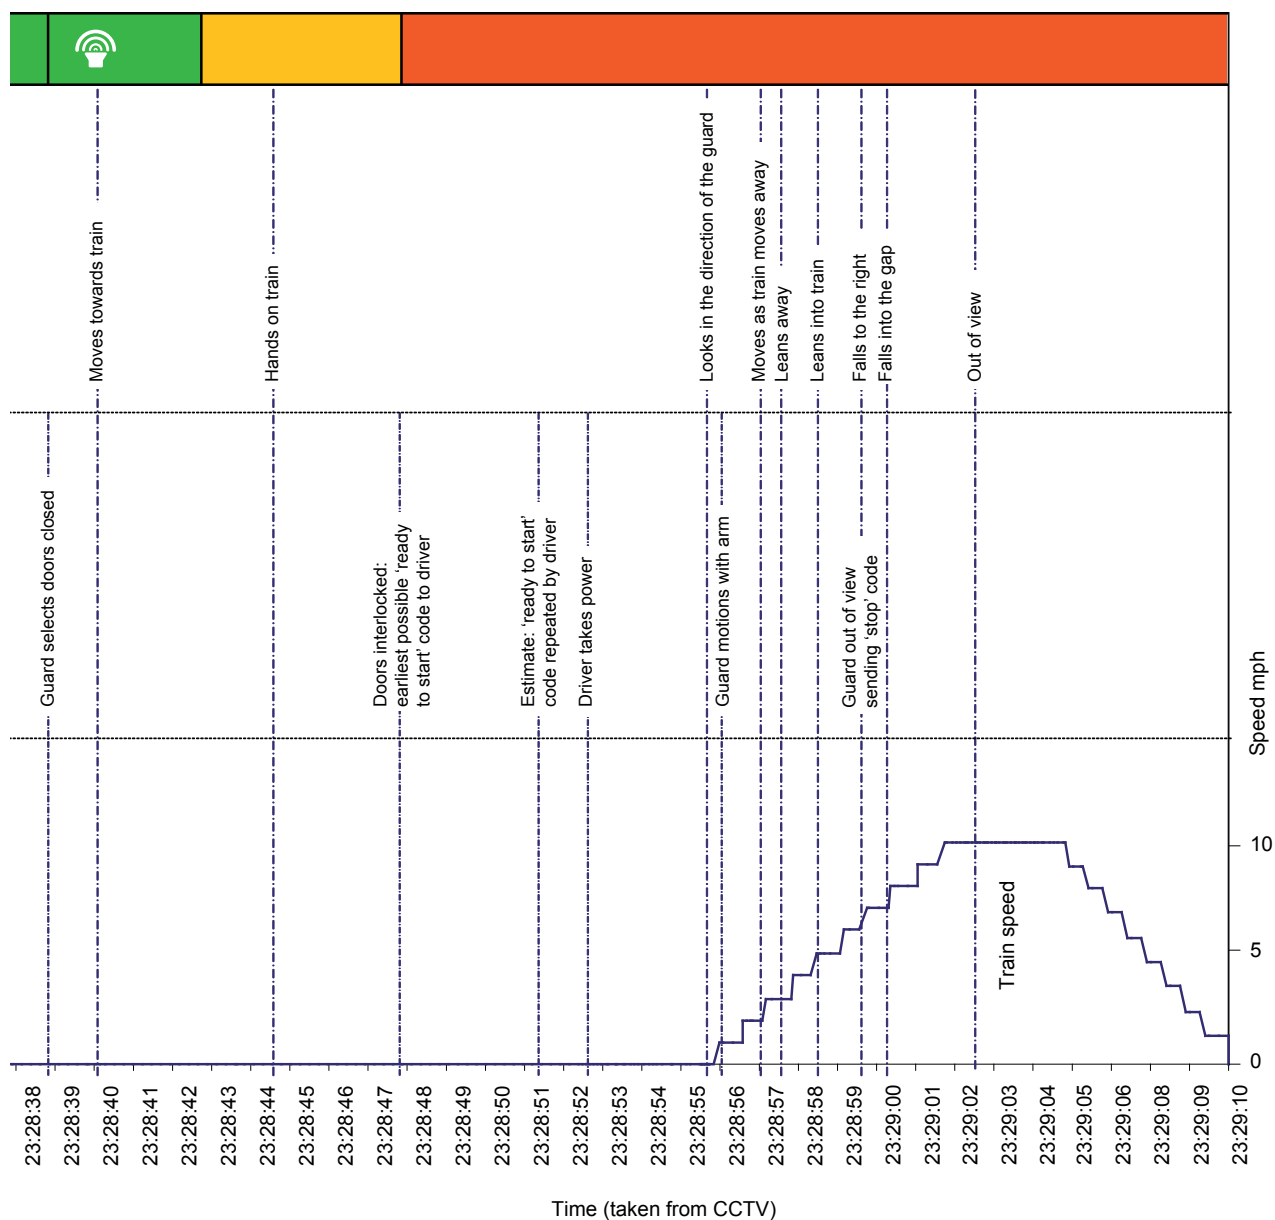
- 9 Figure 5 is a timeline of events recorded by the video camera on James Street platform 1 and the train's data recorder. The timeline begins with the train stopped at James Street at 23:28 hrs, at which time the guard was standing at his open door at the rear of the train in his area separate from the passenger saloon.

- 10 A large group of passengers left the train's centre vehicle and walked in the direction of the guard who stepped down from the train and faced in their direction (figure 5a). Between 40 and 50 passengers remained on board the train. The guard remained standing on the platform facing the large group as he pressed the door close button, which initiated the door close sequence and sounded audible warning devices for approximately four seconds.

- 11 Immediately the audible warnings stopped the passenger doors started to close, the guard stepped back into the train, the young person disembarked and went straight to the tunnel wall (figure 5b). At this time many of the large group of passengers turned to look in the young person's direction as they walked along the platform, possibly because she and her friends were shouting to one another at a level loud enough to be heard by the train driver in her cab.

- 12 Five seconds after the young person had disembarked the guard briefly re-opened and then closed the passenger doors, during which time no-one attempted to get on or off the train, the young person remained at the wall and the large group of passengers continued to walk towards the guard. A second after the audible devices began to sound, the young person began to walk towards the train but did not attempt to board it; instead, she placed her hands on a window near to the doorway and leant against the train (figure 5c). At this time, according to a statement obtained from the British Transport Police, a friend who was onboard told her to stand back and wait on the platform because she was going to come back for her.

- 14 The young person turned to look in the direction of the guard as the last person in the large group left the platform through the exit opposite the guard's door. The guard stated that he warned the young person to stand back and platform video camera footage shows that he gestured with his arm for her to move away from the train (figure 5d) but she continued to lean against it.

Figure 5: Timeline of events recorded by the video camera on platform 1 and the train's data recorder

Figure 5 (continued): Timeline of events recorded by the video camera on platform 1 and the train's data recorder

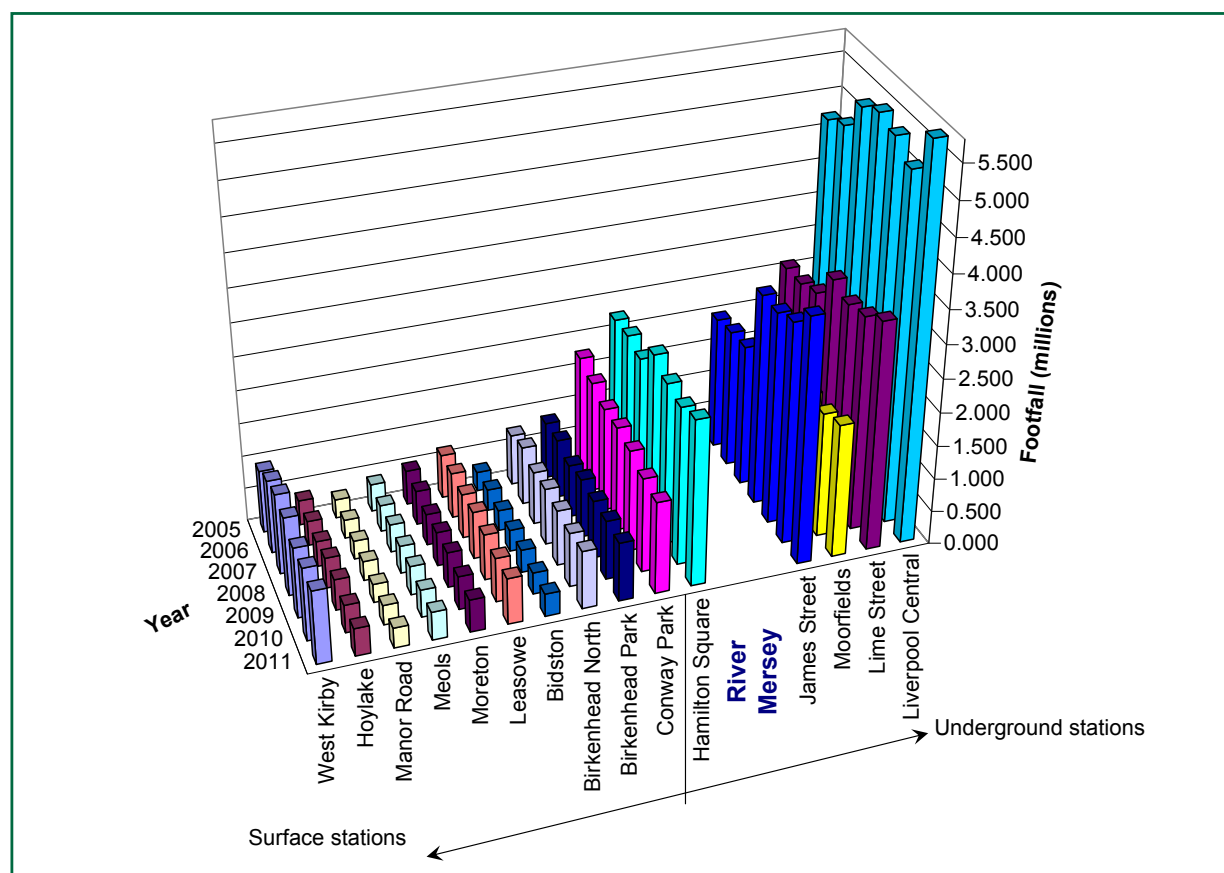
- 21 Figure 6 shows that since 2008, James Street has seen the greatest increase in passenger numbers at an underground station. It also shows that since 2009 it has been the second busiest station on the loop line after Liverpool Central. This is because James Street is the nearest station to a recently redeveloped part of the city with attractions including Liverpool ONE², the Echo Arena³, the docks and city nightlife. The platforms at Merseyrail's underground stations are often more congested than those at its surface stations because trains are more frequent, many more people get on and off those trains and space to stand is limited.

Figure 6: Passenger numbers using the stations on the West Kirby line

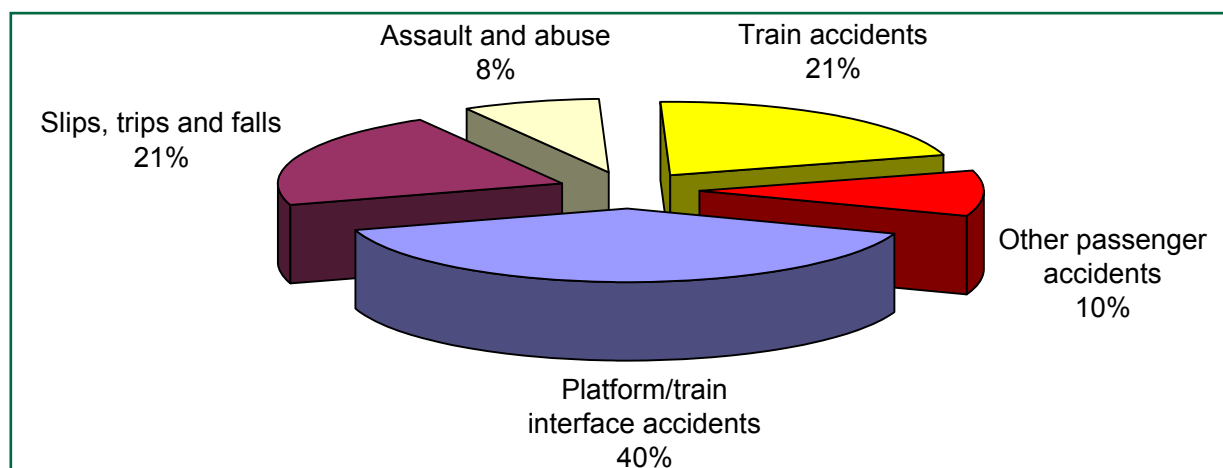
- 50 Platform/train interface accidents represent the most significant fatality risk for passengers on the main line (see figure 13). RSSB records show that in the five years between April 2007 and March 2012, accidents at the platform/train interface were responsible for 14 fatalities (excluding four cases of electrocution) and over 6000 injuries. The RAIB carried out a review of this accident data to identify which of the accidents involved persons falling through the platform edge gap and found that this type of accident resulted in:

Figure 13: Passenger fatality risk. Information courtesy of RSSB's Safety Risk Model v7

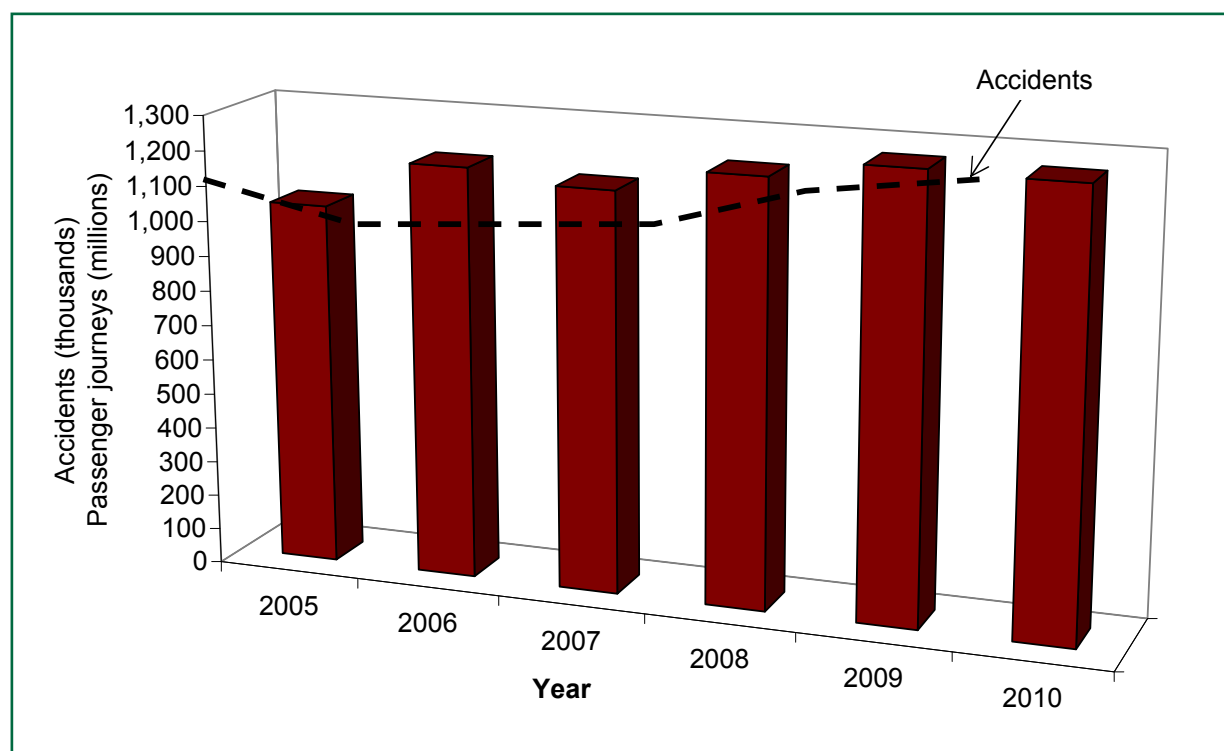
- 56 While the rail industry's overall safety record has improved in recent years, RSSB research shows that accidents at the platform/train interface have increased since 2005/2006, even when accounting for an increased number of passenger journeys²². The increase in this type of accident has taken place over a period of time which saw a known industry hazard (trains with slam doors but no central locking) withdrawn from service (see figure 14). The increase indicates that the industry's focus on operational matters has not delivered improved safety at the platform/train interface, which suggests that there is a need to consider technical solutions to reduce the risk.

Figure 14: Passenger journeys 2002 to 2010²³ and accidents at the platform/train interface²⁴

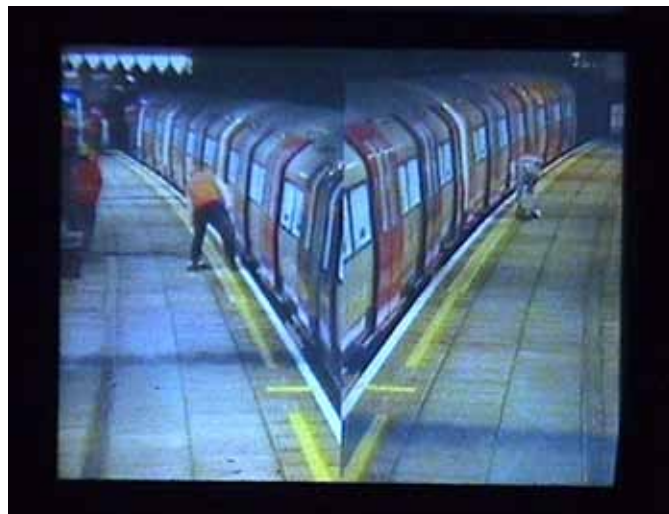
Figure 15: In-vehicle monitor

- Using mirrors fitted to the outside of the train, or cameras that broadcast video footage to in-vehicle monitors (figure 15);
 - Using mirrors or monitors installed on the platform (figure 16);

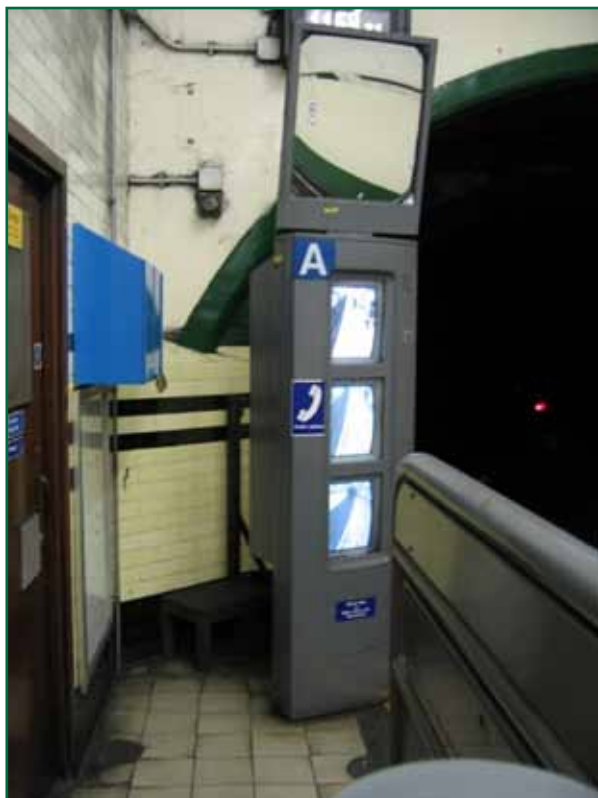
Figure 16: Platform mirror and monitors

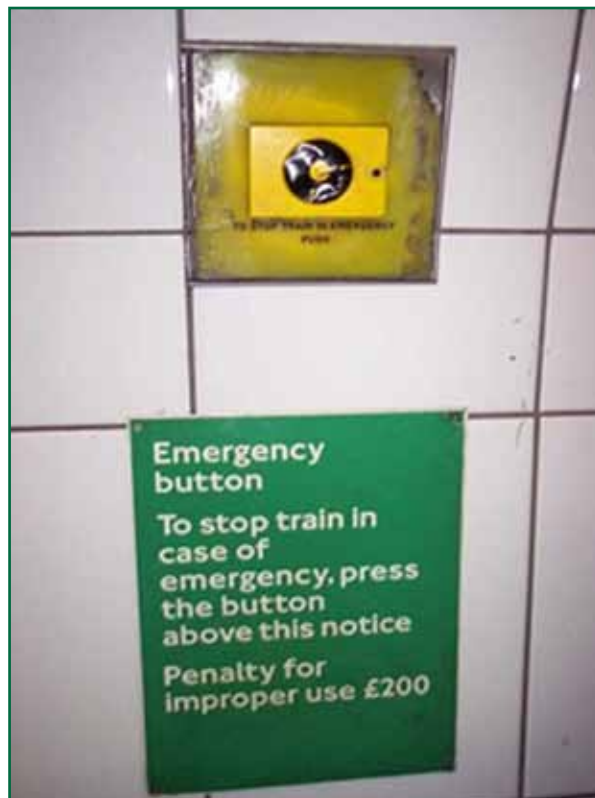
Figure 17: Platform mounted emergency stop button

- b. Providing members of staff that dispatch trains from platforms with an emergency stop button - see figure 17 for an example on London Underground. This solution is made possible because of the sophisticated signalling system; it would be more difficult to apply on conventionally signalled systems.
- c. Placing responsibility for dispatch with a member of staff who has brake controls immediately to hand. If this procedure is adopted it is often in combination with measures that allow the member of staff to observe the platform and train fully and without interruption for as long as possible.

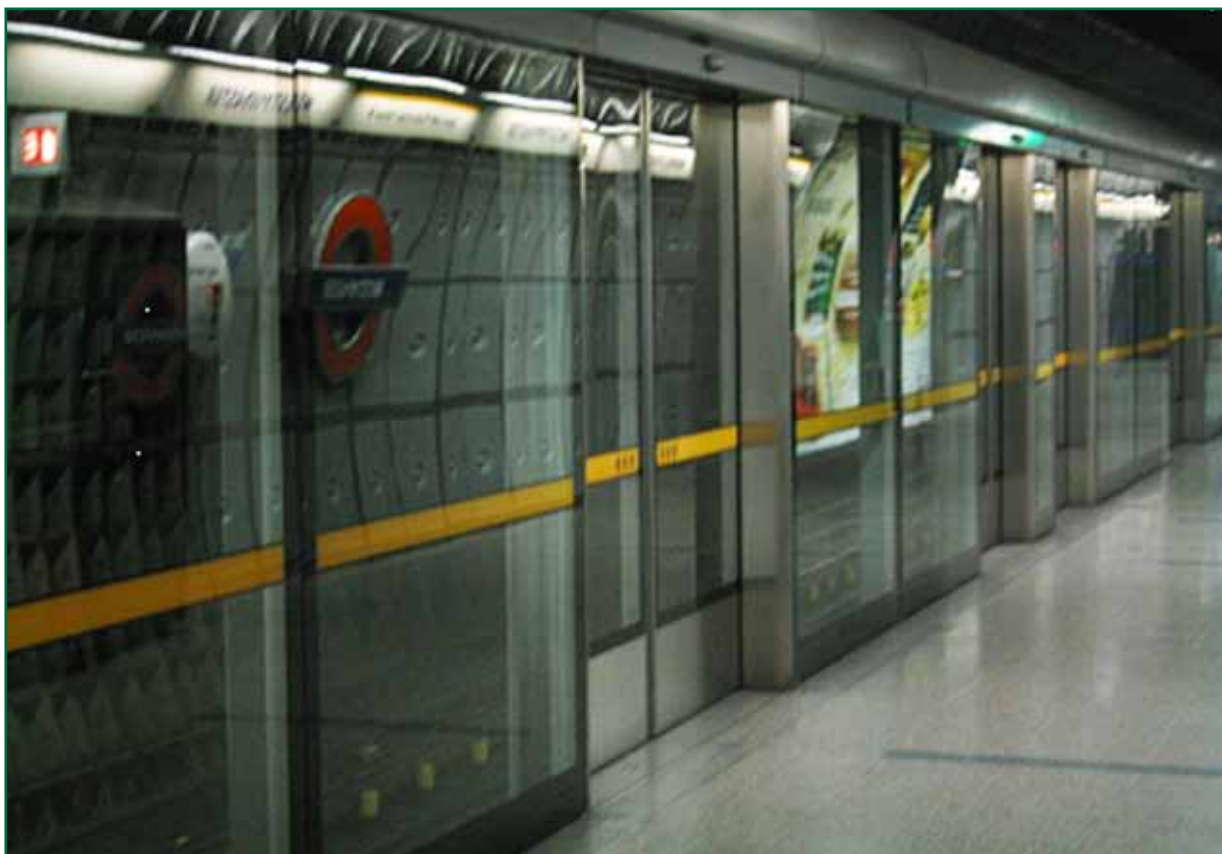
Figure 18: Platform edge doors on London Underground (Courtesy of Transport for London)

- a. Fitting platform screen doors that open when a train is stopped at the platform. At all other times, platform screen doors act as a barrier to prevent people going onto the track by accident, to retrieve something or in an attempt to commit suicide (see figure 18). It should be noted that the high cost of platform screen doors is sometimes justified on benefits other than safety, for example to control platform air flows or allow station air conditioning. In the UK, platform screen doors are most often installed at new stations and platforms.

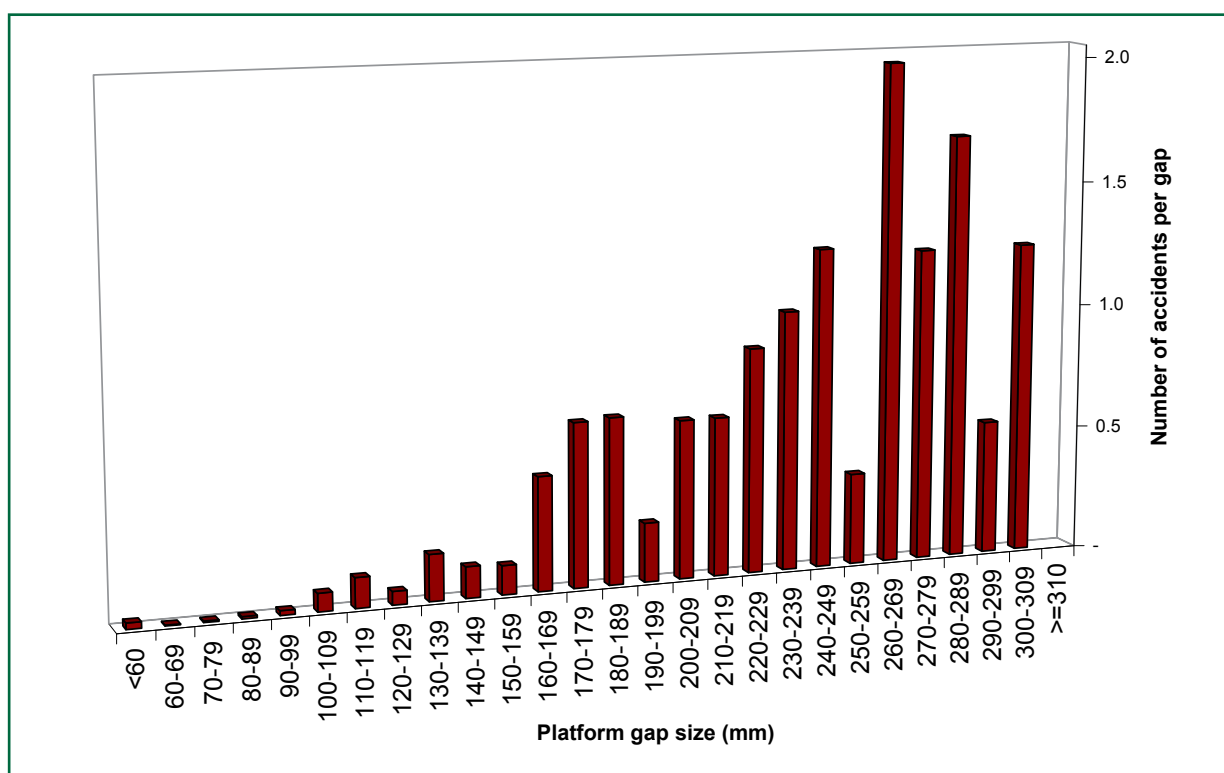
- b. Reducing the gap. A study carried out by the Kowloon-Canton Railway Corporation between 2001 and 2006 showed that where the gap was less than 160 mm the risk of an accident was low but that for gaps of 160 mm or more the accident rate increased²⁷ (see figure 19). Ways to achieve this include:

Figure 19: The number of accidents per gap vs. gap width on the Kowloon-Canton Railway between 2001 and 2006²⁸

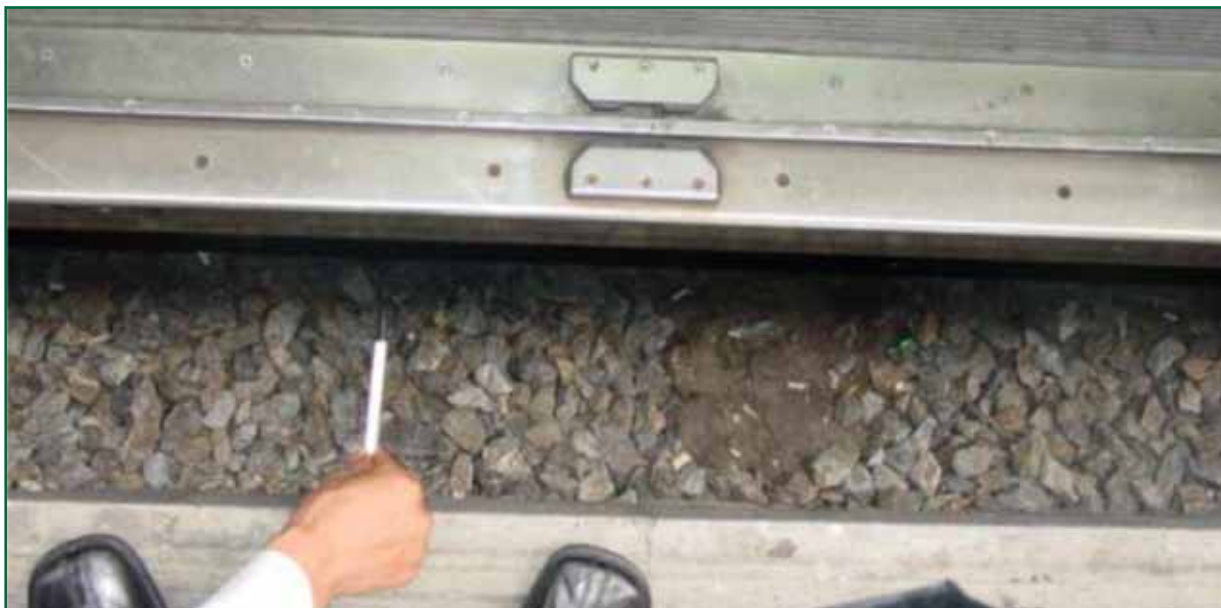
Figure 26: A platform edge (not on the Merseyrail network)

- iii. Adapting the infrastructure. Figure 25 shows a platform edge gap reduced by raising the platform edge. Figures 26 to 28 show the gap reduced by fitting gap fillers to the platform face. The gap fillers are made from blocks with rubber prongs: the prongs are able to support a person's weight vertically and deflect horizontally without damaging themselves or the trains that pass and contact them. The gap can also be reduced by moving the track closer to the platform, moving the platform coping stones closer to the track or both.

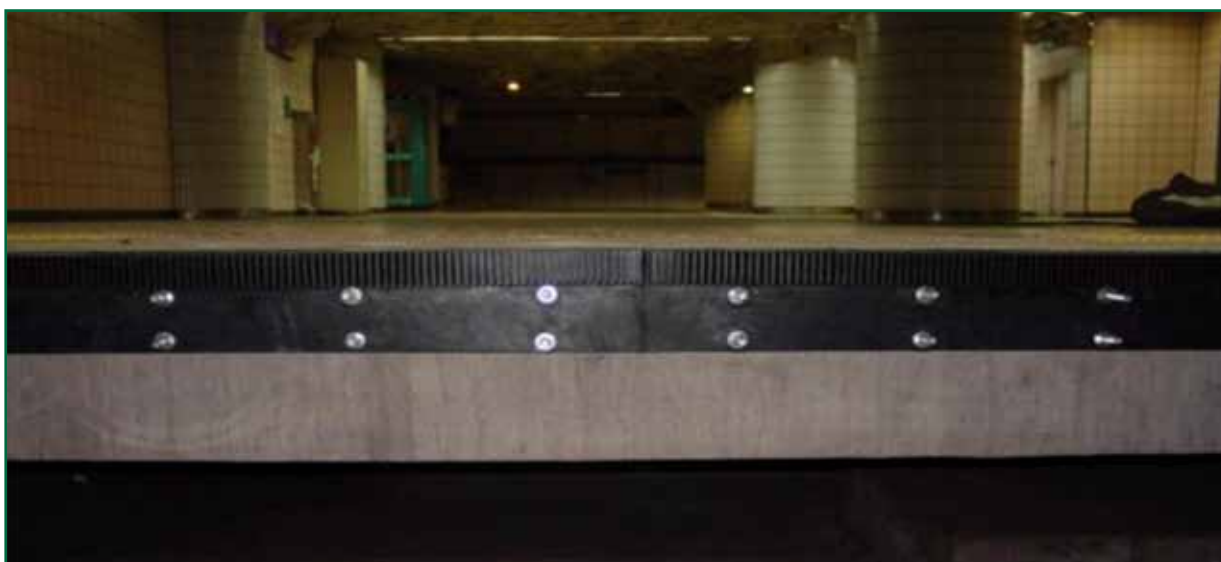
Figure 27: Gap filler bolted to the platform edge

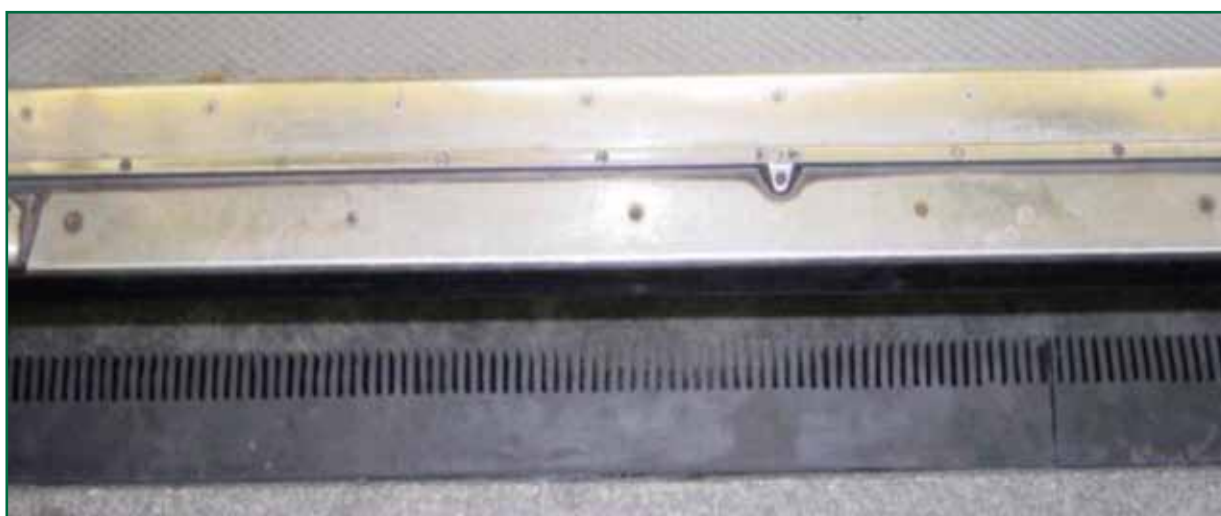
Figure 28: The platform edge after fitting gap filler
