# Rail Accident Report

**Person trapped in a train door and dragged at  
Jarrow station, Tyne and Wear Metro  
12 April 2012**

# **Person trapped in a train door and dragged at Jarrow station, Tyne and Wear Metro**

## **12 April 2012**

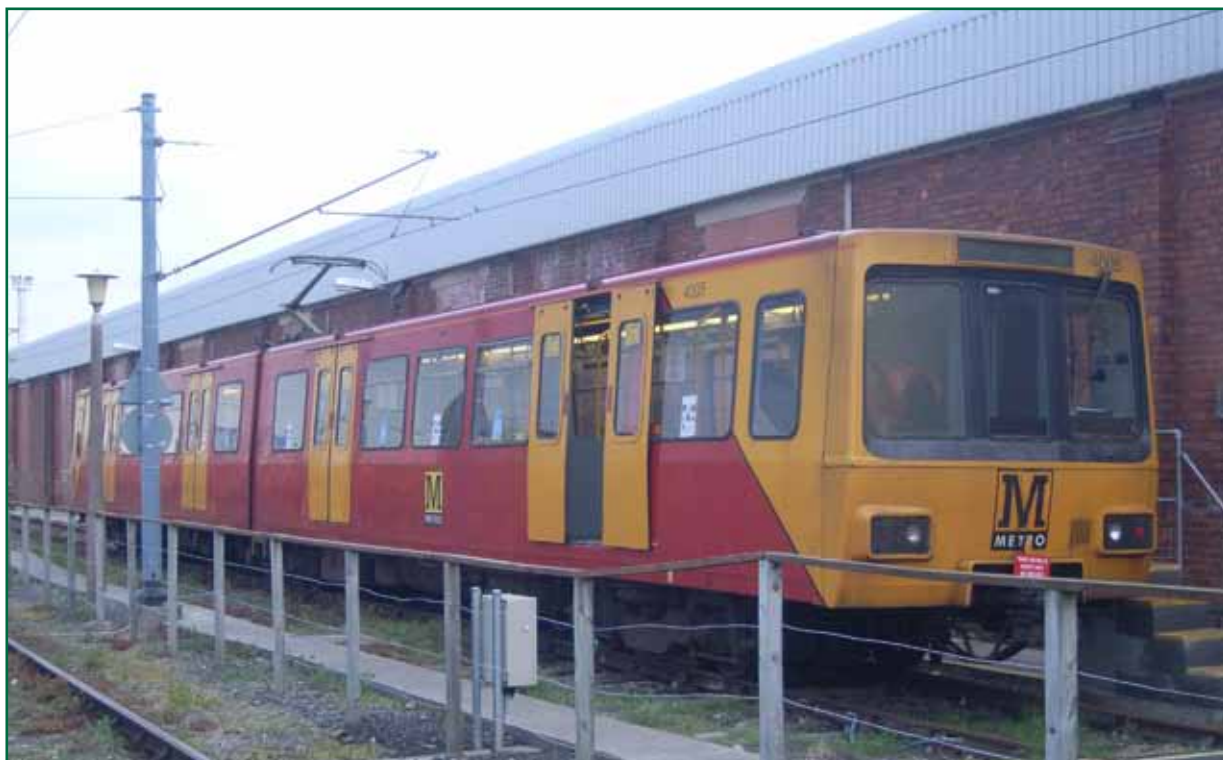
- 6 TWM trains comprise two-car electric multiple units, which receive power from 1500 V DC overhead contact wires, and have a maximum speed of 80 km/h. Each articulated car (figure 2) is 27.8 metres long and has a driving cab at each end and four pairs of passenger doors per side. The trains were manufactured between 1978 and 1981 by Metro-Cammell, in Birmingham. They were refurbished between 1995 and 2001 and are currently undergoing another refurbishment programme which commenced in 2010. The vehicle involved in this incident was car 4005 which first entered service in 1980 and was last refurbished in 2001.

Figure 2: Car 4005 involved in the incident (two such cars make up a TWM train)

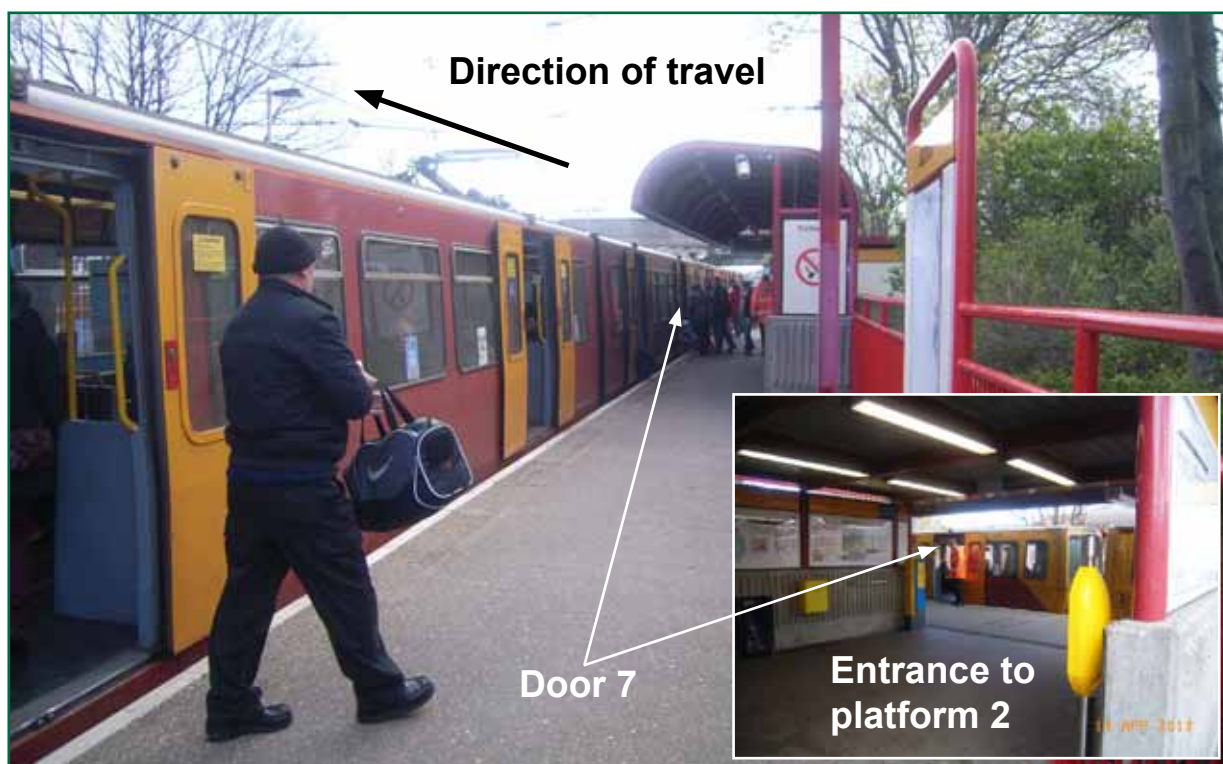
- 7 The location of Jarrow station on the network is shown in figure 1 and a closed circuit television (CCTV) image of the incident train approaching platform 2 is shown in figure 3. Platform 2 serves trains heading towards Newcastle Central station, and is on the left-hand side in the direction of travel (figure 4). Passengers reach platform 2 after passing through a small concourse. At the normal stopping position of trains, door 7 is closest to the concourse.

Figure 4: Platform 2 at Jarrow station

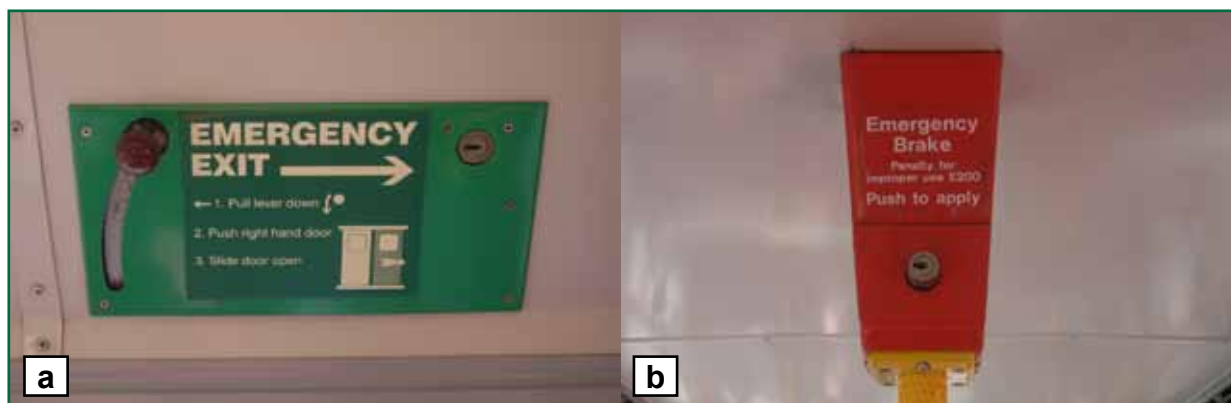
- 13 In the immediate vicinity of each doorway are two emergency systems; an emergency door release (EDR) and a passenger emergency button (PEB) both of which can be operated by passengers. The EDR (figure 6a) is located to the left-hand side of each doorway at head height. Its purpose is to allow the door closing force to be released in an emergency, such as a person becoming trapped in the doors. It is activated by pulling the lever downwards which then allows the right-hand door leaf to be pushed open manually. It also automatically cuts off traction power and activates the train brakes. The PEB is mounted at the top of a vertical grab pole in the middle of each doorway vestibule (figure 6b). It allows a passenger to stop the train in an emergency by pressing the button. Pressing the button cuts off traction power and automatically applies the train's emergency brake.

Figure 6: (a) Emergency door release; and (b) passenger emergency button

- 16 Video footage from the train's internal CCTV shows that passengers on board the train adjacent to door 7 realised what was happening. One passenger tried to prise open the door manually and when this was unsuccessful, he quickly activated the EDR (figure 6a) around 4 seconds after the train had started to move. A second or so later, another passenger pressed the nearby PEB (figure 6b).
