# Rail Accident Report

## **Near miss incident at Ufton Automatic Half Barrier Crossing, Berkshire 4 September 2011**

Report 28/2012  
December 2012

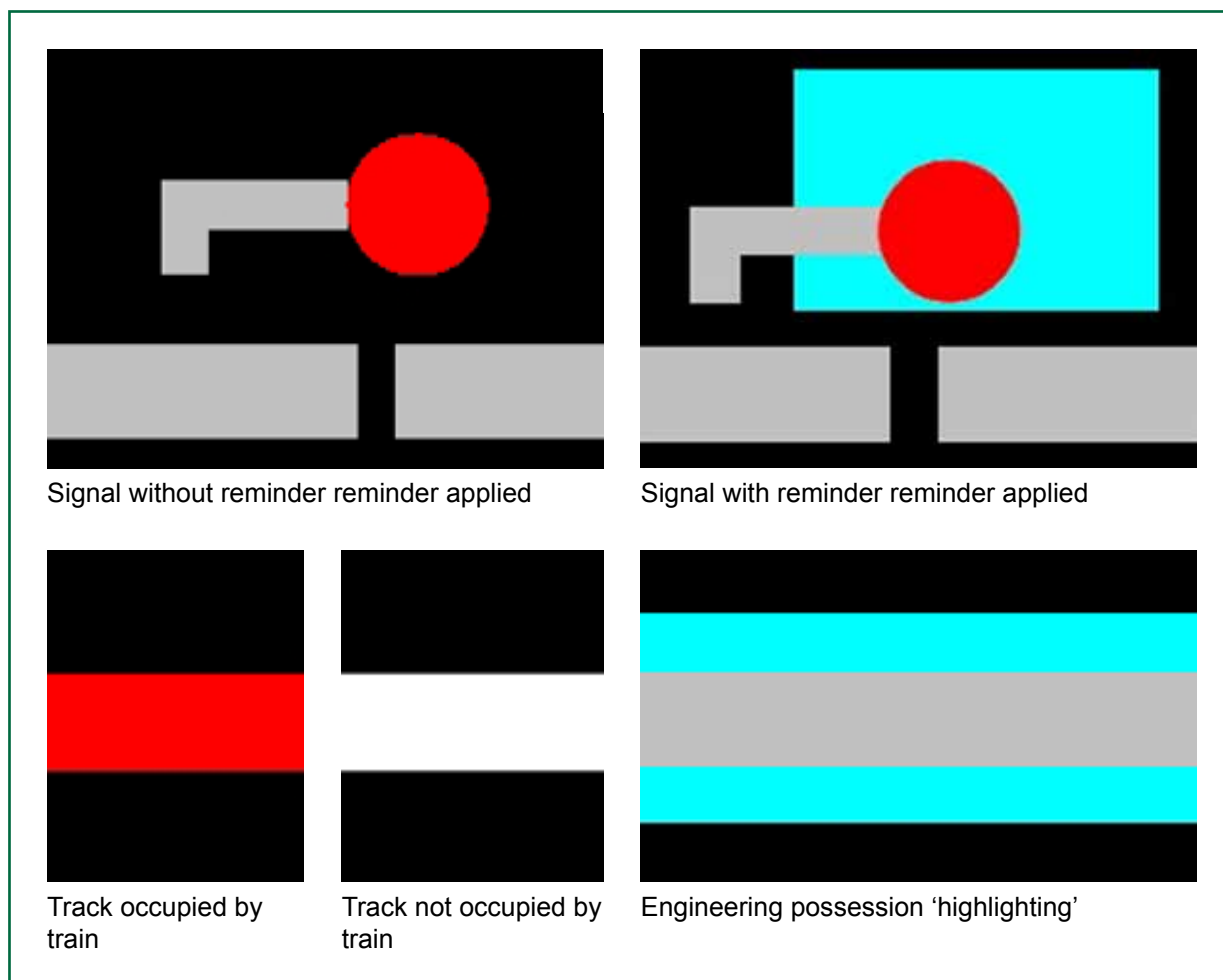
Figure 6: Selected symbols used on VDU displays

- 24 When a reminder is used on an IECC system a coloured symbol surrounds the piece of equipment selected on the workstation display screen. For example, a blue box surrounds the existing signal head when a reminder is placed on that signal (figure 6).

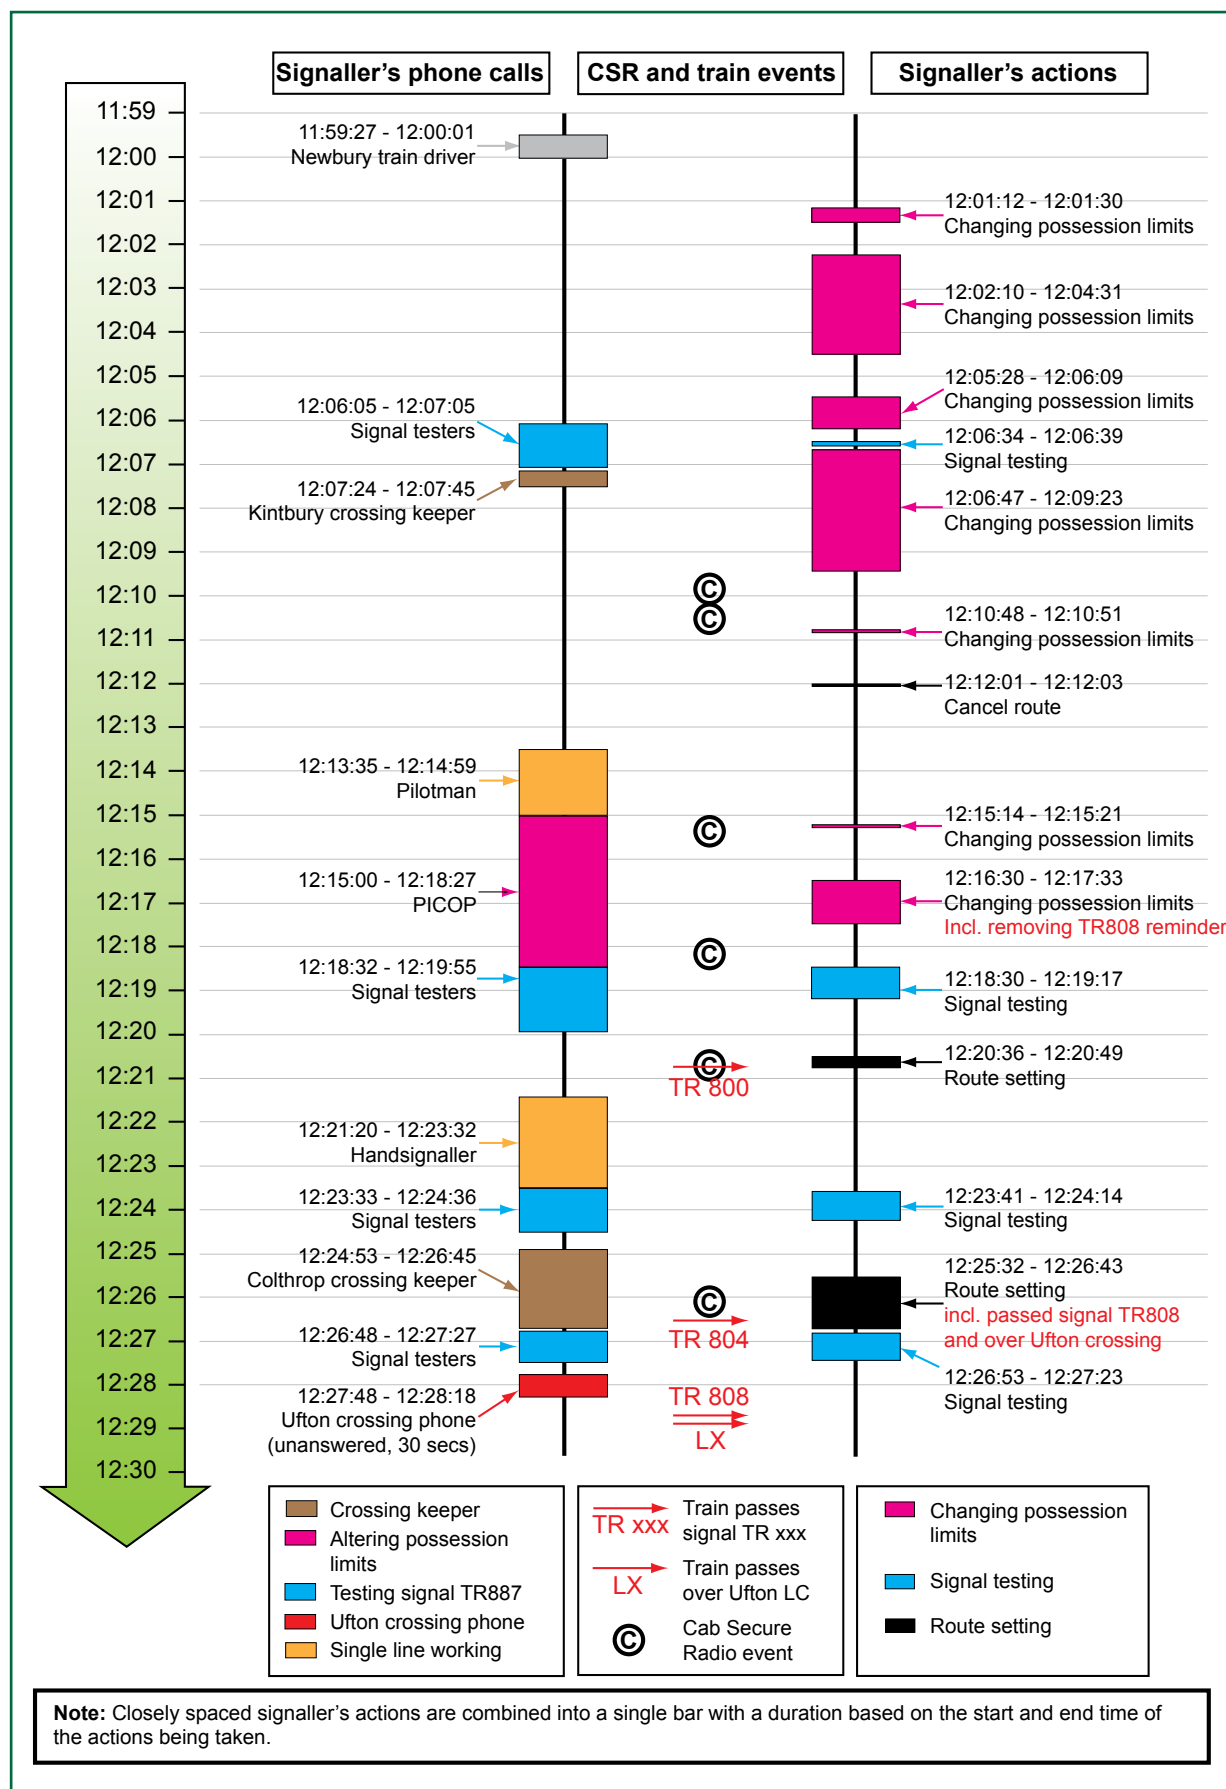
Figure 9: Timeline

- 46 Subsequent events leading to the near miss at Ufton crossing are shown on the timeline at figure 9 and described in paragraphs 47 to 67.
- 47 Signaller B immediately removed the signal reminders, point reminders and engineering possession highlighting from areas which had been returned to normal traffic when part 2 of the possession had been implemented. He then operated the controls needed to allow a train berthed in Newbury station bay platform 3 to be shunted to platform 2. These actions were completed by 12:09:23 hrs.
