Rail Accident Report

Freight train derailment at Reading West Junction 28 January 2012

Report 02/2013
January 2013

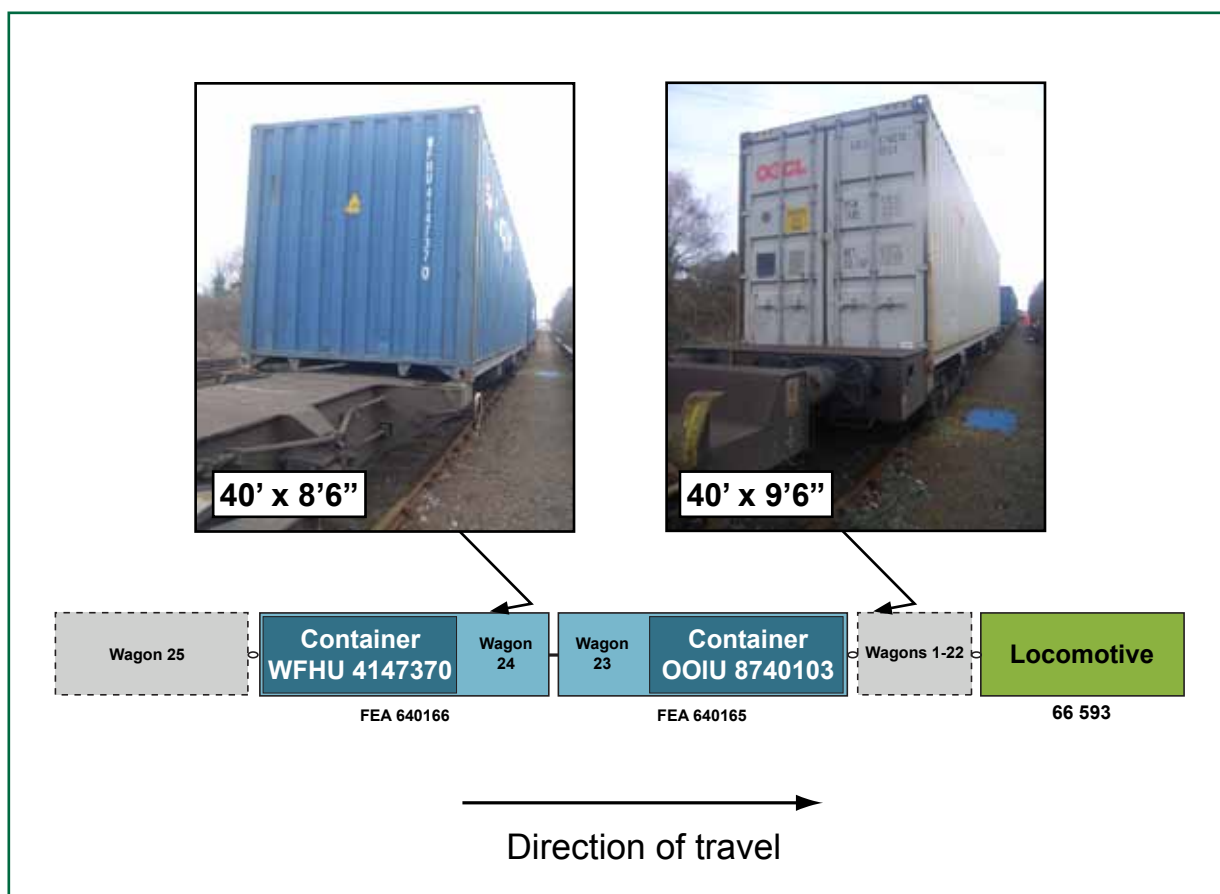
Figure 3: Configuration of train 4002

- 18 Train 4O02 comprised a class 66 diesel electric locomotive and 25 container-carrying flat wagons. The derailed wagon was one of a pair of semi-permanently coupled FEA wagons: FEA 640165 (the 23rd wagon) and FEA 640166 (the wagon that derailed, subsequently referred to in the report as 'wagon 24'). A single freight container, OOLU 8740103 (40 feet long by 9 feet 6 inches high), was loaded on the leading end of the 23rd wagon. The single container on wagon 24 (paragraph 13), WFHU 4147370 (40 feet long by 8 feet 6 inches high), was loaded on the trailing end. Figure 3 shows the train configuration and the position of the containers.
