Rail Accident Report

Derailment of a tram at East Croydon 17 February 2012

Report 04/2013
March 2013

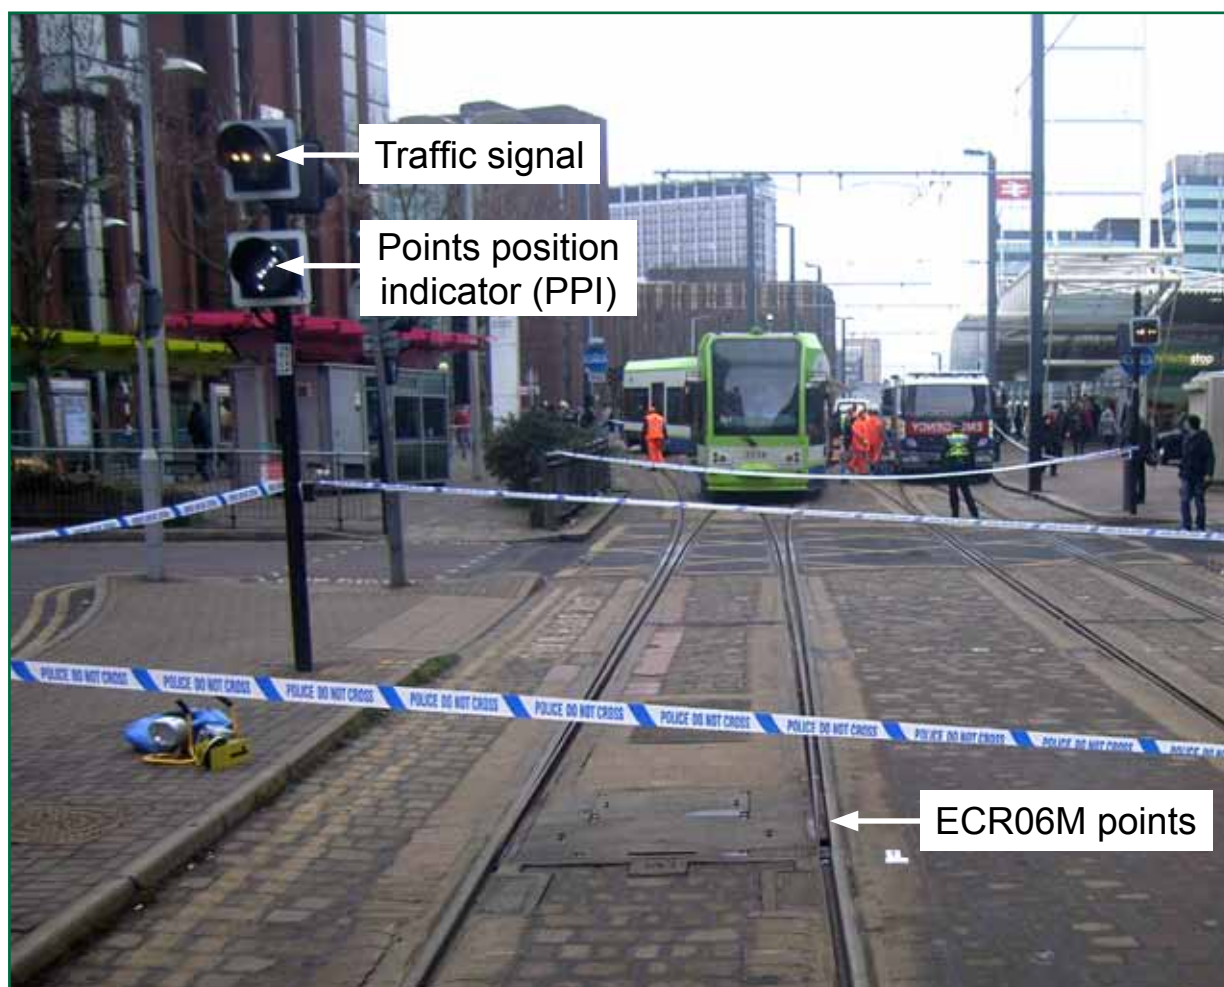
- 9 The westbound line divides at motorised *facing points* ECR06M, located 98 metres from the tram stop and east of Billinton Hill road crossing. The position of points ECR06M (ie whether the route is set to the left or the right) is displayed to an approaching tram by a *points position indicator* (PPI). This is mounted on the same post as the signal that authorises tram movements across Billinton Hill (figure 3). After these points the routes run parallel before diverging near the platforms. Until August 2009, points ECR06M were located west of the road crossing, but they were repositioned during track remodelling to improve reliability. Trams are limited to a maximum speed of 25 km/h (15 mph) in the vicinity of points ECR06M.

Figure 3: Billinton Hill (Post Office Road) crossing showing points ECR06M, the traffic signal (showing a horizontal row of lights indicating 'stop') and PPI (indicating a route to the right)

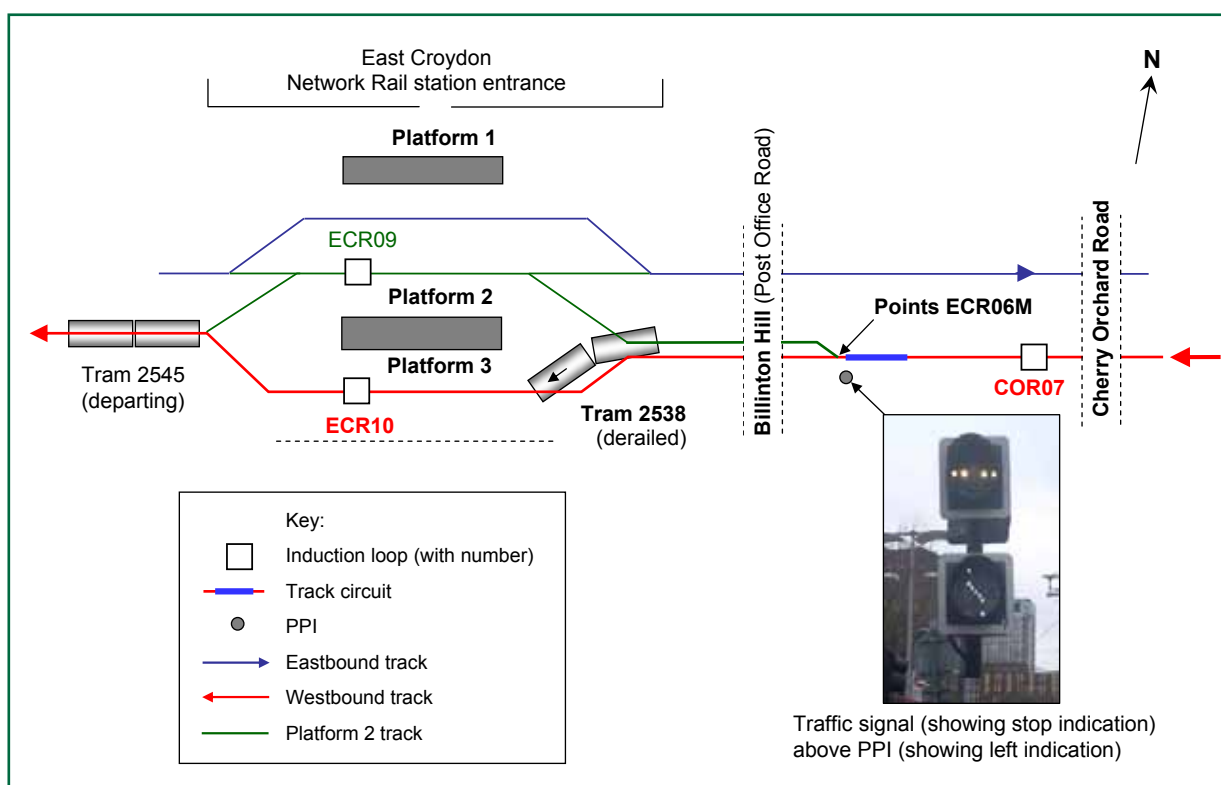
- 20 Tramlink's *programmable logic controller* (PLC) signalling system at East Croydon first detects an approaching westbound tram when it passes over *induction loop* COR07. This loop is located in the road surface west of Cherry Orchard Road crossing, 35 metres before ECR06M points and 133 metres from the tram stop. The system next detects the tram, when it arrives in either platform 3 or platform 2, by induction loops located at the west end of the platforms (ECR10 and ECR09 respectively, figure 8).

Figure 8: Schematic diagram of part of the East Croydon signalling system and location of tram 2538 following derailment

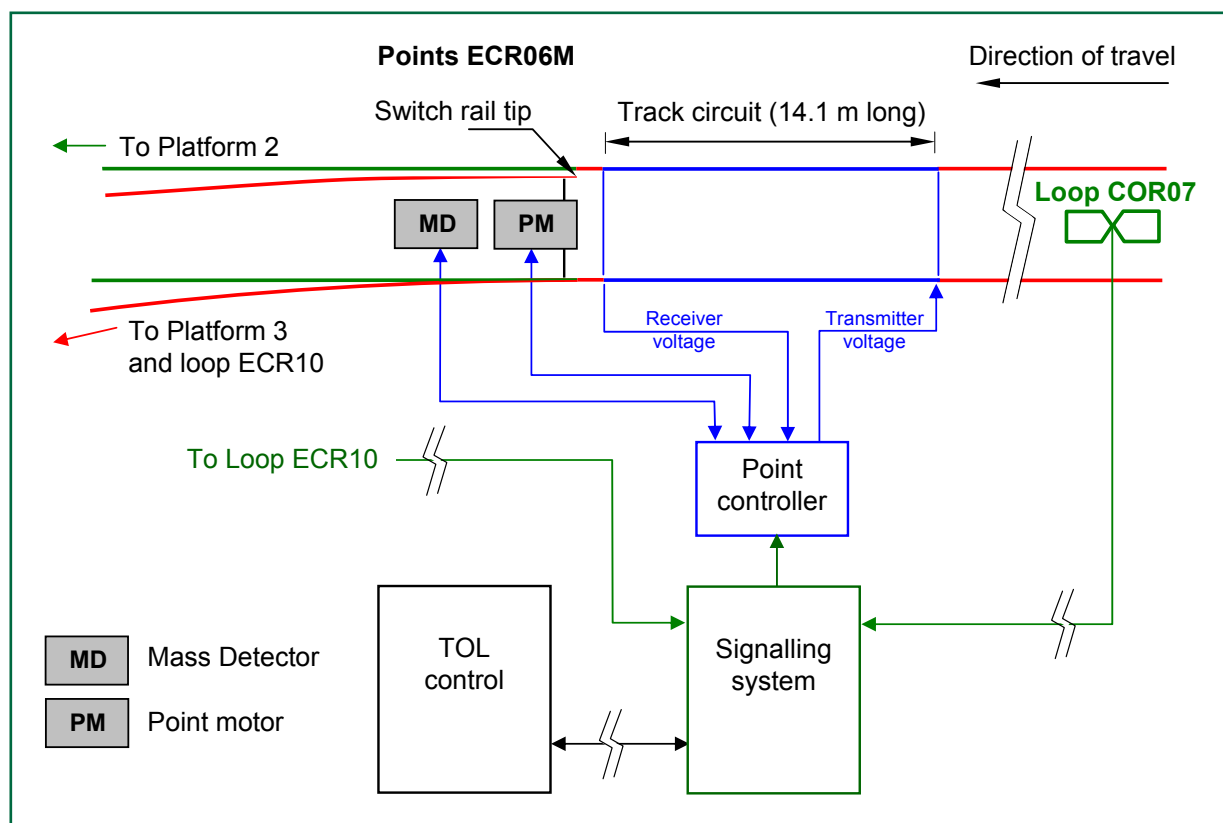
- 35 **The track circuit which locks points ECR06M did not respond to tram 2538, and consequently the points remained free to move while the tram was passing over them. This was a causal factor.**
- 36 London Tramlink staff maintain points ECR06M. It is one of nine sets of motorised facing points on the Tramlink network. Each point controller (paragraph 21) is self-contained, only interfacing with the signalling system to the extent that it receives requests from the signalling system for the points to be changed.
- 37 The point controller for each set of motorised facing points incorporates a track circuit and a mass detector. These are intended to work together to lock the points to prevent movement when a tram is approaching or running over the points (figure 9).

Figure 9: Schematic diagram of the point control system

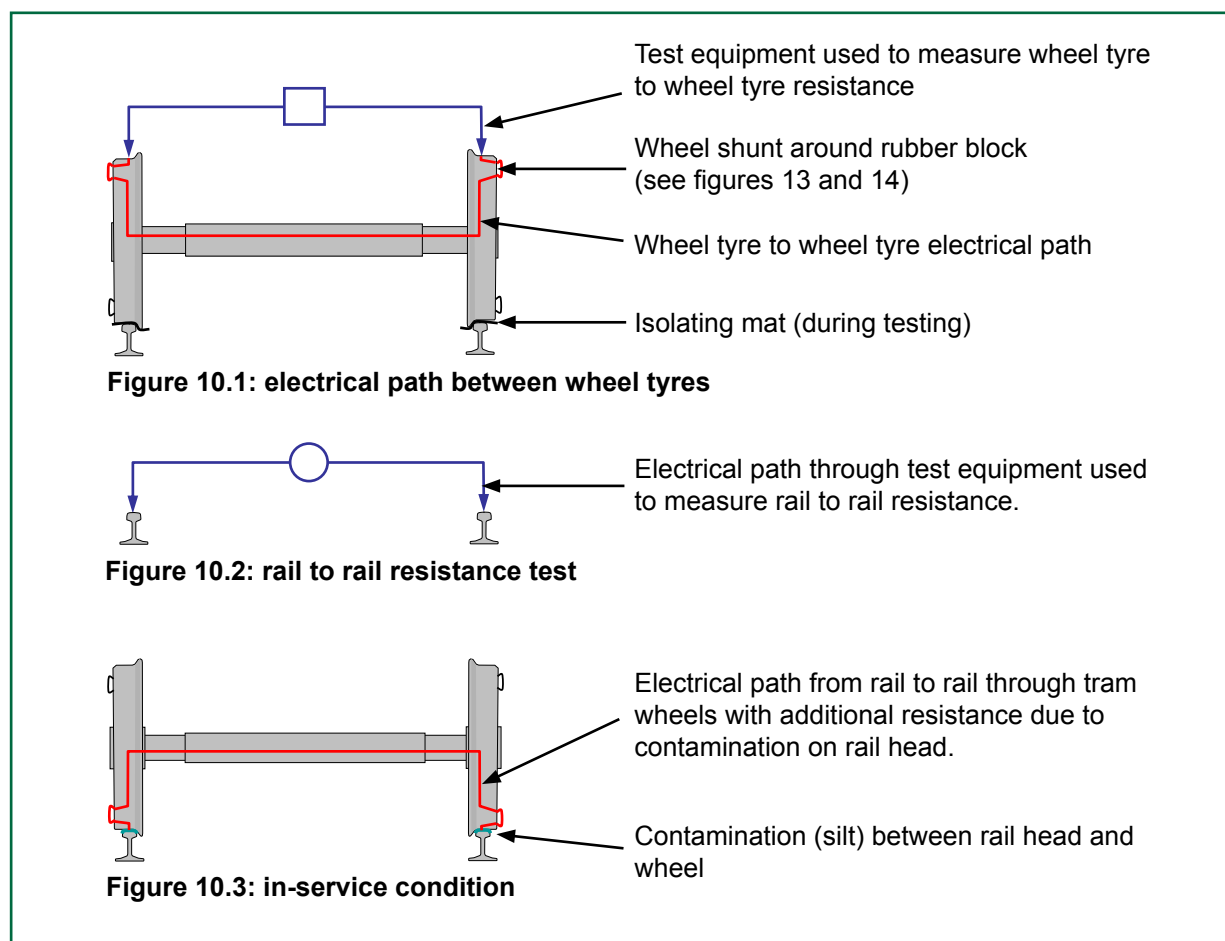
- 38 A track circuit operates by passing a small electrical current through a circuit which includes both running rails. A track circuit responds to the presence of a tram by detecting the effect of the short circuit formed between the rails by a tram's wheels and axles. The resistance of a short circuit applied from one rail to the other is described in this report as the rail to rail resistance³. During installation and maintenance work, this resistance is measured by test equipment connected directly to the rails (figure 10). However, in normal operation, the rail to rail resistance comprises two components:

Figure 10: Diagram of electrical paths affecting operation of track circuit

- It is possible that the track circuit responded to the test tram and not the incident tram because the wheel tyre to wheel tyre resistances of the test tram leading bogie (0.0004 ohms for each axle, table 1) were lower than the corresponding resistances on the accident tram (0.021 ohms⁴ and 0.023 ohms) (figure 10).

- 49 London Tramlink staff did not have access to equipment for measuring the rail to rail resistance required to make the track circuit respond (figure 10). There was no information in any routine maintenance instructions of what the receiver voltage should be, or what the effects of a variation in this voltage would be.

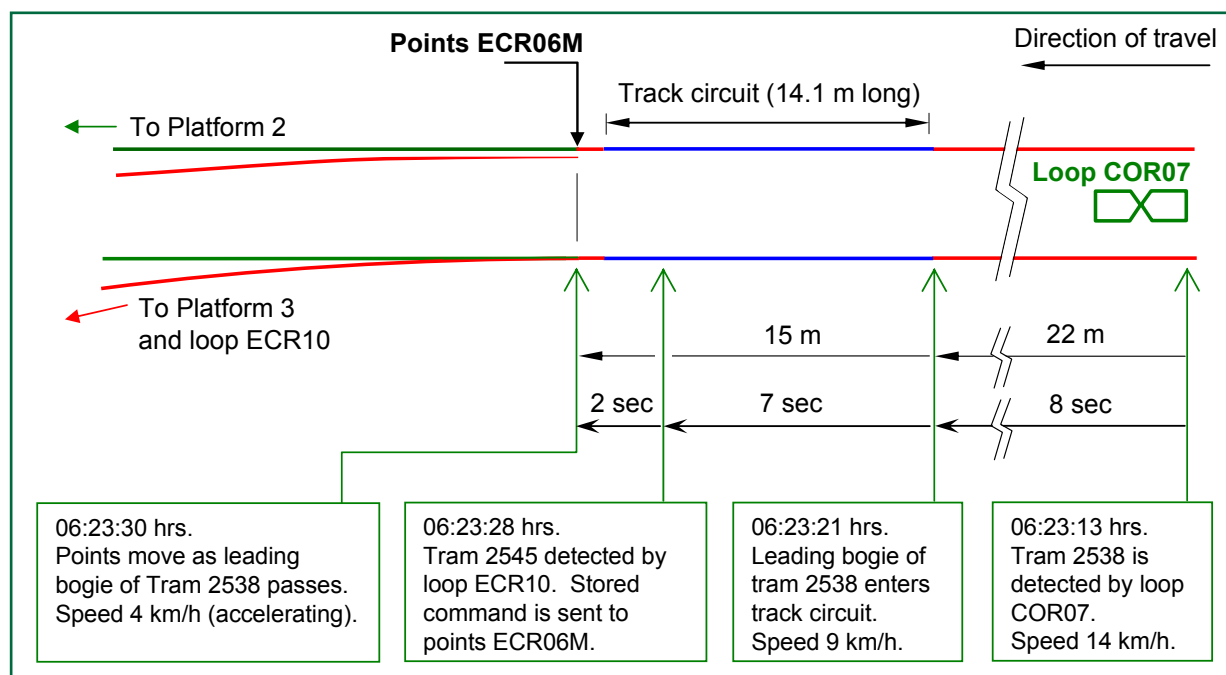
- 41 An analysis of the tram's data recorder, local data loggers and CCTV images shows that the points were actually requested to move seven seconds after tram 2538 entered the track circuit (figure 11) and while it was still occupying it. Had the track circuit responded to the tram's presence the request for the movement would still have been received but the points would not have moved (paragraph 39). Since it is known that the points did move in response to the request, and testing has revealed no other malfunction of the signalling equipment, it is apparent that the track circuit did not correctly respond to the presence of tram 2538.

- 42 At the moment that the points were requested to move, tram 2538 was only about 3 metres, and 2 seconds, from the point tips. The points were still moving as the leading bogie passed over the switch rail tip (figure 11).

Figure 11: Diagram showing calculated position of tram 2538

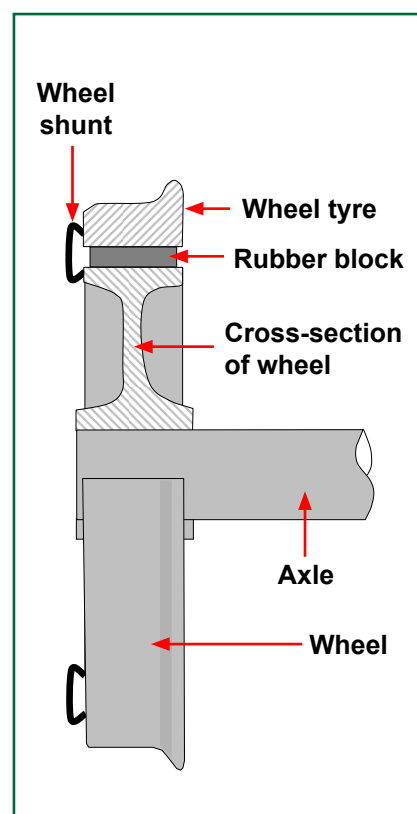
- 57 All axles on the CR4000 tram have *resilient wheels* with braided copper bonds (*wheel shunts*) on each wheel providing electrical continuity between the wheel hub and tyre (figures 13 and 14). Bombardier's maintenance specification for the CR4000 fleet states that wheel tyre to wheel tyre resistance should not exceed 0.01 ohms on a new bogie, or rise above 0.1 ohms in service. The wheel shunts are designed to provide an electrical path for traction current to return to the rails, and Bombardier stated that the requirement for the trams to operate track circuits was not specified when the trams were designed. At the time of the derailment, Bombardier's maintenance staff remained unaware that the wheel shunts performed both roles.

Figure 14: Part-section of wheel
