Rail Accident Report

**Accident involving a pantograph and the
overhead line near Littleport, Cambridgeshire
5 January 2012**

Report 06/2013
May 2013

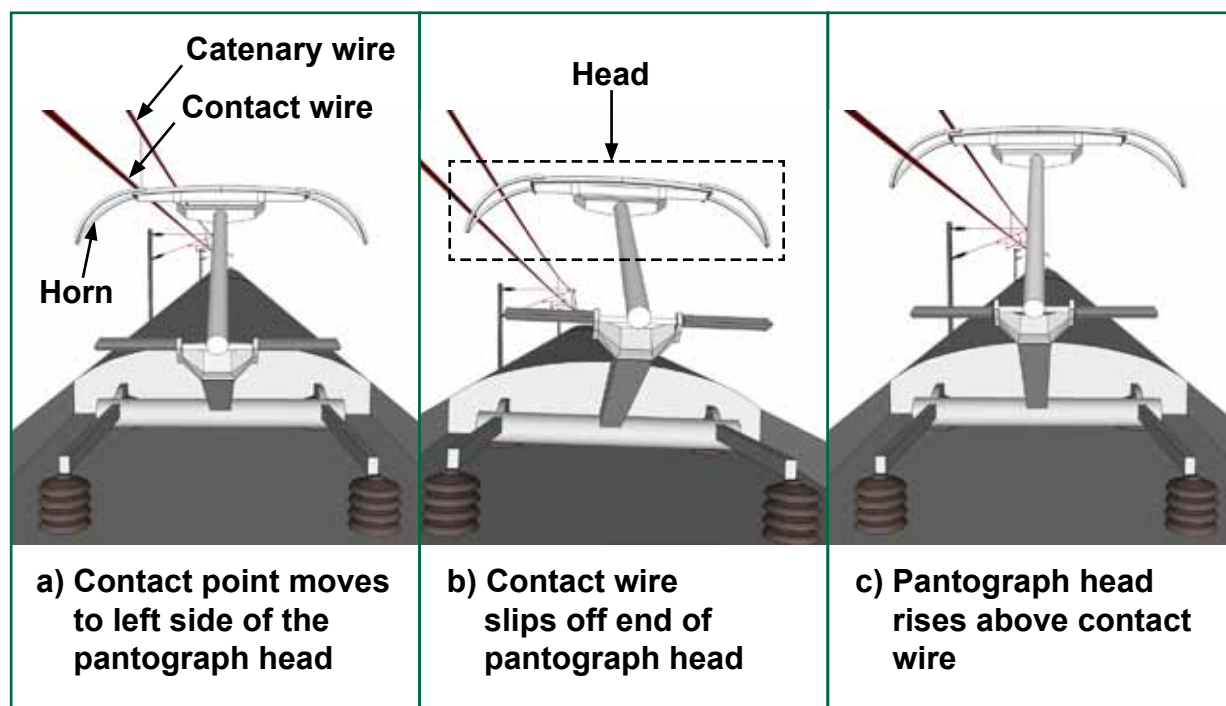
Figure 3: Illustration of process of dewirement

- 29 As the train approached the accident location, the contact point between the contact wire and the pantograph moved towards the left side of the pantograph head (facing the direction of travel) and reached a position where it slipped off the left end of the pantograph head. This allowed the pantograph head to move upwards past the contact wire (figure 3), as evidenced by witness marks on the left-hand horn (the curved side of the pantograph head).

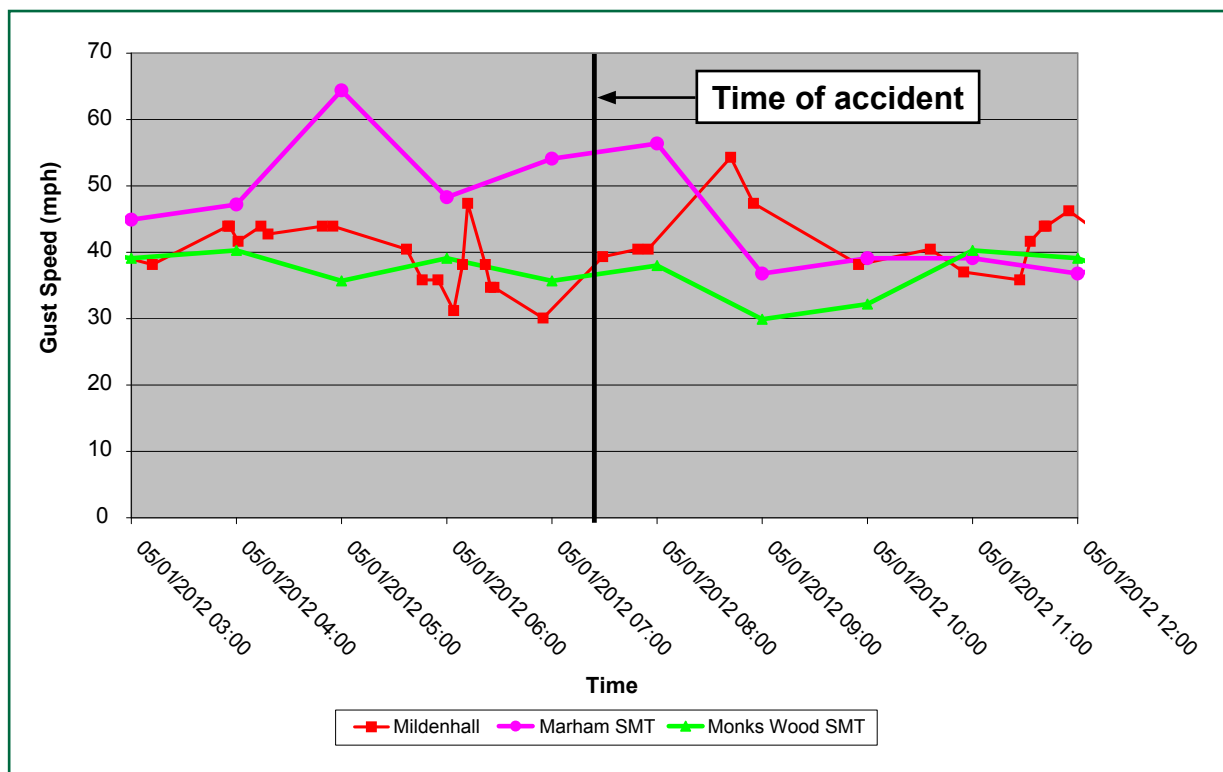
Figure 11: Wind gust speeds at weather stations

52 Figure 11 shows wind speed data recorded at weather stations close to Littleport, around the time of the accident, while figure 12 shows the locations of those weather stations relative to the accident site. The wind speed information is summarised in table 1.

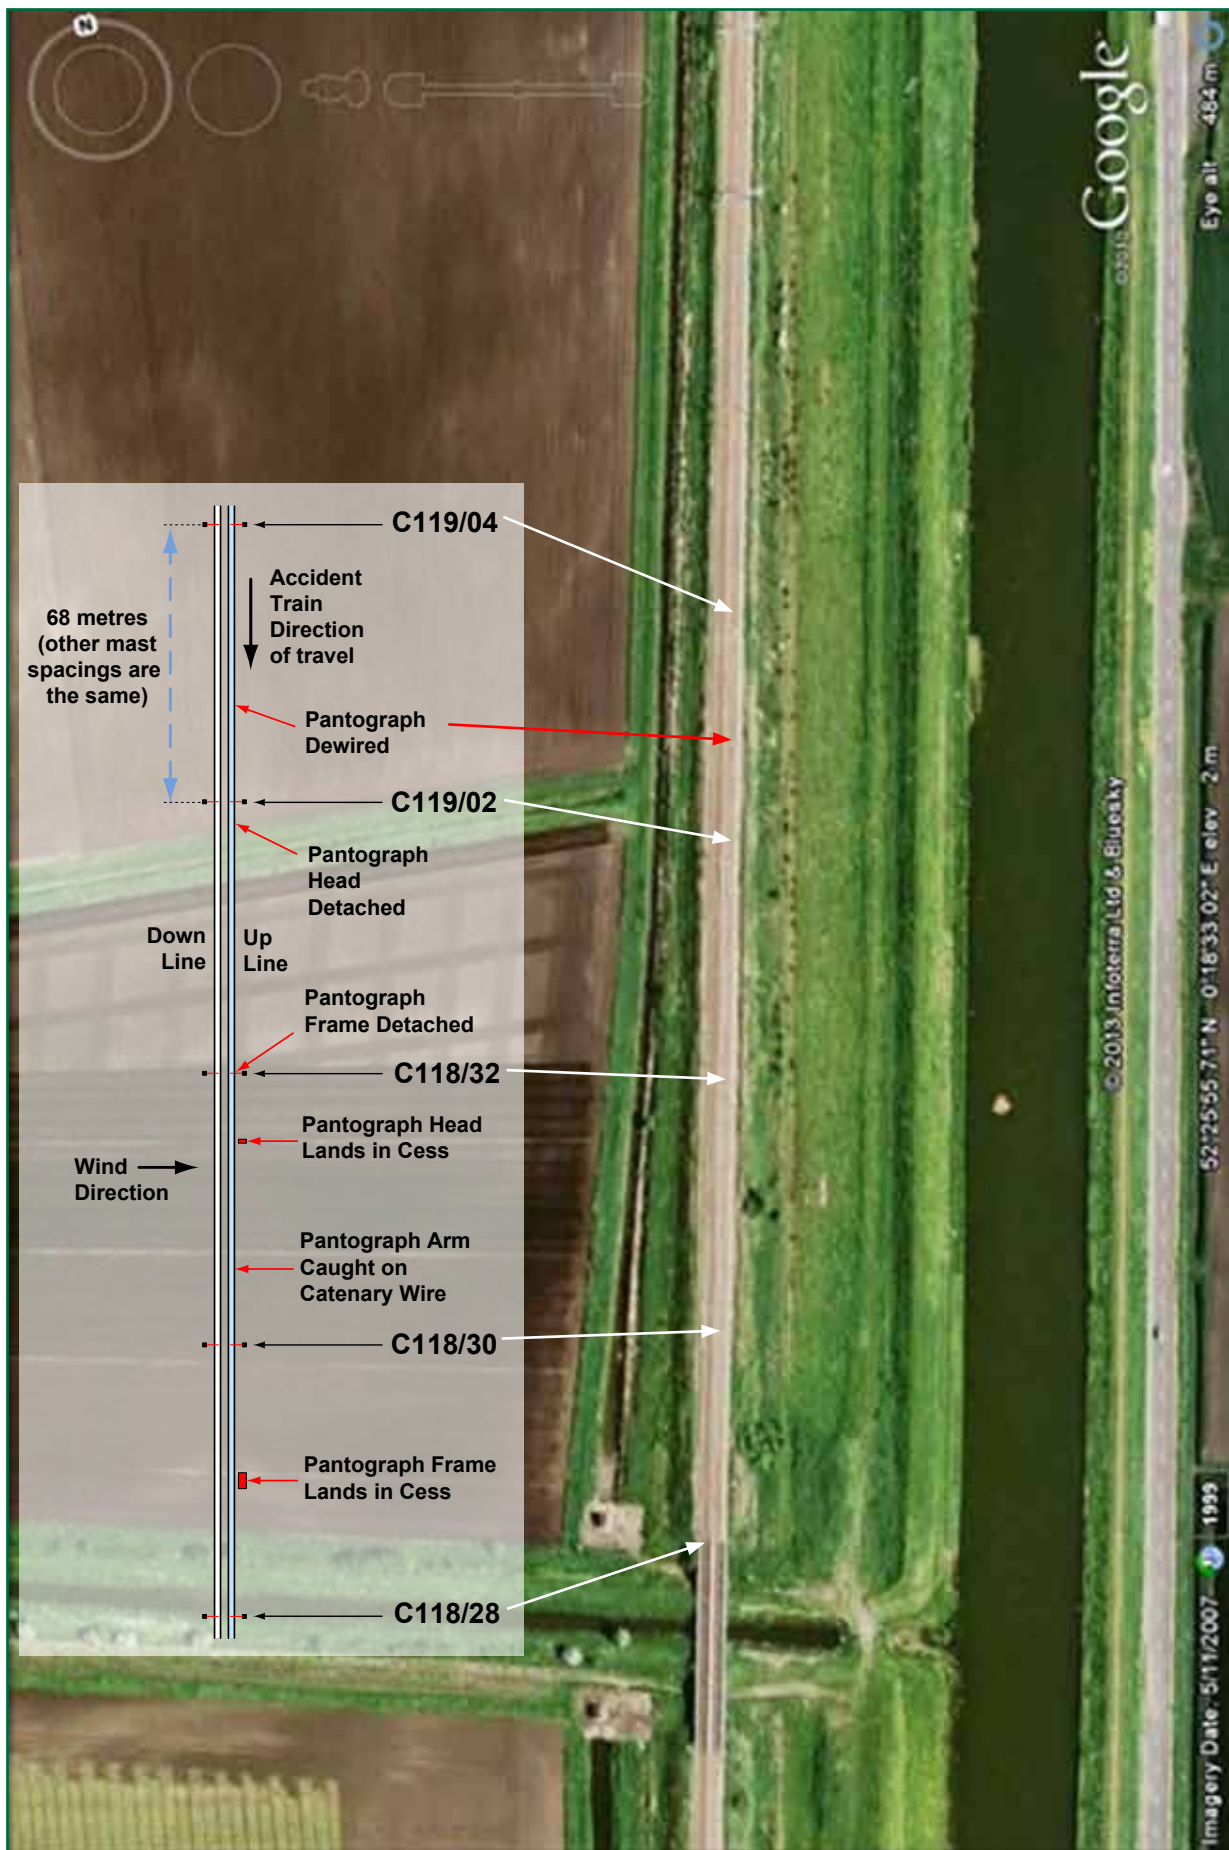
Figure 13: Overview of the accident location

- 65 The RAIB examined the damage to both the pantograph and the overhead line equipment. This, in conjunction with photographic evidence of where the damaged components came to rest, allowed the RAIB to develop a likely sequence of events that led to the dewatering and detachment of the pantograph (figures 13, 14 and 15).

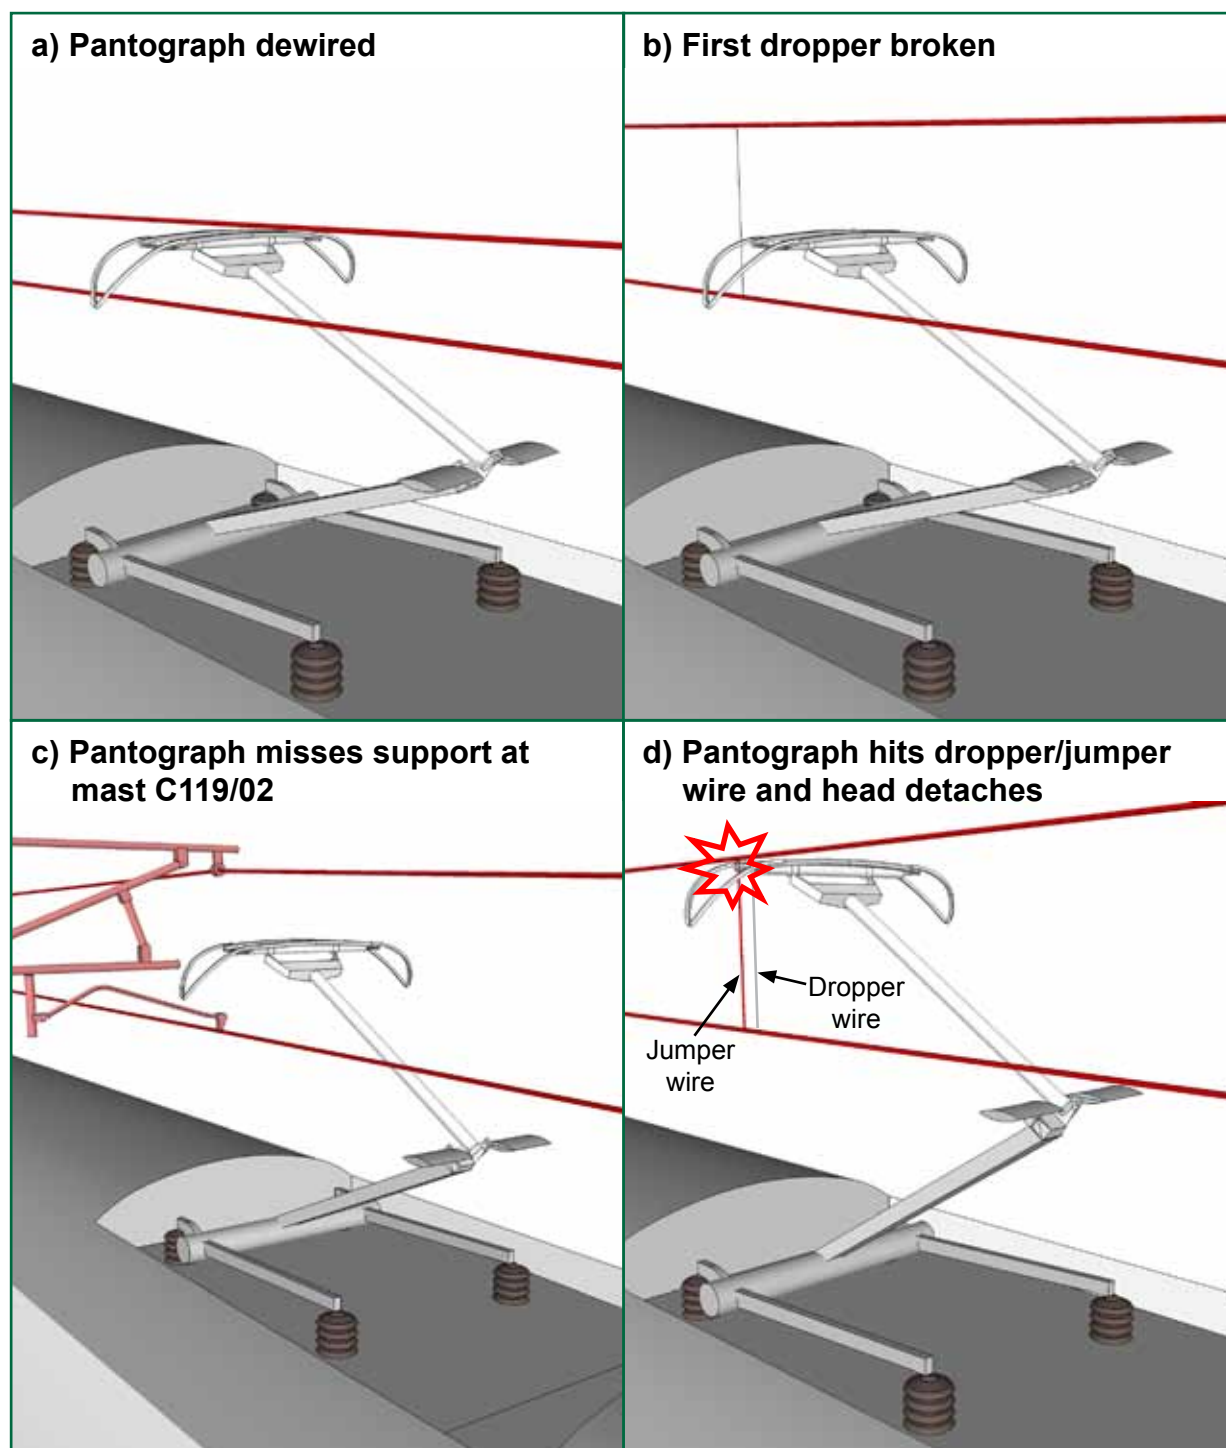
Figure 14: Illustration of pantograph failure sequence

- 66 The pantograph became dewatered to the right of the contact wire (figure 14a), between electrification mast numbers C119/04 and C119/02.
- 67 The pantograph head moved into the gap between the contact wire and the catenary wire, and broke a dropper wire as the train moved towards electrification mast C119/02 (figure 14b).

- 68 At mast C119/02, the overhead line was supported from the left, while the pantograph arm was positioned to the right of the contact wire. The pantograph head passed this mast without hitting any of the cantilever structure (figure 14c).

- 69 The pantograph head, still between the contact and catenary wires, hit the first dropper wire after mast C119/02 (figure 14d). Adjacent to this dropper wire was a jumper wire, which had a much bigger cross section (it was designed to make a good electrical connection between the catenary and contact wires, rather than to provide mechanical support). It is likely that the pantograph head became detached from the arm as a result of hitting the jumper wire. The next five dropper wires, up to mast C118/32, remained intact as the pantograph arm passed to the right of them.

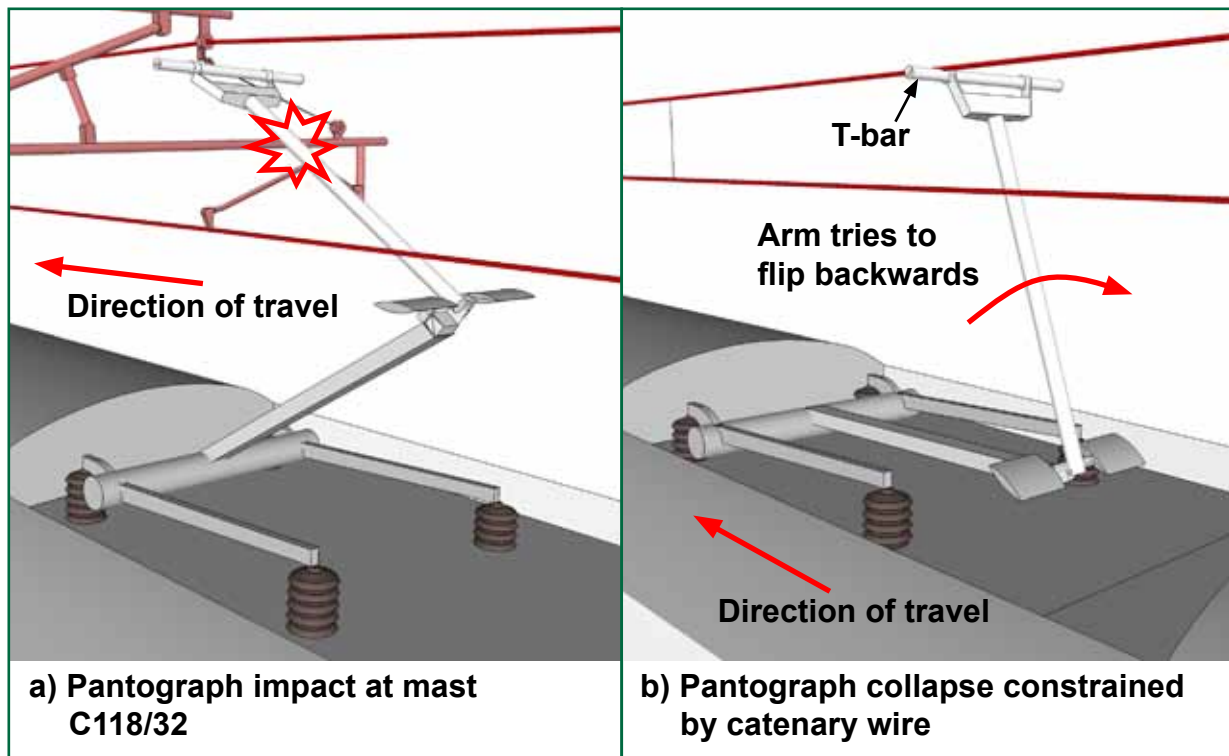
Figure 15: Illustration of pantograph failure sequence (continued)

- 70 At mast C118/32, the overhead line was supported from the right side, meaning that the cantilever structure was hit by the pantograph arm, which was still positioned to the right of the contact wire (figure 15a).

- 78 When the pantograph arm collapsed, aerodynamic forces from the forward movement of the train, as well as friction forces as the upper arm was dragged along the underside of the catenary wire, would have acted to try and flip the upper arm backwards. However, because the pantograph T-bar was below the catenary wire, and there was insufficient space between the roof of the train and the catenary wire, the upper arm was unable to flip backwards (figure 15b).

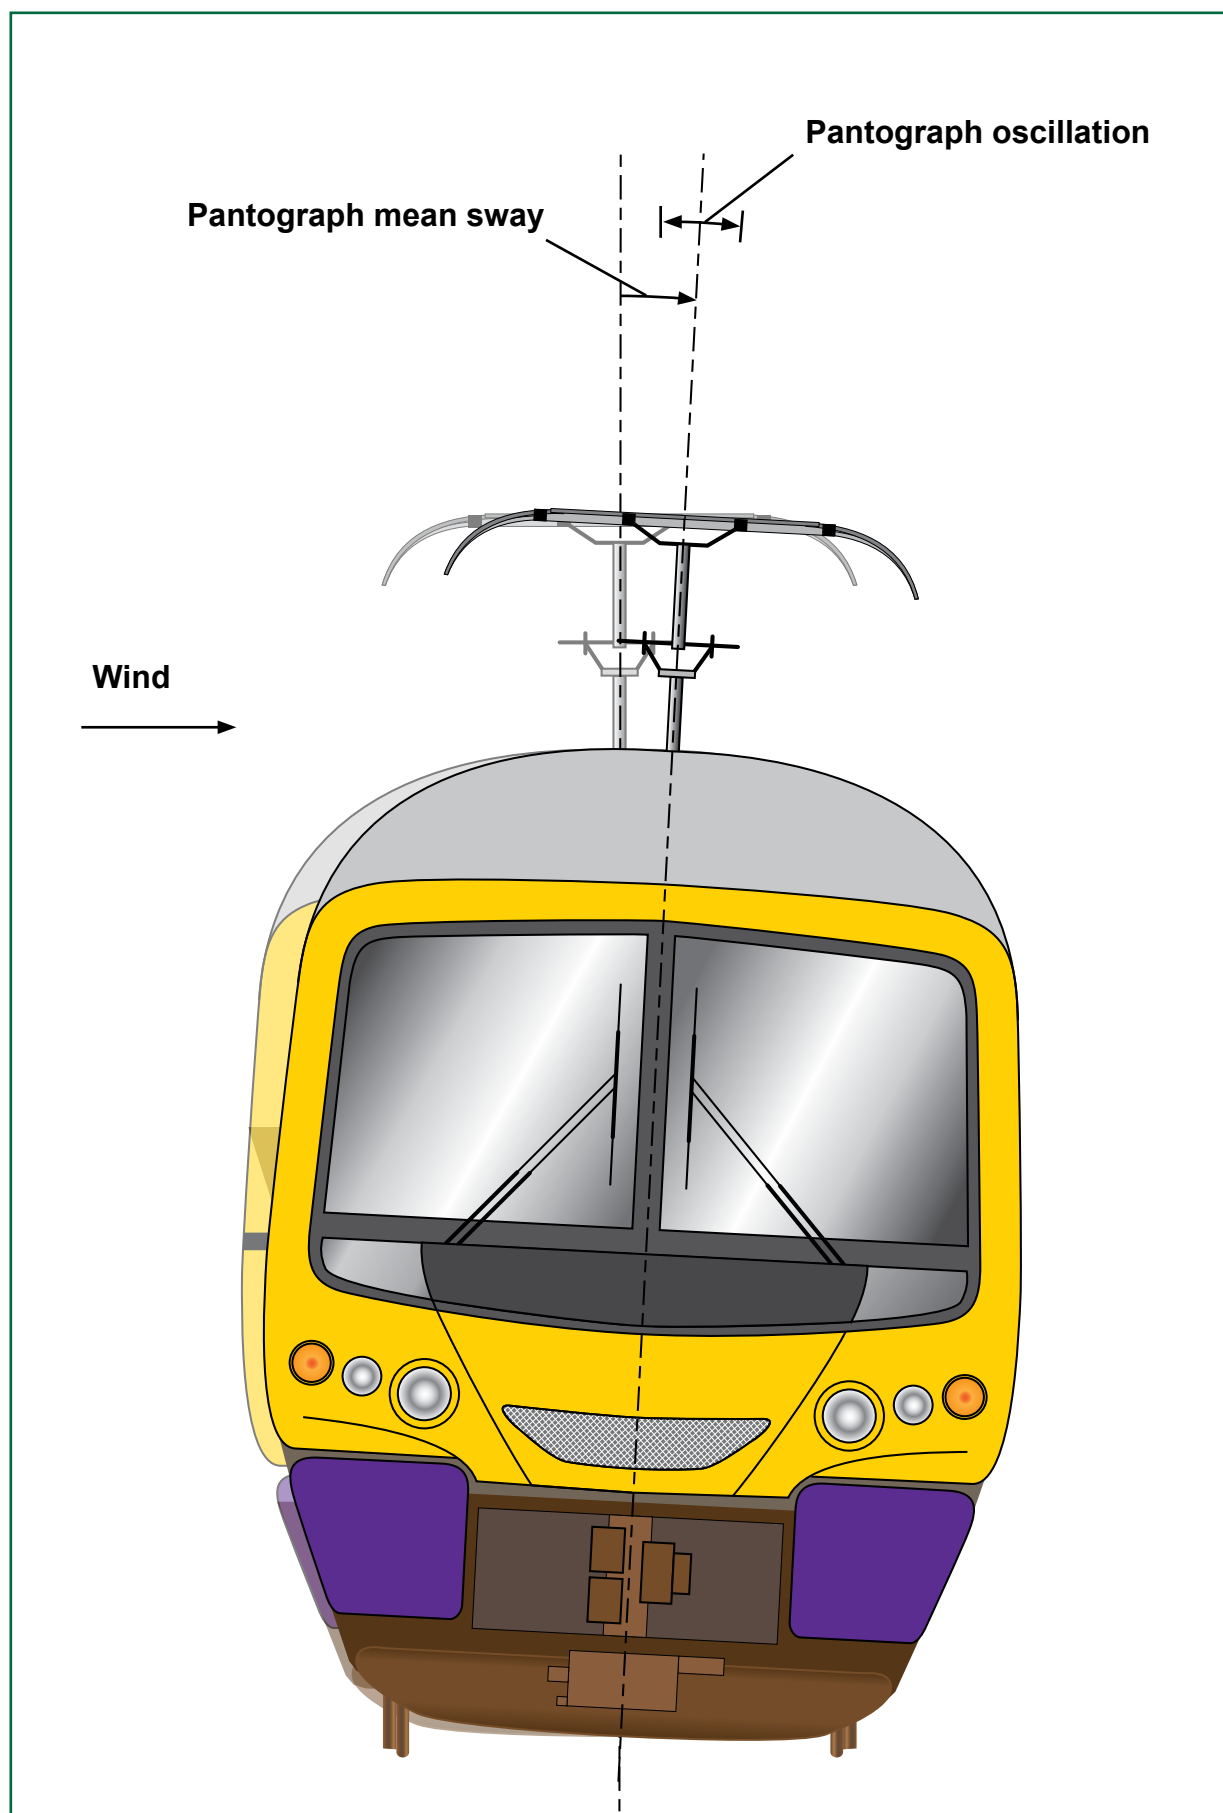
Figure 19: Illustration of train sway

- 102 The post-accident modelling considered two scenarios with winds gusting to 37 mph and 55 mph (16 m/s and 25 m/s), similar to the likely wind range at the accident location (paragraph 56). The modelling showed that the train swayed about a mean position on the down-wind side of the track centre line (figure 19).

- 103 The RAIB has used the RSSB modelling data to assess the approximate mean sway and the approximate amount of oscillation at the pantograph head for a lightly loaded train with a pantograph height of 4.96 metres (the accident situation) in the likely range of wind speeds. A mean sway of 72 mm, with an oscillation of 37 mm each side, was obtained for the lower end of the range (42 mph gust at contact wire height). Corresponding values of 111 mm and 39 mm were obtained for the upper end of the range (61 mph gust at contact wire height).

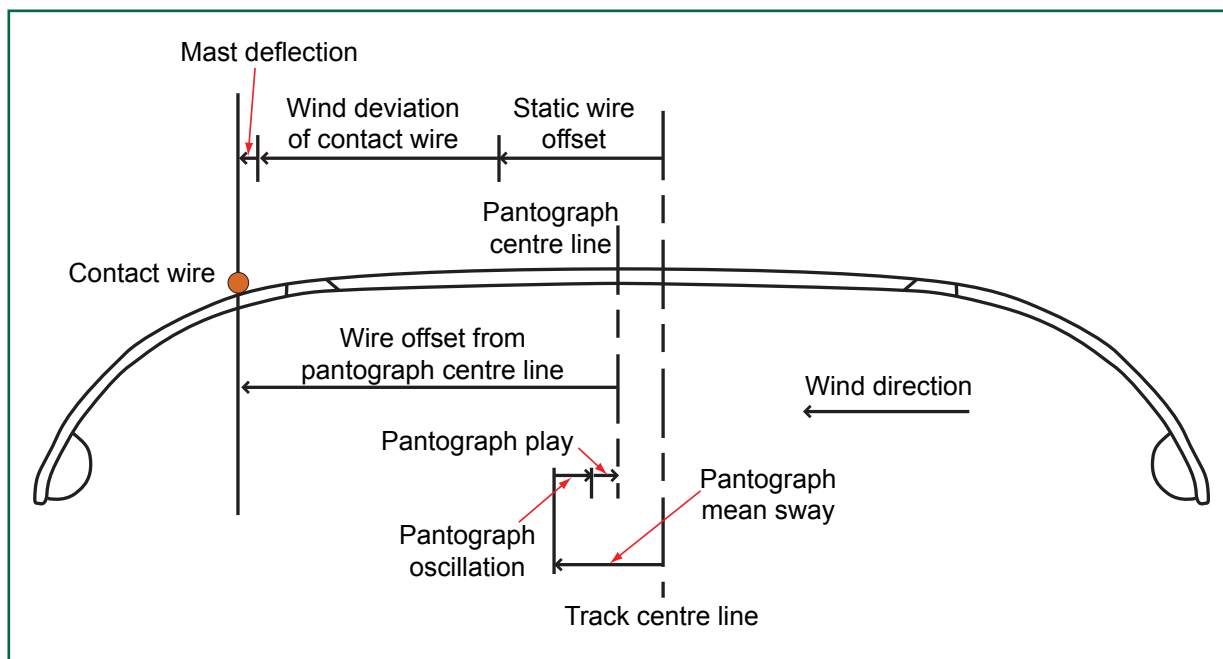
Figure 20: Pantograph head profile showing the factors affecting the contact wire position

- 105 Table 4 and figure 20 summarise the characteristics which affect the contact position of the overhead line on the pantograph at the wind speeds of interest. Positive values indicate movements in the direction tending to cause dewirement. Oscillating values (eg pantograph play) are shown in the configuration most likely to cause dewirement.

- 106 This shows that, if the most adverse effects occur simultaneously, the contact wire could deviate up to 465 mm from the centre of the pantograph during the maximum likely gust speed at the time of the accident. However a higher deviation would be possible in the presence of the feasible gusts (paragraph 112).
- 107 The pantograph head is curved downwards towards the ends, to allow the contact wire to run on and off the pantograph as the train passes the ends of wire runs and locations where adjacent lines converge and cross. It also has an upwards force applied to it to keep it in contact with the overhead line (paragraph 40). Because of this the pantograph will push up past the contact wire, and dewirement will occur, if the wire moves too far from the centre line of the pantograph head.

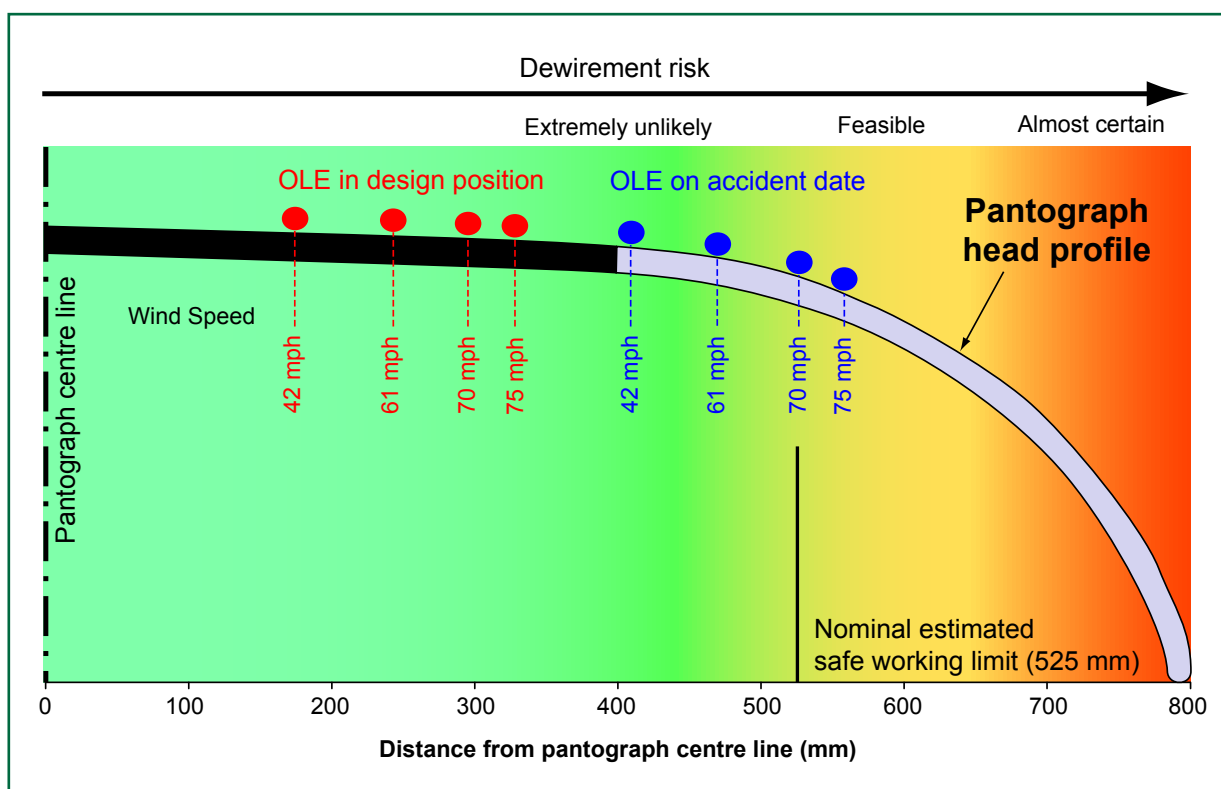
Figure 21: Illustration of dewirement risk in high winds (worst case conditions)

- 114 Figure 21 gives a qualitative illustration of how the dewirement risk relates to contact wire position on the pantograph head. This shows that a dewirement starts to become feasible when the contact wire moves past the safe working limit. As the wire moves further across the pantograph head, the likelihood of dewirement increases, until it becomes almost certain as the contact wire moves towards the end of the horn. Factors affecting the likelihood of dewirement include the time that the contact wire remains beyond the safe working limit, the tension in the contact wire, and the up force on the pantograph.

- 115 Figure 21 also shows the worst case positions of the contact wire in different wind conditions, indicating that a dewirement was feasible in gusts of 70 mph, with the likelihood increasing for higher wind speeds. Figure 21 also shows that dewirement would have been extremely unlikely to have occurred if the overhead line had been maintained in the design position.

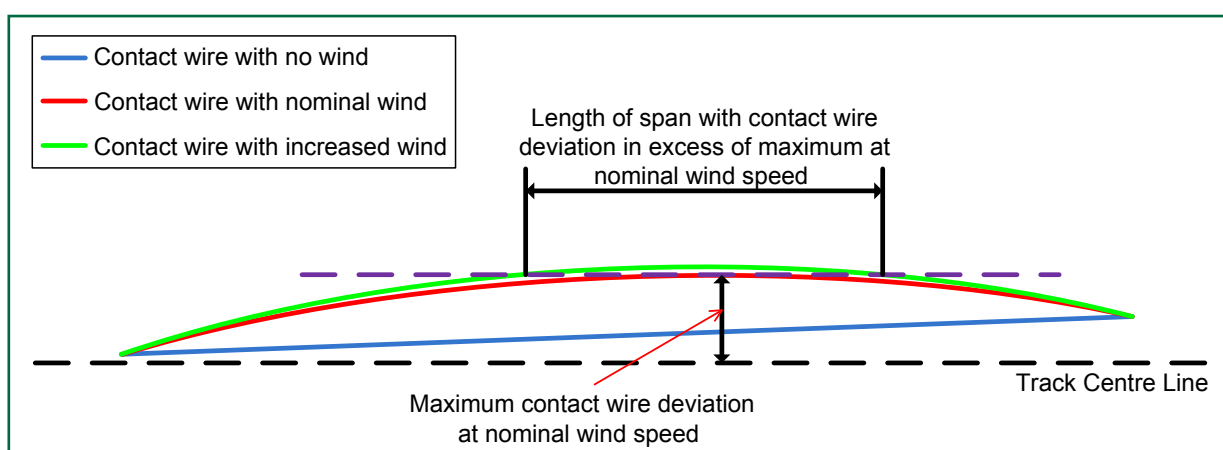
Figure 22: Effect of increased wind speed

- 116 The contact wire deviations due to wind, shown in table 4, are the maximum values which occur at only one position on the 68 metres long wire span. However, a significant length of wire is close to this value. As a result, if the wind speed is increased, even by a small amount, a significant length of wire moves beyond the original deviation (figure 22). For example, if the wind speed is increased by 1 mph, more than 15% (10 metres) of the span moves to a position beyond the original maximum deviation. Similarly, if the wind speed increases by 5 mph, more than 34% (23 metres) of the span moves to a position beyond the original maximum deviation. This shows that a small change in the wind speed can have a large effect on the length of the overhead line that exceeds a defined wind deviation, and thus a large effect on the probability of a dewirement occurring. The lengths of span affected by changes in the wind speed do not change significantly for wind speeds in the range 42 mph to 70 mph (19 m/s to 31 m/s).
