Rail Accident Report

Derailment of a freight train at Shrewsbury station, 7 July 2012

Report 08/2013
July 2013

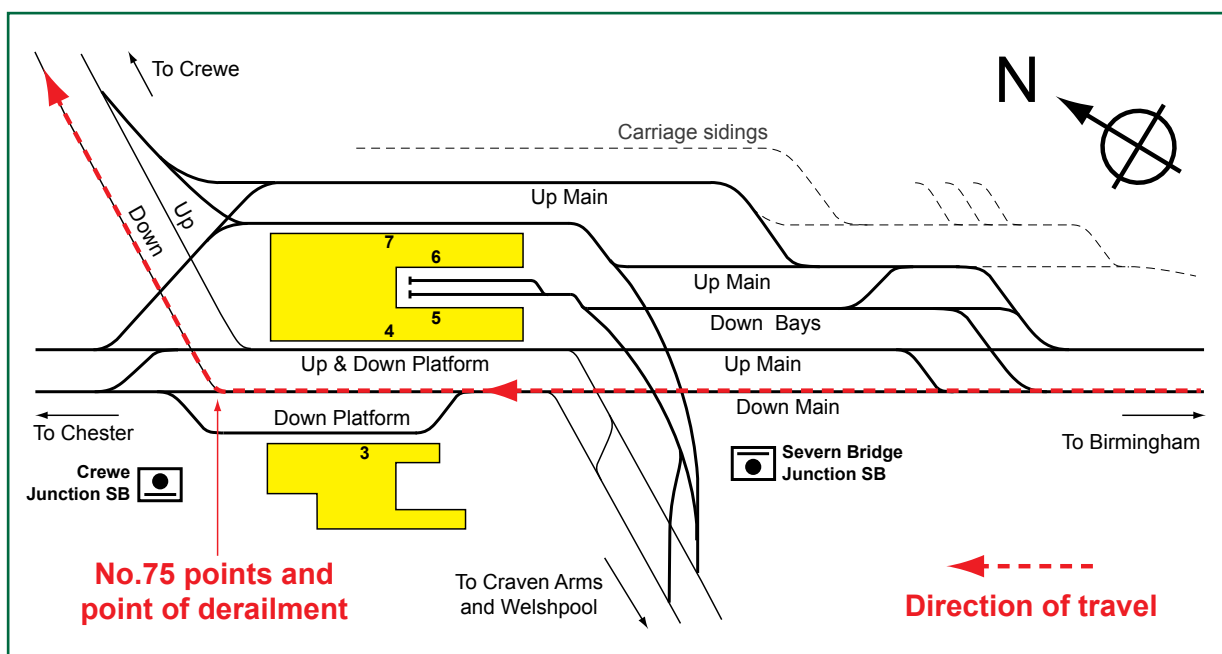
Figure 3: Schematic diagram showing location of accident

- 9 Shrewsbury station is located at 171 miles and 46 *chains* from Paddington via Oxford and Birmingham Snow Hill. The train derailed on No. 75 points at 171 miles 53 chains located at the north end of the station at a place known as Crewe Junction (figure 3). These points enable the traffic travelling along the *down main* line to be directed either towards Chester or towards Crewe. Train 6M61 was heading towards Crewe. The maximum permitted speed on the down main line and through the junction is 15 mph (24 km/h).

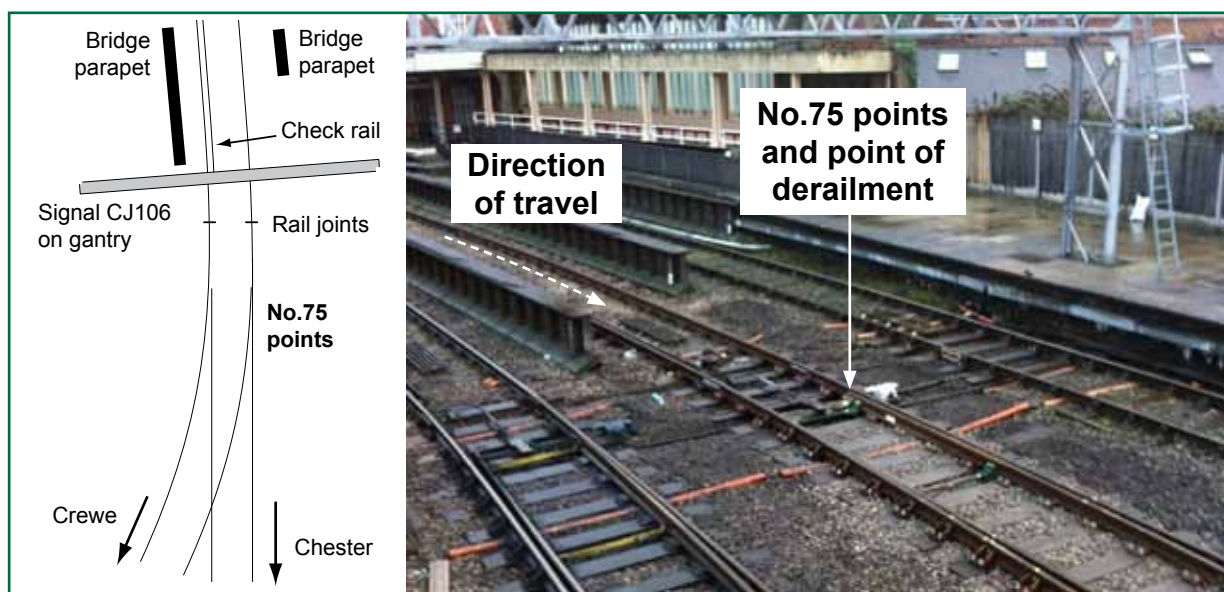
Figure 4: Layout of the area

- 11 The down main line on the approach to No. 75 points is laid on a curve (130 metres radius at its tightest) on top of a bridge. Along the curve, the inner rail is fitted with a *check rail* which terminates 2.8 metres before the *toe* of the points. The track in the area is *jointed track* with the closest rail joint located approximately 1.7 metres before the toe of the points. Figures 4 and 5 show the track layout in this area. The rails on the approach to No. 75 points are laid on *vertical baseplates* except for the section of track between the end of the check rail and the toe of the points which were on *inclined baseplates*. No. 75 points are of the *B-type* with two *permanent way stretcher bars* and one *lock stretcher bar*. The *flat-bottomed rails* in No. 75 points are laid on vertical baseplates and the switch rails are *full depth*. There is no *supplementary drive*.

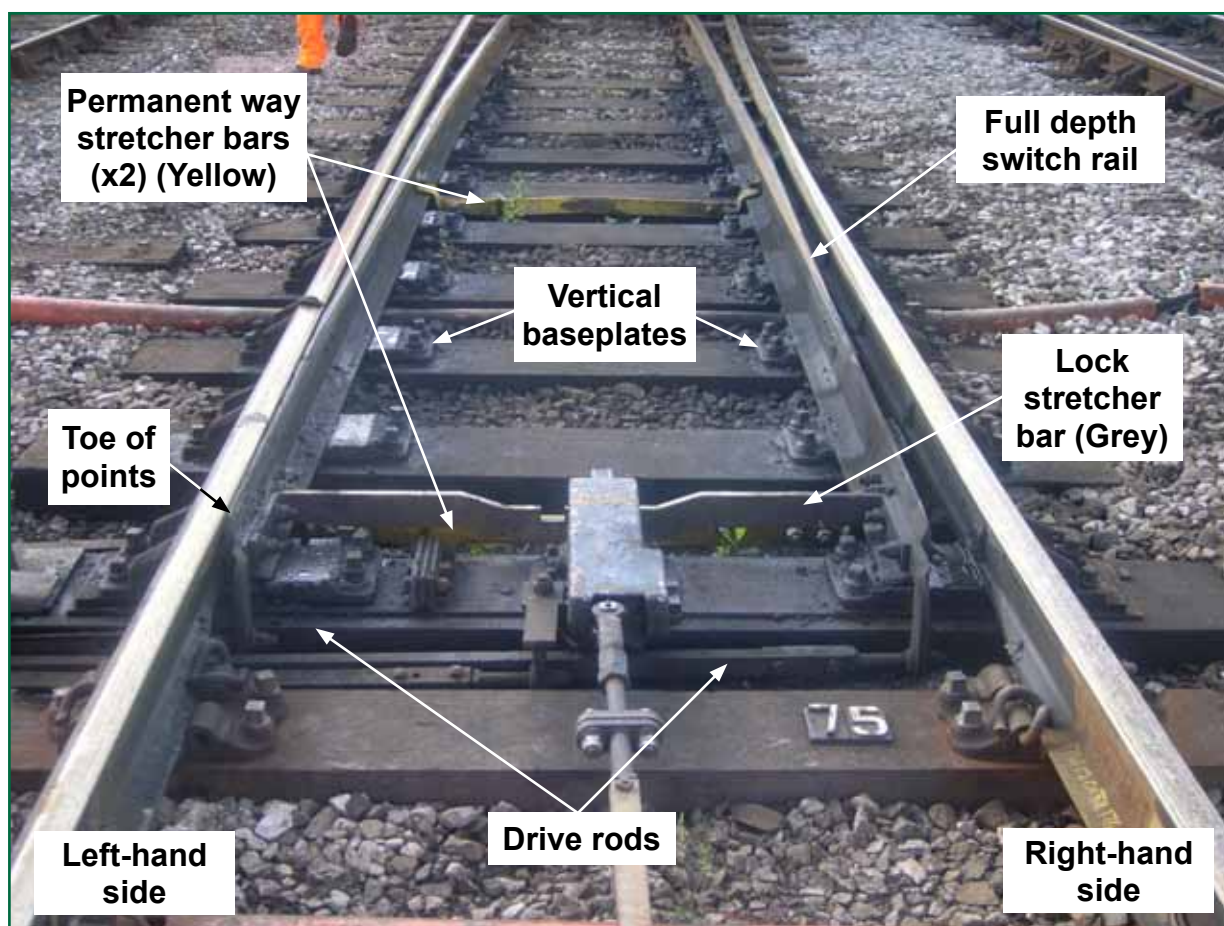
Figure 5: No. 75 Points

23 Wagon 370510 derailed on No. 75 points because the points were unsafe to negotiate due to wear and damage.

- 24 After the derailment at Shrewsbury and before any further rail traffic passed over them, the RAIB examined No. 75 points and found signs of wear and damage which are believed to have been there before the derailment. After removal of the grease and residue, the examination revealed that the left-hand switch rail was worn and damaged close to the toe of the points (figure 7). The switch rail damage started 120 mm from the toe of the points and continued for an additional 110 mm. The switch rail wear started close to the toe of the points (approximately 50 mm from the toe) and extended beyond the damage. The presence of grease obscuring the damage on the switch rail indicates that the damage is unlikely to be a consequence of the accident. The RAIB carried out a detailed inspection of No. 75 points against the requirements of TRK/053. The detailed inspection revealed that No. 75 points failed three out of the four checks for derailment hazards identified within the standard for this type of points. No. 75 points were therefore at risk of creating a derailment (see appendix B for more details about the results of this detailed inspection). Measurements carried out by the RAIB indicated that the first section of the switch rail, between 50 mm and 120 mm from the toe, in front of the damage, was compliant with TRK/053 despite the presence of wear.
