Rail Accident Report

Dangerous occurrence involving an engineering train at Blatchbridge Junction, near Frome, 19 March 2012

Report 15/2013
September 2013

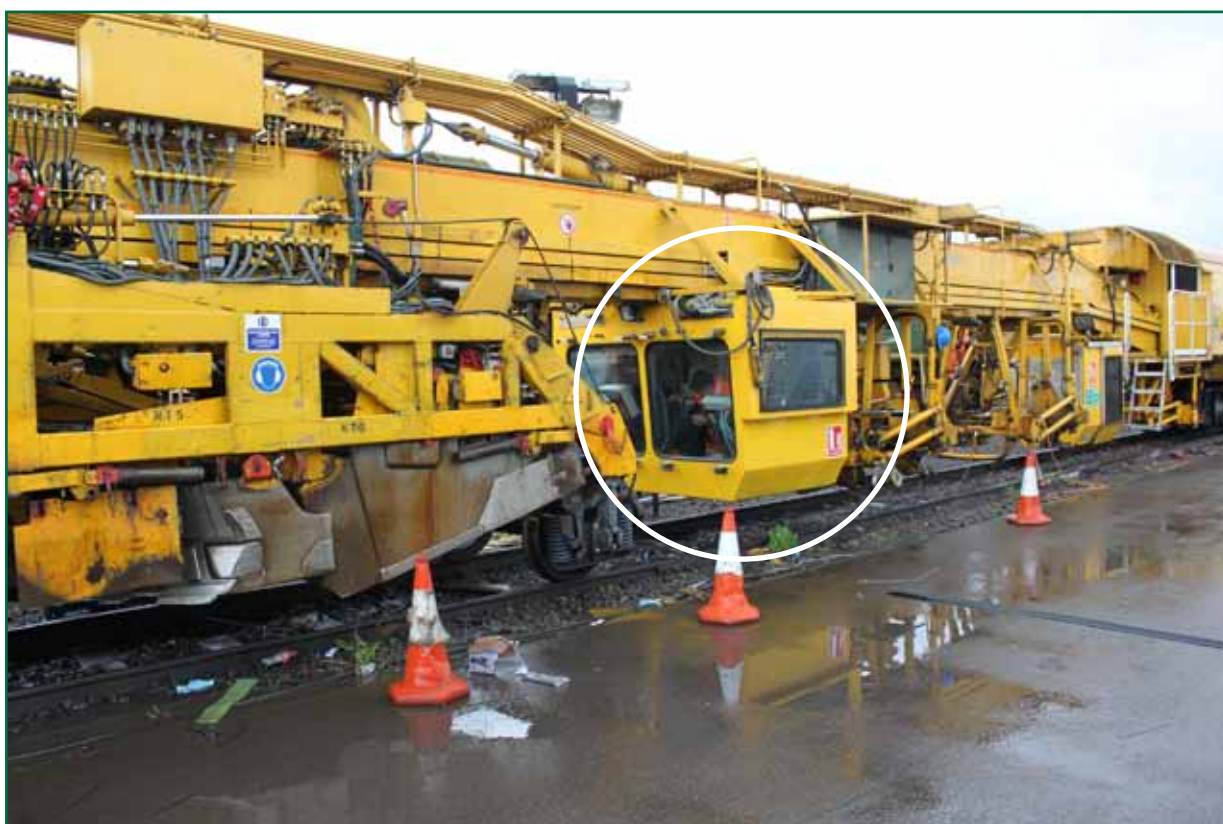
Figure 4: The P3 operators cab (circled)

- 22 The P3 cab is suspended from the vehicle using a supporting frame which is welded to an overhead beam. To minimise transmission of vibration to the occupants of the P3 cab when the machine is working, the cab is secured to the supporting frame by eight flexible mounts. Each flexible mount is secured to the frame by two steel bolts. Each flexible mount secures the P3 cab to the supporting frame by one steel bolt (figure 5). It was the failure of these bolts that allowed the P3 cab to fall onto the track.

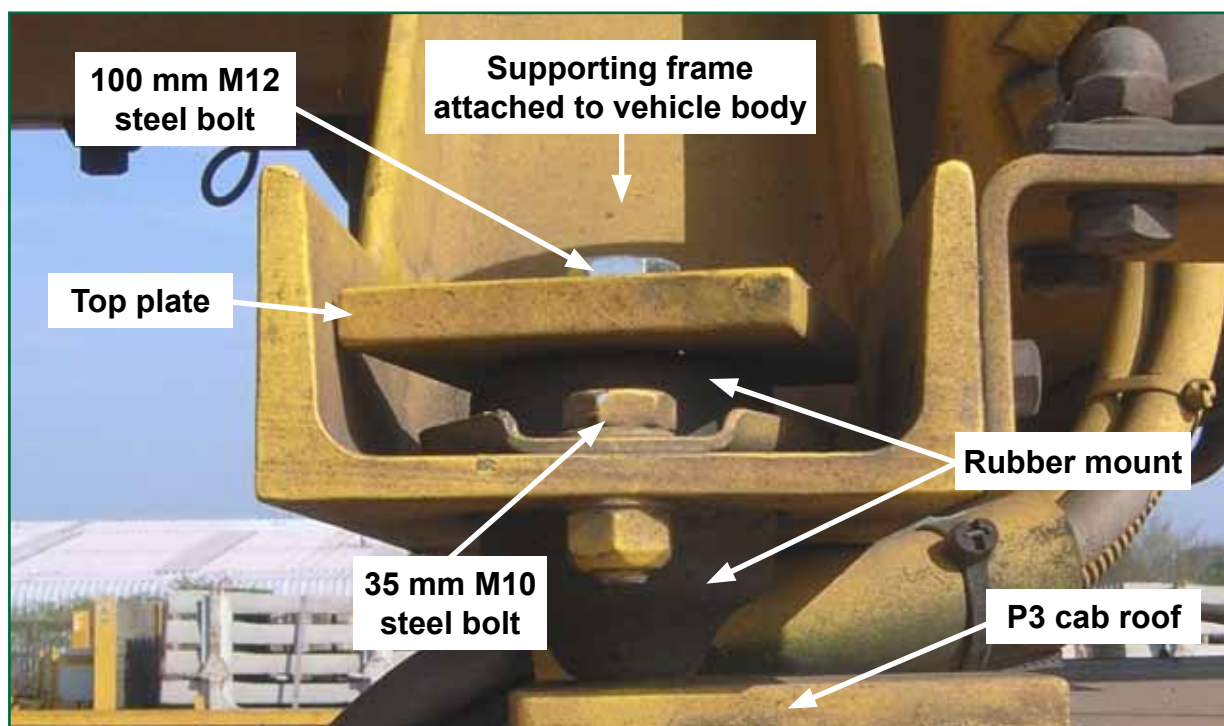
Figure 5: The flexible mounting arrangement

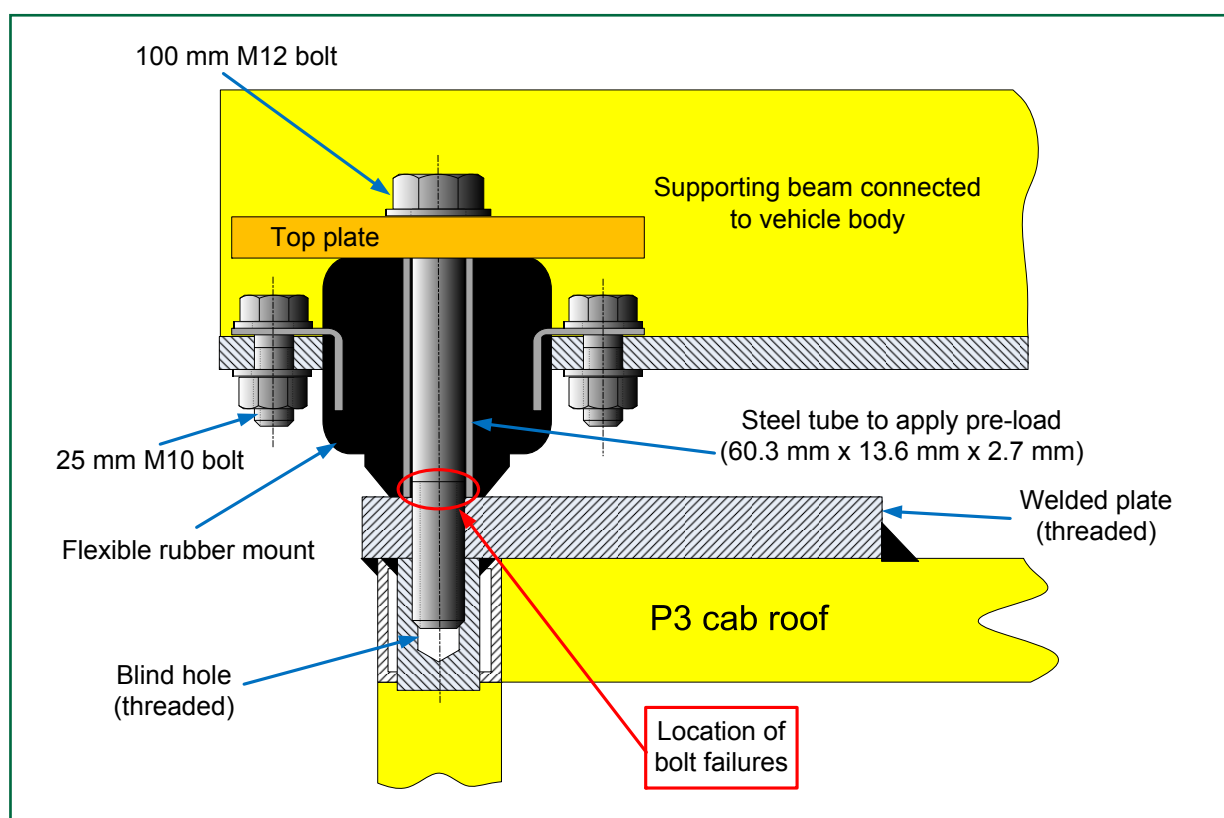
- 38 The P3 control cab is suspended from the supporting framework of its vehicle by eight flexible mounts: four at the front relative to the direction of travel (referred to in the report as F1 to F4) and four at the rear (referred to in this report as R1 to R4).
- 39 Each flexible mount is bolted to the control cab roof by means of one 100 mm long M12, grade 8.8 steel bolt passing through a steel washer and steel top plate into a threaded *blind hole* in the roof via a steel tube incorporated within the rubber mount (figure 8). The steel tube serves as a spacer, against which the bolt is tightened in order to generate a *preload* without compressing the rubber mount. The rubber mount is attached to the vehicle's supporting structure by two 25 mm M10 steel bolts. Witness evidence indicates that the bolts supplied to Matisa were zinc plated, for protection from corrosion.

Figure 8: Representation of the flexible mounting arrangement (not to scale)

- 62 The corrosion on the threads was most likely to have been caused by moisture ingress through capillary action at imperfections around the interface between the bottom of the flexible mount (which was not designed to seal against the P3 cab) and the cab roof (figure 8). Bolts that had corrosion along their shanks, right up to the bolt heads, may have been exposed to moisture ingress from the interface between the bolt head and the top of the flexible mount, once the bolt had failed and the joint was no longer tightly clamped. Although the bolts were zinc plated for corrosion protection, contact between the threads of the bolt and the threaded hole of the cab roof appears to have removed this protection (figure 19 insert). It is also possible that the corrosion protection was imperfect at the thread roots. In either case, unprotected metal could have been exposed to moisture, allowing corrosion to develop and fatigue cracks to initiate from some of the corrosion pits in the presence of service stresses (paragraphs 50 to 54) until the affected bolts eventually fractured.

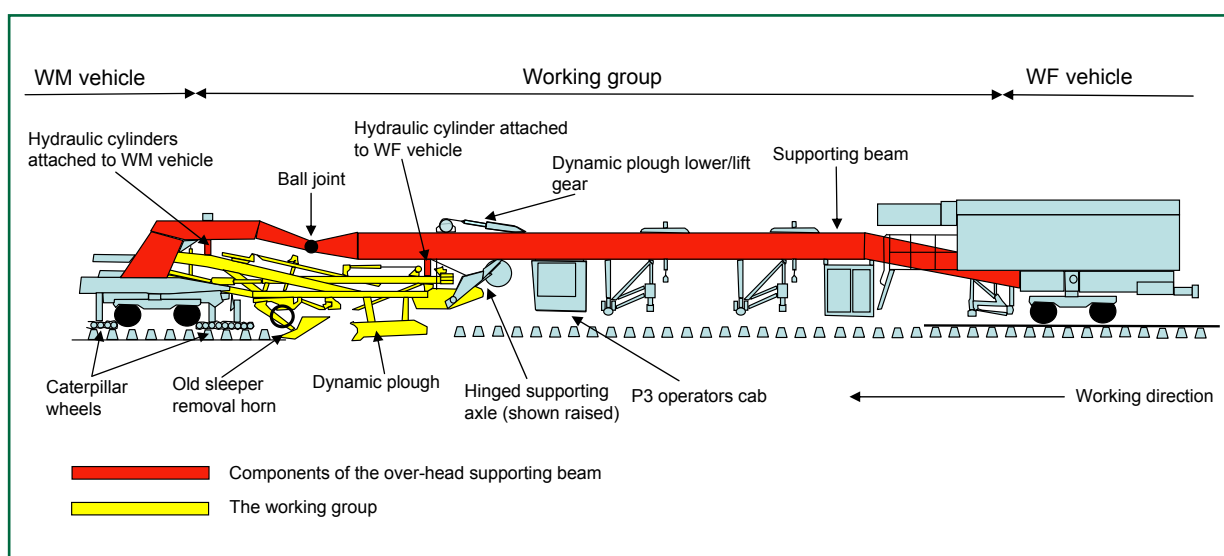
- 58 The dynamic plough and old sleeper removal horn are two of the tools attached to the P95/1 UK (figure 15). These tools are attached to a two-part overhead supporting beam. The front of the plough and horn assembly is supported by two hydraulic cylinders attached to the supporting beam, and the rear of the plough and horn assembly is suspended by a single hydraulic cylinder. The two parts of the overhead supporting beam are connected by a ball joint which permits movement between the two parts of the overhead supporting beam when the caterpillar wheel sets are deployed on the vehicle ahead of the working group. Loading of the bolts during operation of the machine in working mode was not considered in the original design of the cab mounts (paragraph 97).

Figure 15: Simplified plan of the working group and adjacent vehicles, including the working group (yellow) and overhead supporting beam (red)

- 59 When the plough and horn are deployed, the forces acting on them may be reacted through the overhead supporting beam. Data from the service tests (paragraph 50) appears to indicate that these forces may cause the beam to flex in such a way as to cause high strains in the cab mounting bolts without significant accelerations in the cab (paragraph 52). However, it was not possible from the measurements to determine exactly how the bolts were becoming loaded and it is not known if the bolts on the other P95 machines experience the same loading as the P95/1 UK machine.
