Rail Accident Report

Fatal accident at Athelney level crossing, near Taunton, Somerset 21 March 2013

Fatal accident at Athelney level crossing, near Taunton, Somerset, 21 March 2013

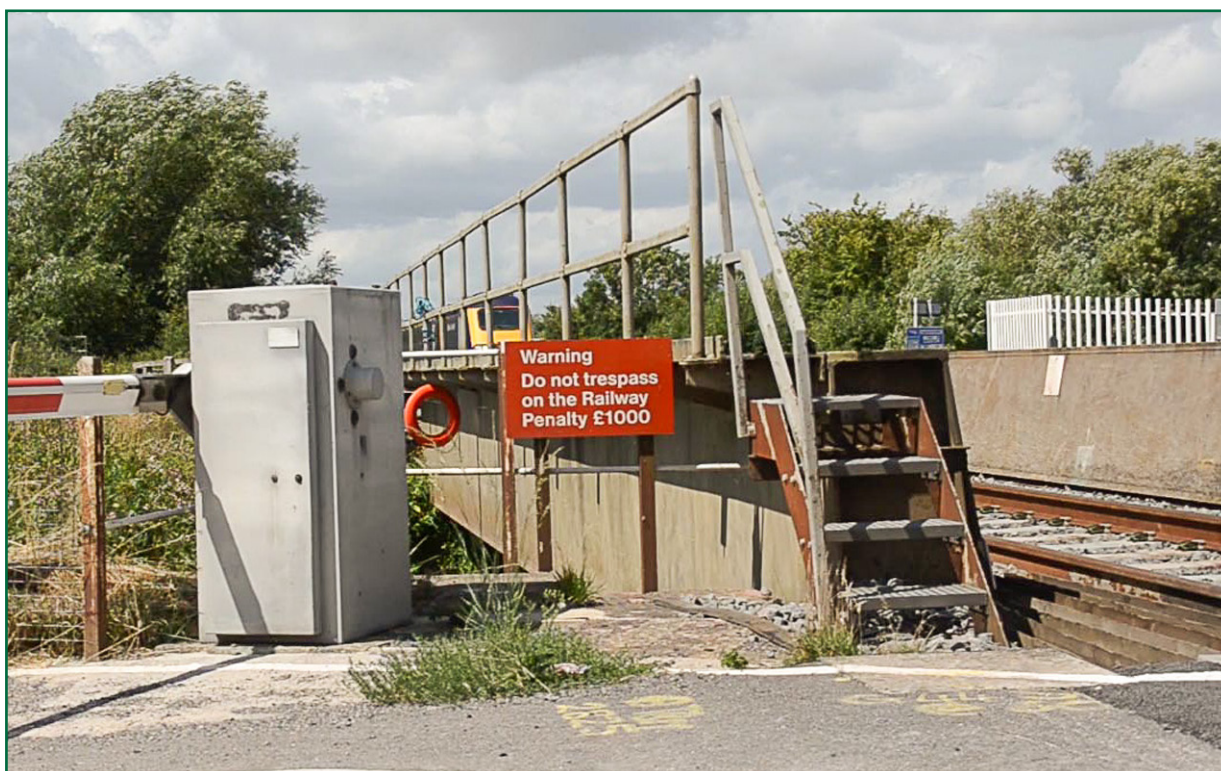
Figure 5: Motorist's eye view of a passenger train approaching Athelney on the Up Athelney line

58 A video taken by the RAIB from the perspective of the motorist (figure 5), indicates that the yellow front end of train 1A73 would have been visible for approximately four seconds, and the headlights of the train for less than two seconds, before it reached the crossing on the Up Athelney line. It would therefore not have been possible for the motorist to react in time to avoid a collision with an approaching train.
